# **EARTHQUAKE DAMAGE LOMA PRIETA EARTHQUAKE OCTOBER 1989**

## **PART 2: EFFECTS IN SAN FRANCISCO AND OAKLAND**

# **THE LOMA PRIETA EARTHQUAKE**

### **PART 2: EFFECTS IN SAN FRANCISCO AND OAKLAND**

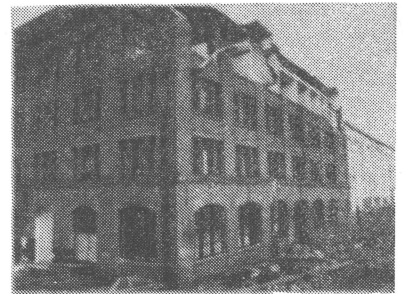
**1** The fourth-story wall of this unreinforced masonry building on Bluxome Street near Sixth and Townsend collapsed onto the street, crushing five people in their cars. No one in the building was killed. Photograph Credit: U.S. Geological Survey (E.V. Leyendecker).

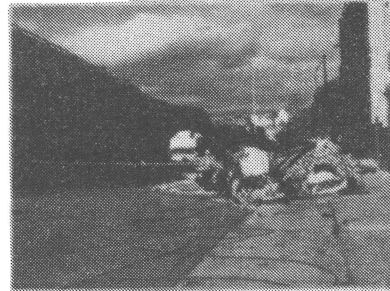
**2** Detail of damage to cars in which five people were killed by parapet collapse of the four-story building on Bluxome Street. The 6th Street freeway on-ramp is visible on the left of the photo. This building is located in an area south of Market Street that had a number of damaged buildings. An eight story building in the same area was damaged severely and had to be demolished. Photograph Credit: U.S. Geological Survey (D. Perkins).

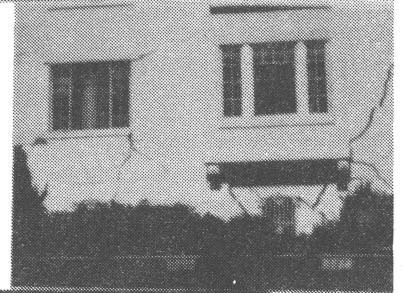
**3** These cracks in a building along Jefferson Street in the Marina District of San Francisco are typical of the damage in that area. One hundred eighty-five buildings were structurally damaged in the area. Photograph Credit: U.S. Geological Survey (D. Perkins).

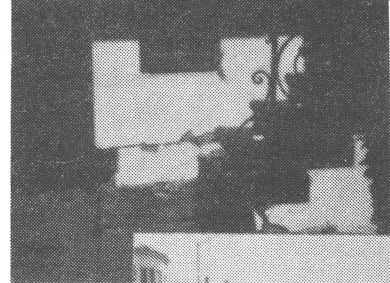
**4** This house along Jefferson Street in the Marina District shifted more than 10 cm on its foundation. Houses that were not bolted to their foundations were particularly vulnerable to damage. Photograph Credit: U.S. Geological Survey (D. Perkins).

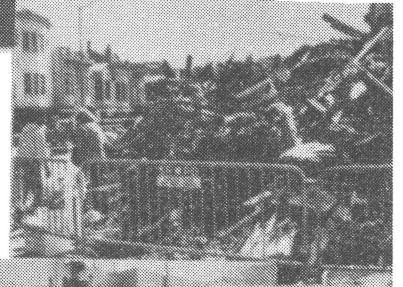
**5** This collapsed and demolished building along Jefferson Street is typical of about 35 buildings that were eventually torn down. Note buildings that remain standing at left and at right top. Photograph Credit: U.S. Geological Survey (D. Perkins).

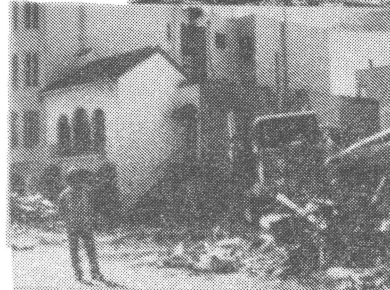
**6** Demolition of above building on Jefferson Street. View is taken around the corner from location of previous photograph. Note damage to the remaining building with an open first floor. Photograph Credit: U.S. Geological Survey (D. Perkins).

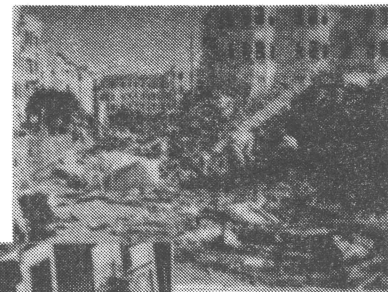
**7** Another view along Jefferson Street in the Marina District. Tenants try to salvage items from the rubble. Photograph Credit: U.S. Geological Survey (D. Perkins).

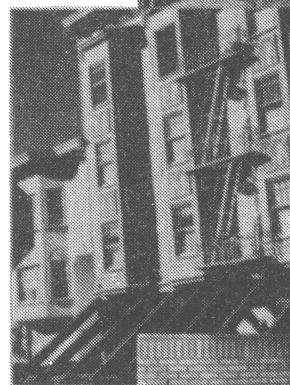
**8** Shored building on Beach Street in the Marina District. Note the garage area on the first floor beneath the apartments. This common construction practice weakened the first floors of the structures. Photograph Credit: U.S. Geological Survey (D. Perkins).

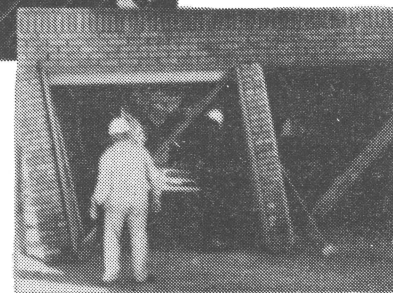
**9** Detail of shoring to garage area in building on Beach Street in the Marina District. The practice of using the first floor for garages left the building with inadequate lateral bracing on the ground level. Photograph Credit: U.S. Geological Survey (D. Perkins).

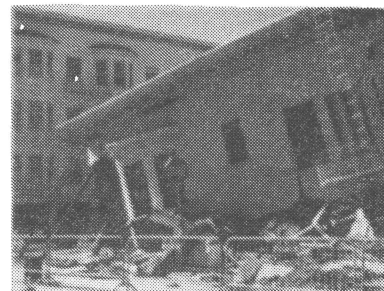
**10** A collapsed building in the Marina District. The first story of this three story structure failed when ground shaking was intensified by liquefaction. The second story collapsed, leaving only the third story. Photograph Credit: U.S. Geological Survey (D. Perkins).

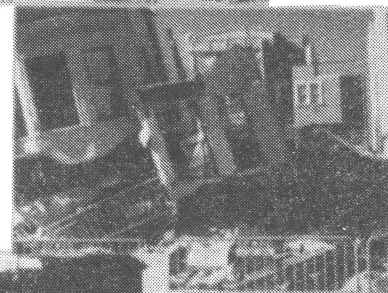
**11** A second view of the collapsed building shown in the previous slide. Nine people were killed in the Marina District as a result of the fires and the building collapses. Photograph Credit: U.S. Geological Survey (D. Perkins).

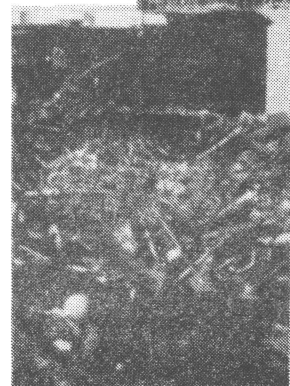
**12** Rubble after the fire at North Point Street and Divisadero in the Marina District. As in 1906 water mains failed and fires in this area could not be fought with city water. Water was pumped from a fireboat to extinguish this fire. Photograph Credit: U.S. Geological Survey (D. Perkins).

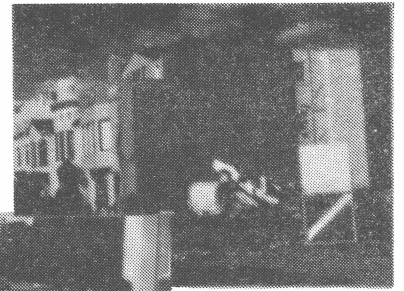
**13** Demolished cars and rubble. This view is looking east across the street from fire at North Point and Divisadero in the Marina District of San Francisco. Photograph Credit: U.S. Geological Survey (D. Perkins).

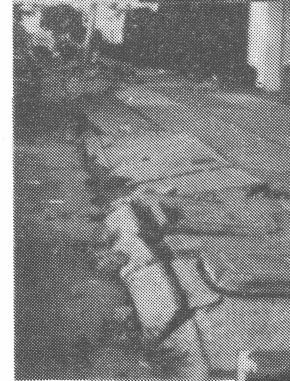
**14** View south on Webster Street in the Marina District. Sidewalk damage is the result of liquefaction of the land fill upon which the area was built. Note the upheaved section in background near pole. The manmade fill beneath the Marina was permanently deformed by liquefaction. Structures resting on the fill had to accommodate the deformation. Photograph Credit: U.S. Geological Survey (D. Perkins).

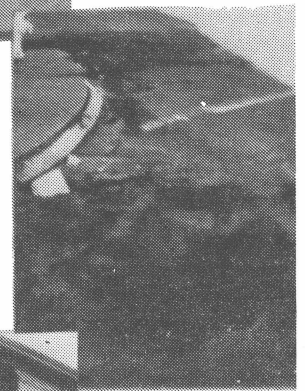
**15** The fine sand deposited near the curb is evidence of the liquefaction that took place in the Marina District of San Francisco. Some sand boils in the area spewed forth charred wood and other debris, remnants of the San Francisco that was destroyed by earthquake and fire in 1906. Photograph Credit: U.S. Geological Survey (D. Perkins).

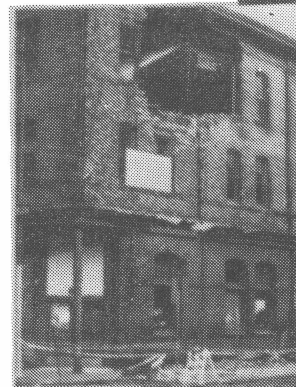
**16** Damage to the upper floor of the three-story Clay Building at the corner of 10th & Clay Streets in Oakland, California. Photograph Credit: U. S. Geological Survey (C. Stover).

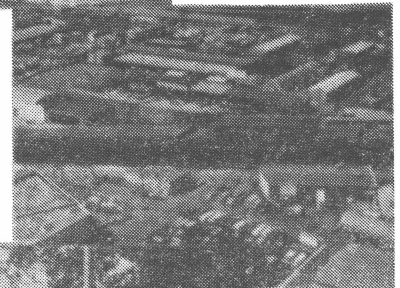
**17** Aerial view looking west of part of the collapsed Interstate 880 double-decked highway structure. Fifty-one spans of this structure were involved in the collapse which killed 41 motorists. Only one 1.2 km span, shown in the center of the photo, did not collapse. Photograph Credit: U.S. Geological Survey (E.V. Leyendecker).

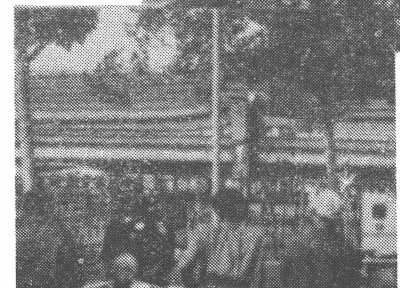
**18** Side view of the collapsed Cypress section of the Interstate 880. Note the failed column support in the center of the photo and the ambulance to remove survivors. Photograph Credit: U. S. Geological Survey (C. Stover).

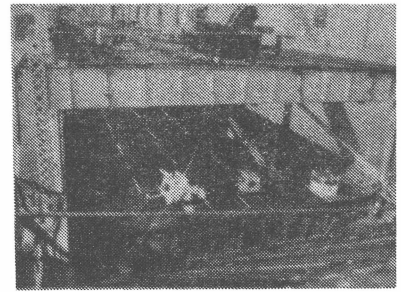
**19** View of the San Francisco Oakland Bay Bridge looking west showing the failed 15-m long section at Pier E-9. The view is looking west from the upper deck of the 88-m truss (beam) supported by Pier E-9. A 153-m-long truss, also supported at Pier E-9, is shown on the west side of the opening. The 15-m span of the upper deck was supported at the west end by bearings attached to the large north-south girder visible on the west side of the opening. These support bearings allowed expansion movement of the 15-m sections. Similar supports were provided on a girder on the east side of the opening, except the bearings were attached to prevent movement. Failure of the bearings of the 88-m (east) truss allowed movement toward the east. This pulled the 15-m sections (upper and lower), which were attached to it, off their expansion bearings on the west end. The spans then collapsed but remained partially attached at the east end. Photograph Credit: U.S. Geological Survey (E.V. Leyendecker).

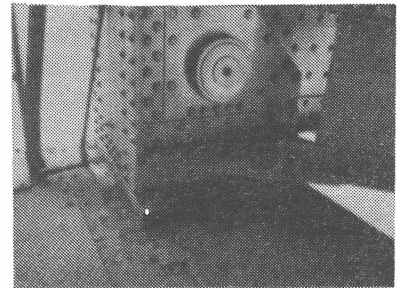
**20** Truss support bearing shoe at Pier E-9 of the San Francisco-Oakland Bay bridge. This bearing shoe was located at the northeast corner of Pier E-9 and supported the northwest corner of the 88-m truss shown in photo 16. An identical bearing shoe was located in the southeast corner. Together, these bearings provided support for the 88-m truss at Pier E-9. Each bearing shoe was attached to Pier E-9 with 20 2.54 cm diameter bolts. During the earthquake all of the bolts in both bearing shoes failed. This allowed movement of the previously attached 88-m truss. As evidenced by the exposed paint, the bearing shoe came to rest about 14 cm to the north and 1.58 cm to the east of its original position. Photograph Credit: U.S. Geological Survey (E.V. Leyendecker).
