# PATA DAYS 2017: 8<sup>th</sup> International Workshop on Paleoseismology, Active Tectonics and Archeoseismology

Blenheim, New Zealand

November 13 – 19, 2017

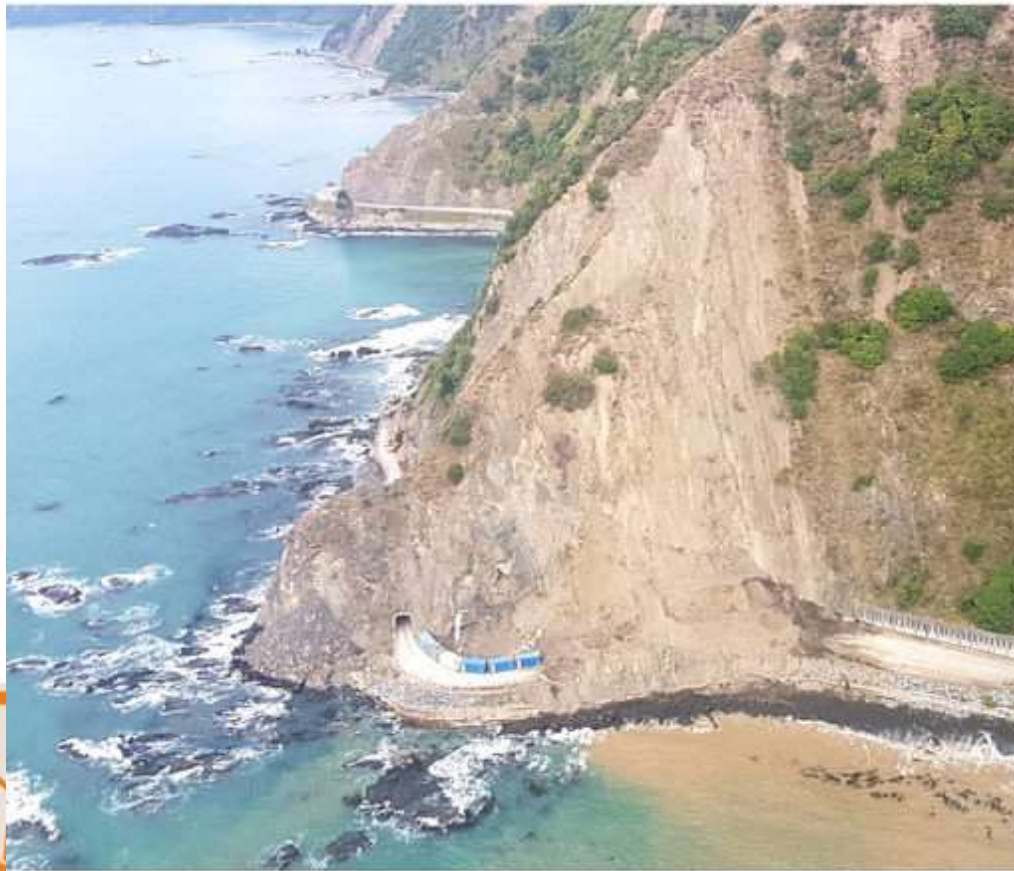
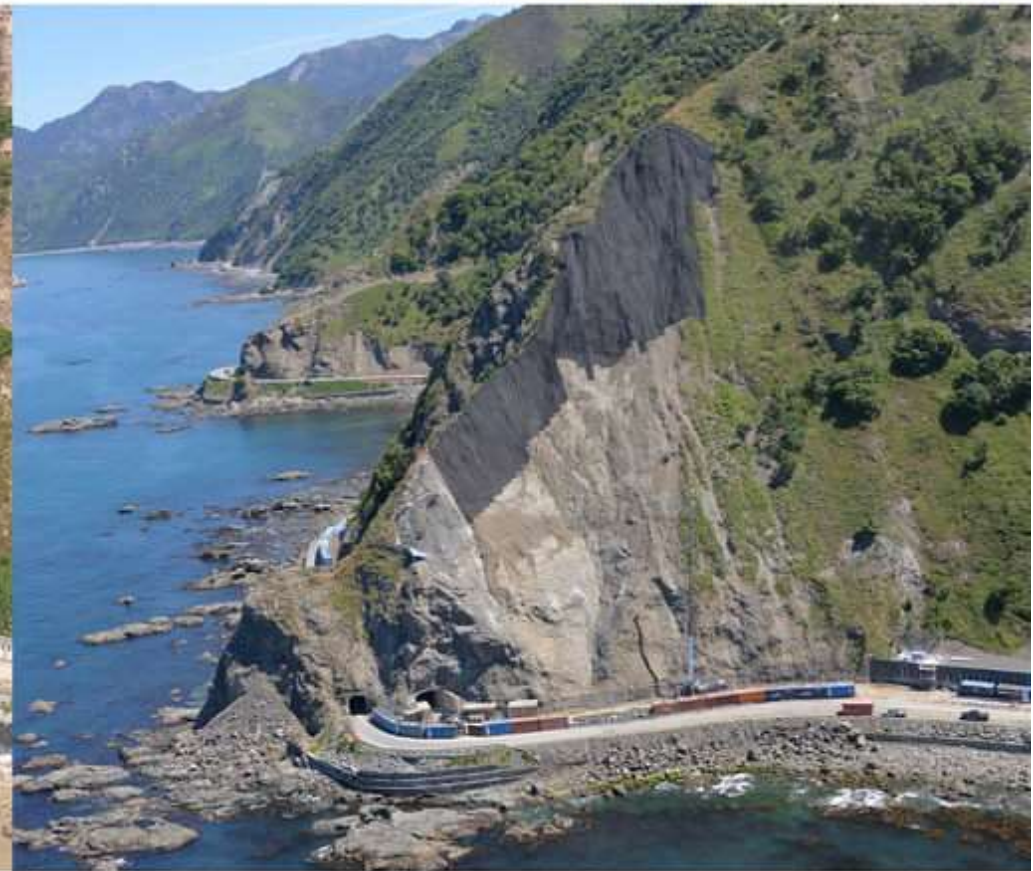
## Site 14, south of Kaikoura

January 2017

November 2017

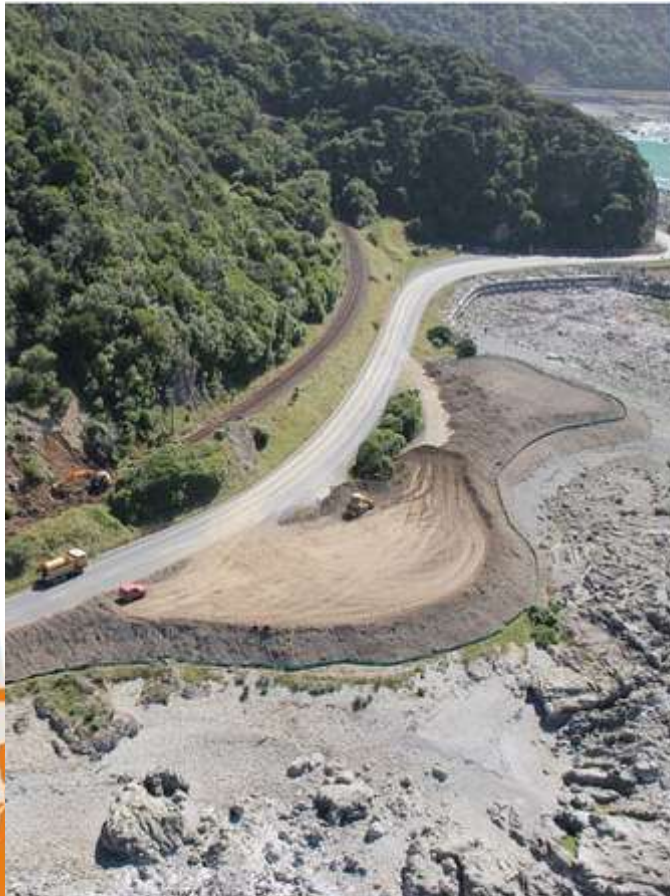
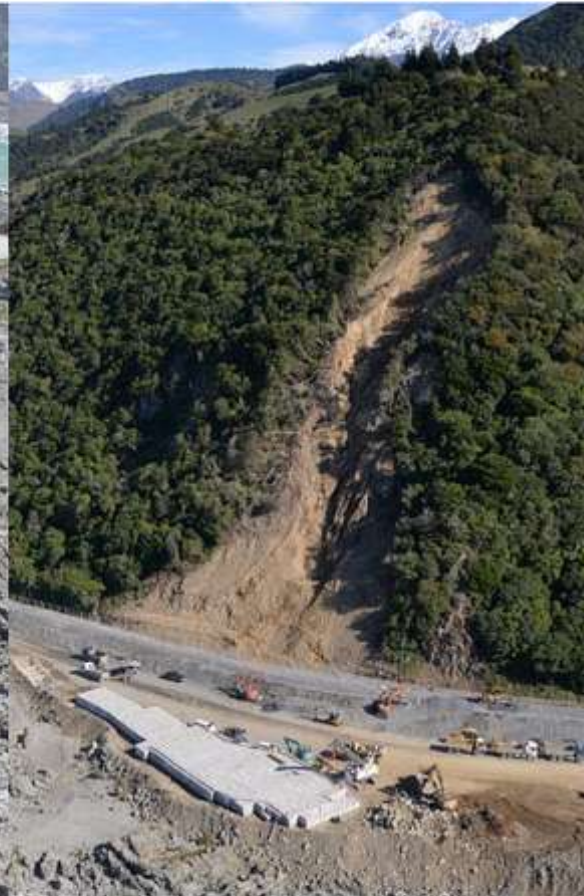
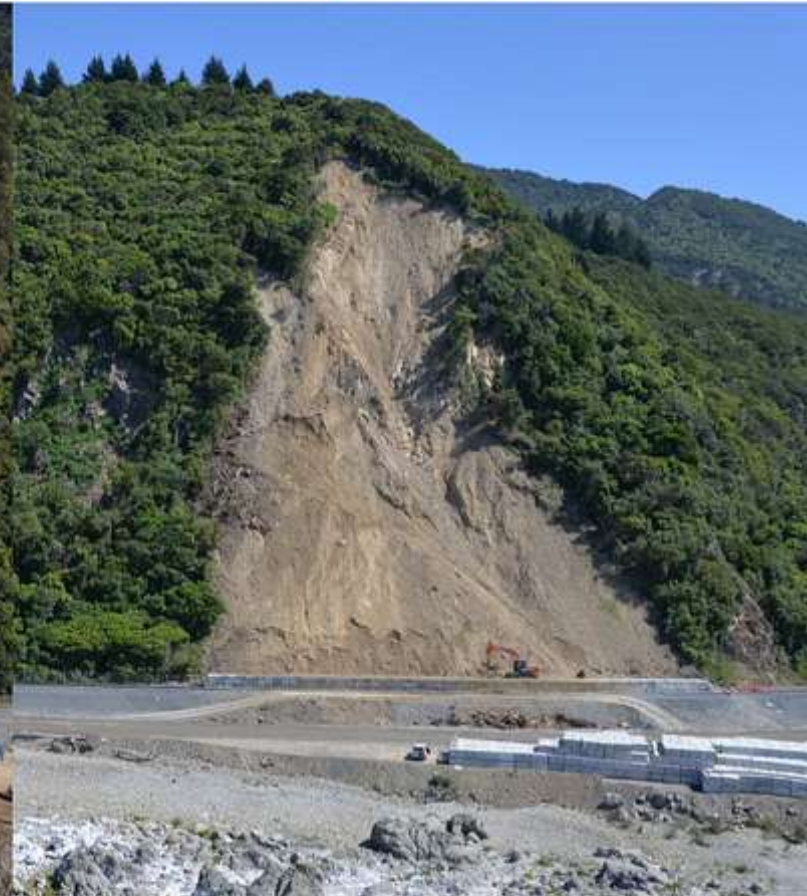
## Slippy McSlip Face, north of Kaikoura

March 2017

September 2017

November 2017

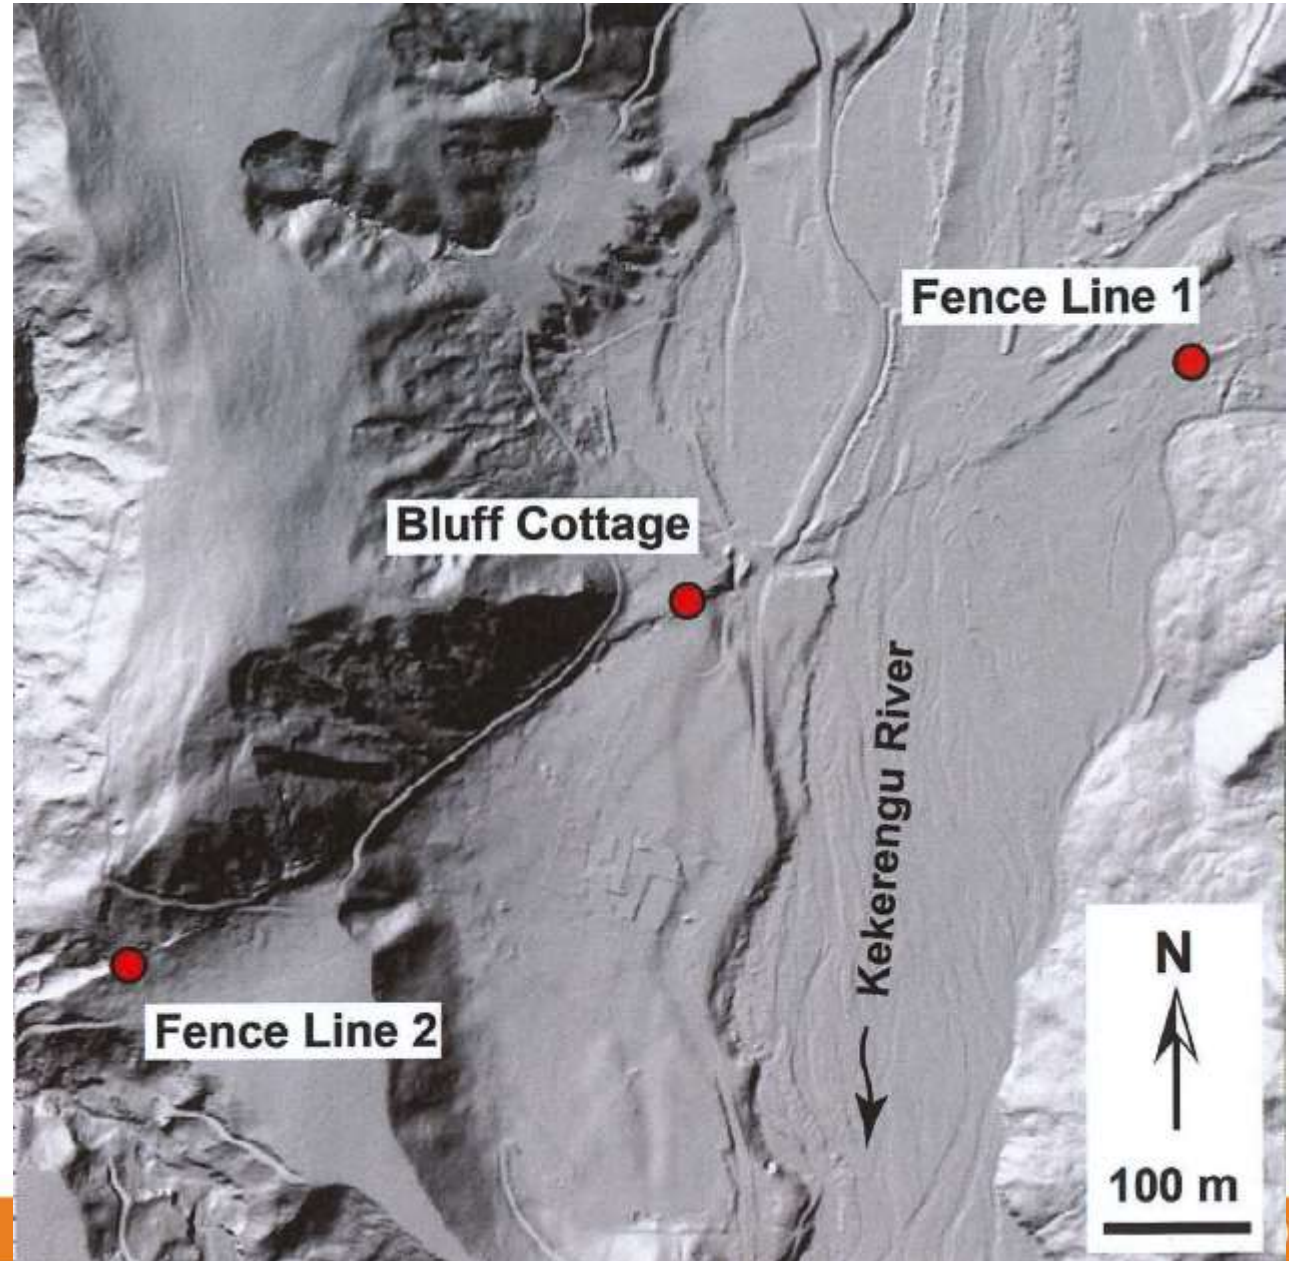
# Stop 2- Kekerengu Fault

- Offset man-made features
- Fences and a cottage

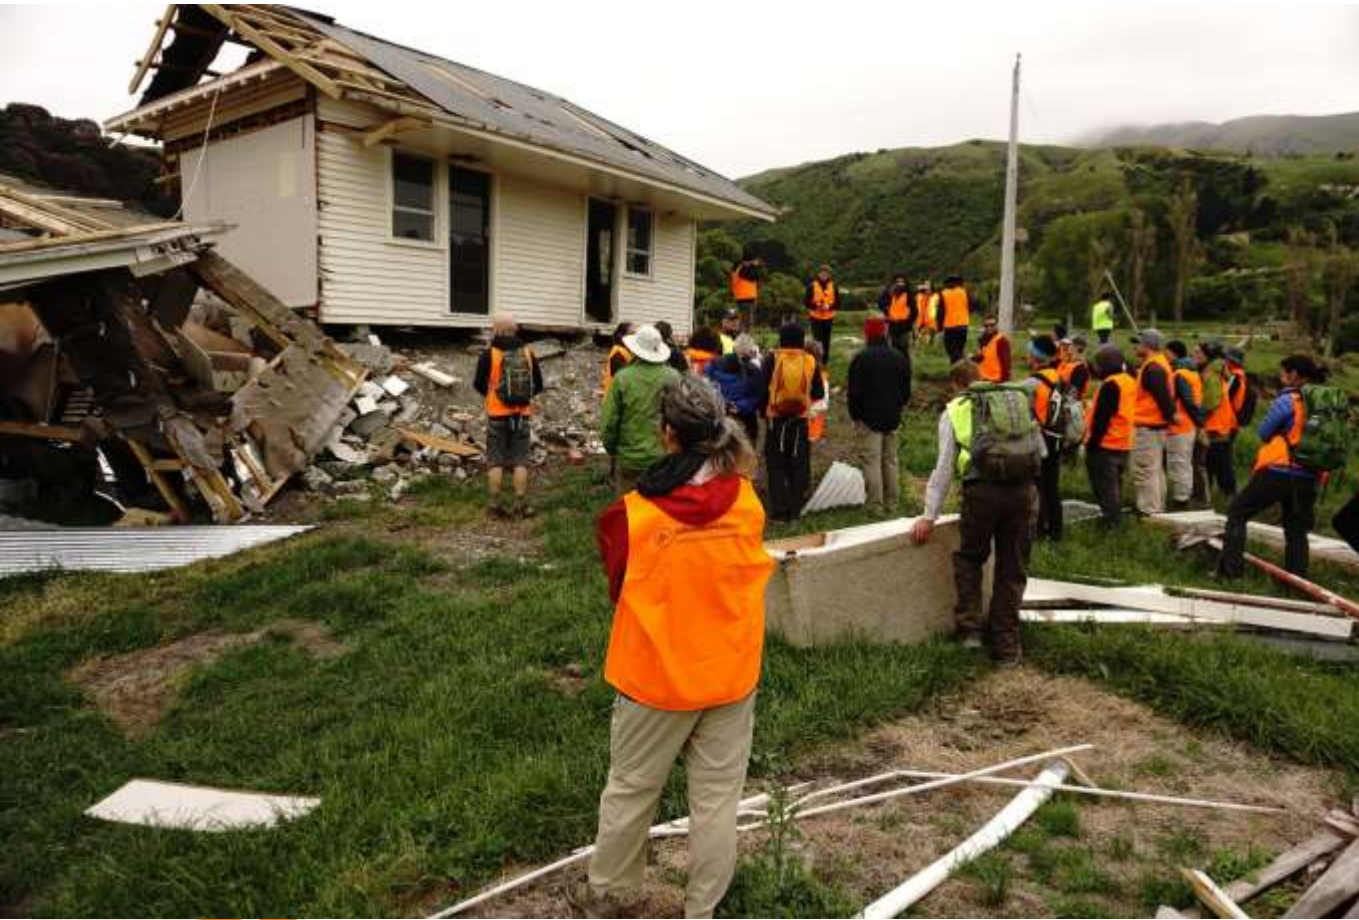
# Stop 2- Kekerengu Fault Bluff Cottage

10 meters of localized horizontal fault displacement extended through the cottage.

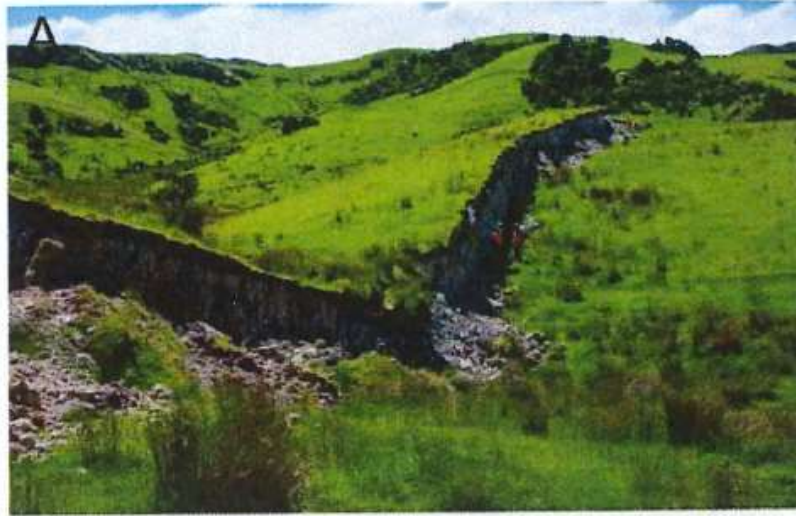
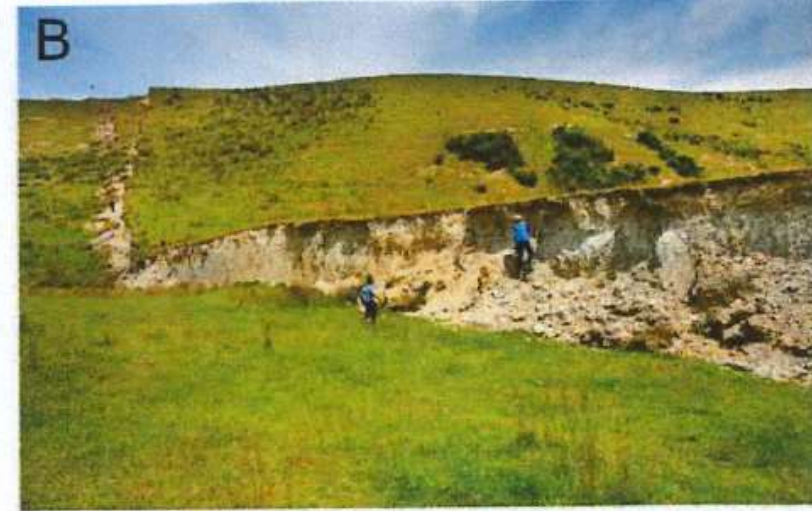
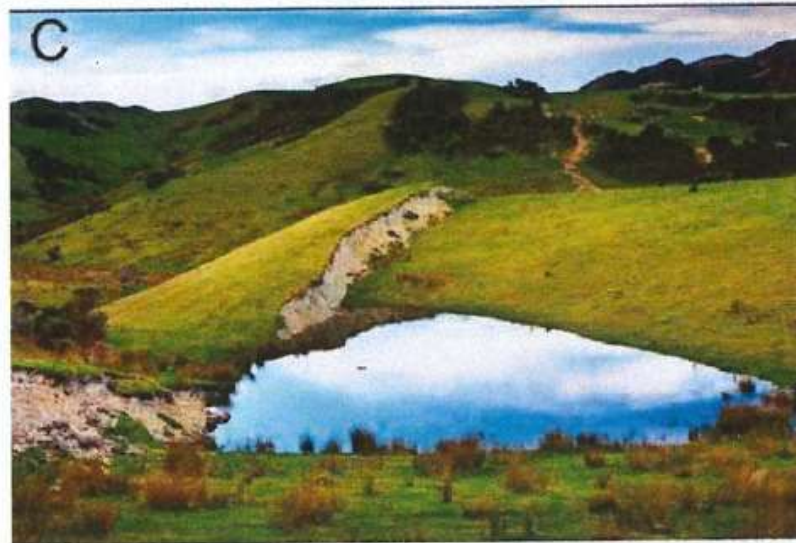
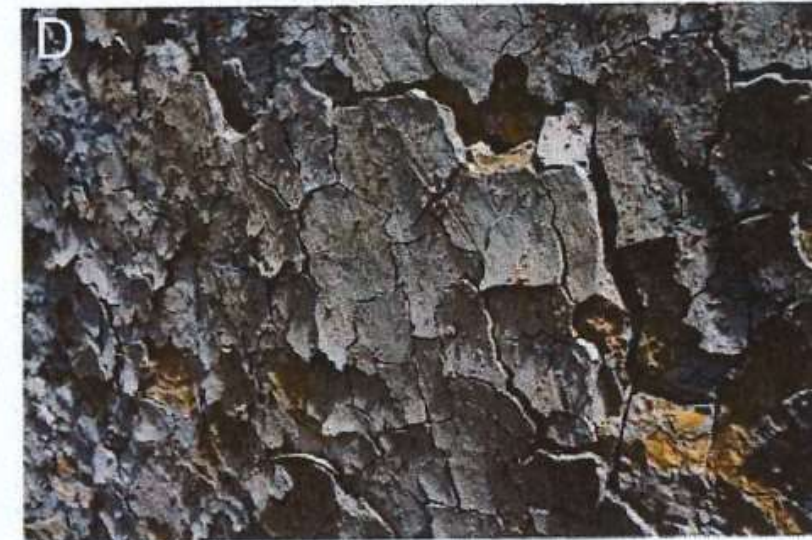
# Stop 4- South Leader Fault Zone - The Wall

- 3.3 m of offset
- A- Nov 26, 2016
- B- Dec. 6, 2016
- C- Sept. 9, 2016
