**Utah Seismic Safety Commission
Nevada Earthquake Safety Council
Joint Meeting
Field Trip**

**Friday, May 11, 2007, 8:00 a.m. – 12:00 noon
St. George, Utah**

UTAH GEOLOGICAL SURVEY

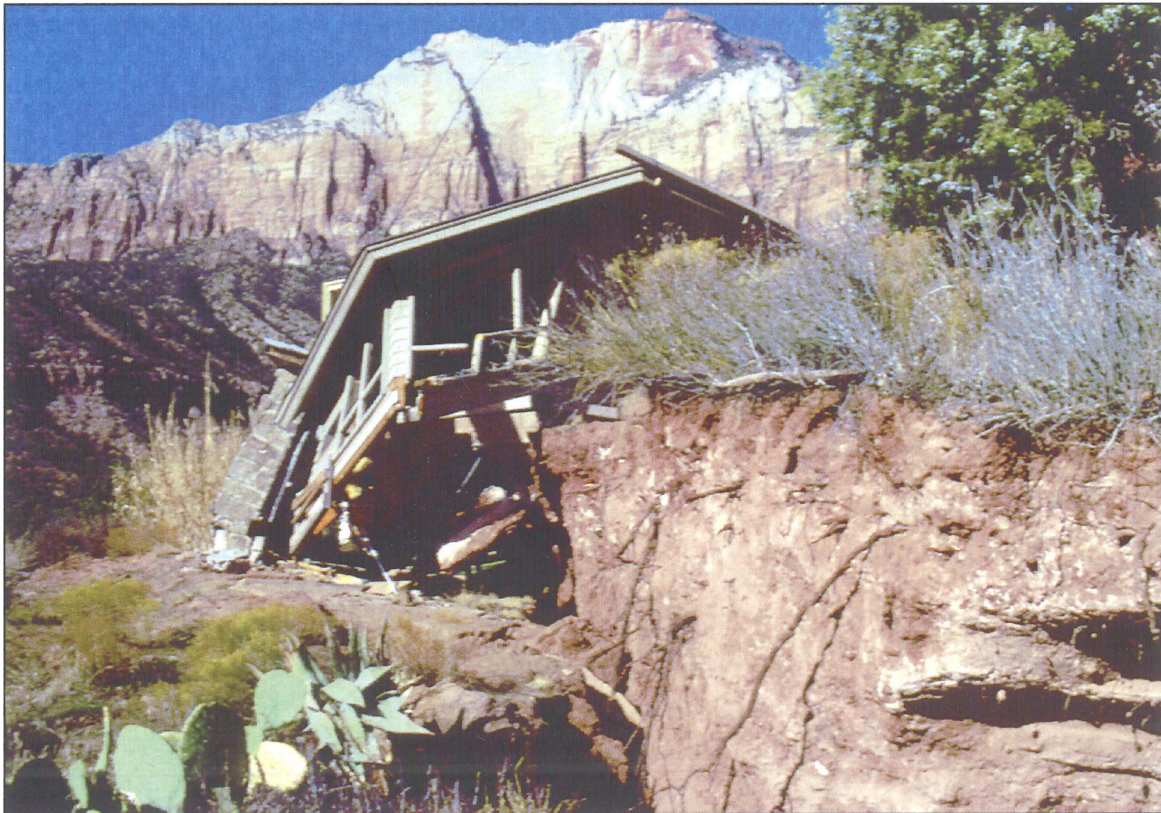
Springdale landslide in Springdale, Utah, which moved in response to the 1992 M 5.8 St. George earthquake.

1992, St. George earthquake (M_S 5.6, M 5.7, M_L 5.8; Arabasz and others, 1992) was the Springdale landslide (figure 19), which destroyed three homes (see road log cover), two water tanks, and several storage buildings. The landslide also blocked SR 9 leading to Zion National Park, ruptured both buried and above-ground utility lines, and caused a condominium complex and several businesses around the periphery of the slide to be temporarily evacuated. The earthquake also triggered a smaller slope failure west of the Springdale landslide, called the Paradise Road landslide (figure 19), which caused no damage.

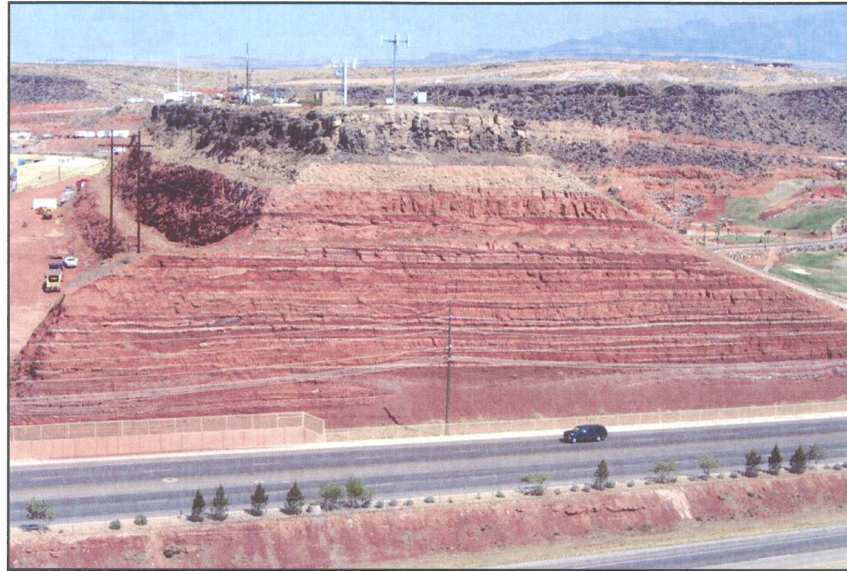
Figure 3. Road cut on the southbound side of I-15 through Middleton Black Ridge. Early Jurassic Kayenta Formation is capped by Quaternary fluvial deposits (light brown outcrops), which are in turn overlain by a Pleistocene (1.5 Ma) basalt flow (black) that originally flowed down the channel of a tributary of the Virgin River (photo courtesy J. D. Harris, Dixie State College).

0.8	1.2	MP-7	Historic St. George LDS Temple at 9:00.
2.0	3.2	MP-9	Middleton Black Ridge at 12:00. Road cut (figure 3) exposes the Middleton basalt flow, which occupies a now-inverted valley in the Jurassic Kayenta Formation (Willis and Higgins, 1995). The Middleton flow is about 200 feet above the Virgin River. Best and others

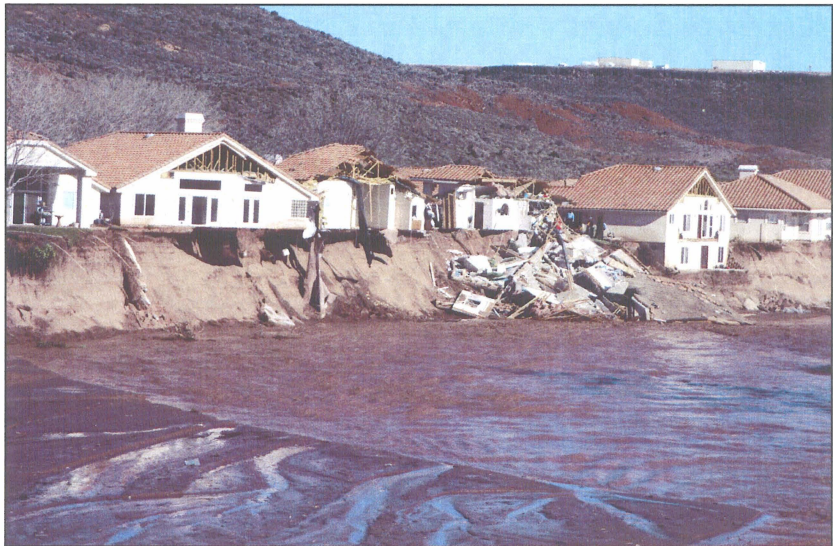
Figure 4. Damage to homes caused by flooding in January 2005.

In the January 2005 flood as many as 50 homes were destroyed or condemned, chiefly along the Santa Clara River (figure 4), and damage exceeded \$180 million dollars (USGS, 2006b). Washington County

received a federal disaster declaration following the flood. The majority of the damage occurred as a result of bank erosion and channel migration. This behavior is a common occurrence along rivers in the arid Southwest, but not typically addressed in flood-plain mapping. Long stretches of stream banks along both the Virgin and Santa Clara Rivers were armored with riprap following the 2005 flood.

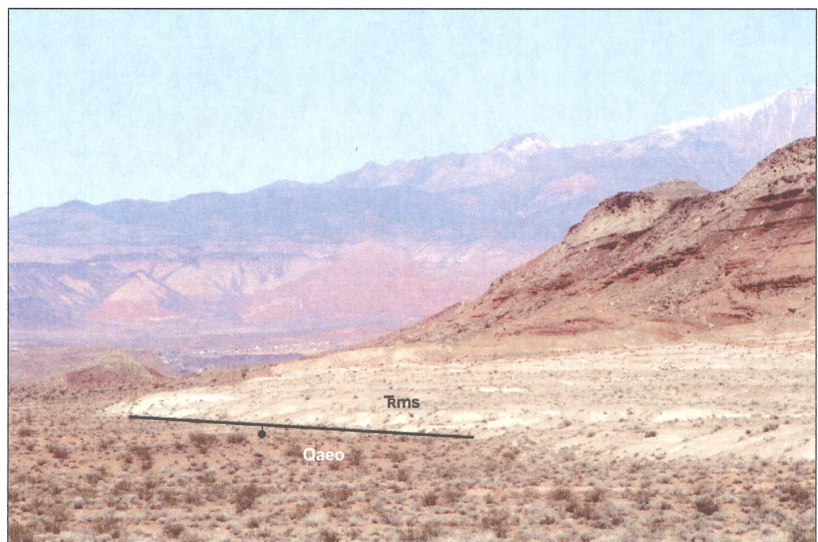
Figure 5. View northwest to the Washington fault, about four miles south of Stop 1. Mixed alluvial and colluvial deposits (Qaeo) on the hanging wall are in fault contact with the Shnabkaib Member (TRms) of the Moenkopi Formation exposed in the footwall (from Biek and Hayden, 2007).

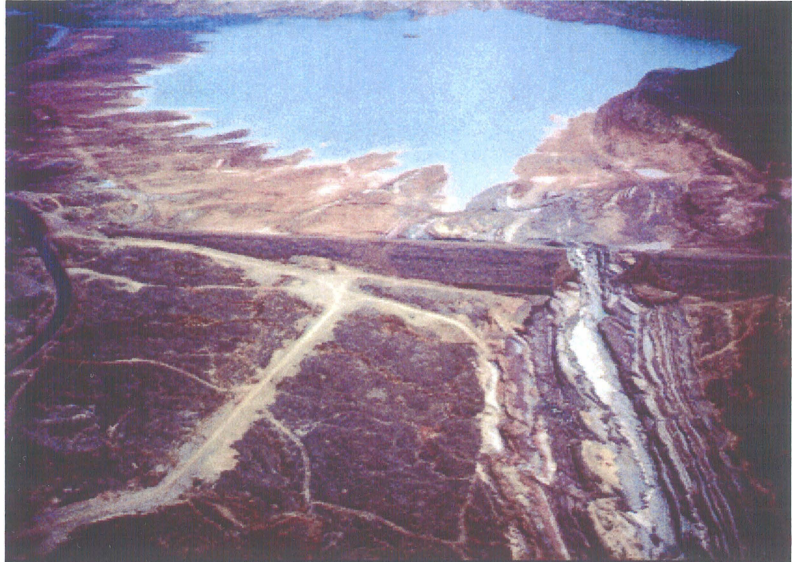
Figure 7. View looking north at the Quail Creek south dam failure, January 1989. Photo courtesy of Benjamin Everitt.

The south dam was constructed approximately perpendicular to the axis of the doubly-plunging Virgin anticline in thin-bedded sediments of the gypsiferous Shnabkaib Member of the Triassic Moenkopi Formation. Gypsum content exceeds 50 percent in some Shnabkaib beds. Due to the folding, bedrock within the anticline is highly fractured, and both the fractures and the strike of the bedrock were oriented normal to the axis of the dam (O'Neill and Gourley, 1991; Gourley, 1992).

The failure resulted from seeping water removing embankment material and/or in-situ soils at the dam/foundation contact. As the seepage and erosion accelerated, a process of backward erosion caused caving and the eventual breach of the dike embankment. Several factors contributing to the failure: (1) erodible materials existed or were placed at the dike/foundation contact, (2) the rock foundation was extensively jointed and weathered with discrete seepage paths, particularly near the ground surface where open cavities caused by expansion, dissolving, and erosion of gypsum were common, and (3) participation of an engineering geologist was limited

during all phases of the project (Gourley, 1992). Lacking critical geologic information, errors contributing to the dike's failure included an underestimation of the gypsum content in the foundation, a mistaken assumption of low foundation permeability, and inadequate preparation and treatment of the foundation (O'Neill and Gourley, 1991; Gourley, 1992).

| 0.5 | 23.9 | | At 10:00 is the flood path created by the Quail Creek dam failure (see figure 7 for an aerial view). The floodwater stripped away all soil and vegetation in its path and exposed Moenkopi bedrock. |

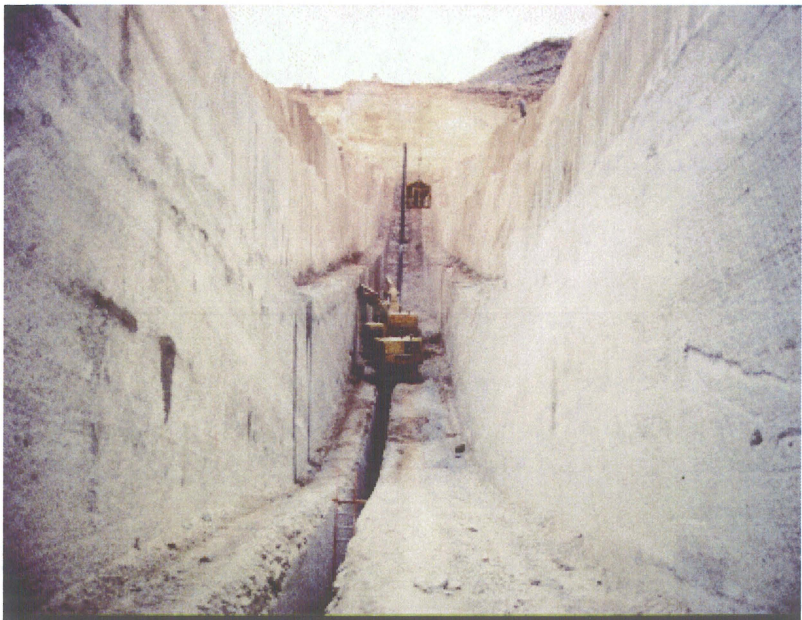
Figure 8. The Quail Creek south dam cutoff trench during reconstruction.

A 2000-foot-long concrete cutoff trench was constructed with a maximum depth of approximately 75 feet in the breach area and tapering to 50 feet at the left abutment and 25 feet at the right abutment (figure 8). The volume of material excavated for the cutoff was 68,000 yd³. The rebuilt dam is a concrete gravity dam constructed using 176,000 yd³ of roller-compacted concrete. The new dam has a crest length of approximately 2000 feet, a width of 16 to 86 feet, and ranges in height from 6 to 78 feet.

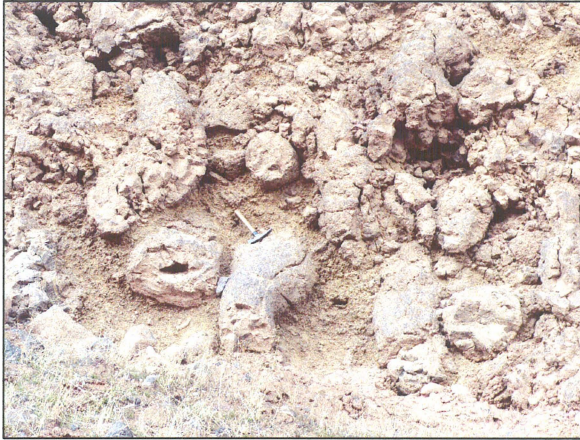
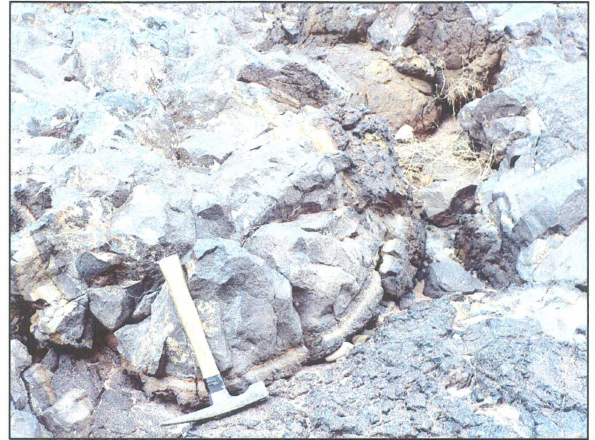
Figure 10. Close-up of pillow basalt near the SR 9 bridge (from Biek and Hayden, 2007).

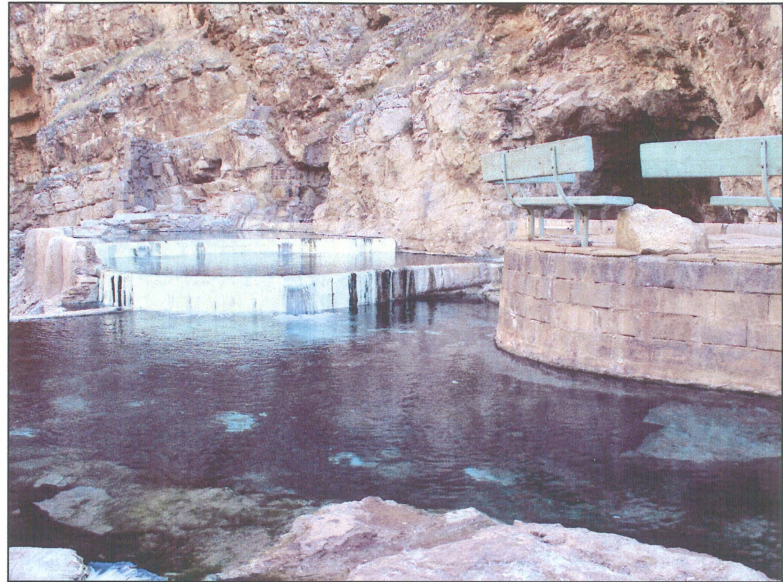
Figure 12. Pah Tempe Hot Springs average about 104 °F (40 °C) and issue from and immediately above the bed of the Virgin River, just upstream from the Hurricane fault (from Biek and Hayden, 2007).

Pah Tempe Hot Springs: Pah Tempe Hot Springs (also known as LaVerkin or Dixie Hot Springs) (figure 12) has the highest recorded spring-water temperature in the St. George area (Budding and Sommer, 1986). The springs average about 104 °F, have a pH of 6.3, and discharge sodium-chloride-type water with an average of 9600 to 9900 mg/L TDS. They issue from and immediately above the bed of the Virgin River (from near the base of the Brady Canyon Member of the Toroweap Formation) for a distance of nearly 1500 feet upstream of the Hurricane fault. Mundorff (1970) and Yelken (1996) summarized physical and chemical parameters of the Pah Tempe Hot Springs. They noted that the average annual dissolved-solids discharge at the springs is about triple that of the Virgin River just upstream of the springs. The high TDS of the spring water contributes to poor downstream water quality, and is the reason Virgin River water is collected above the springs and piped to Quail Creek and Sand Hollow Reservoirs.

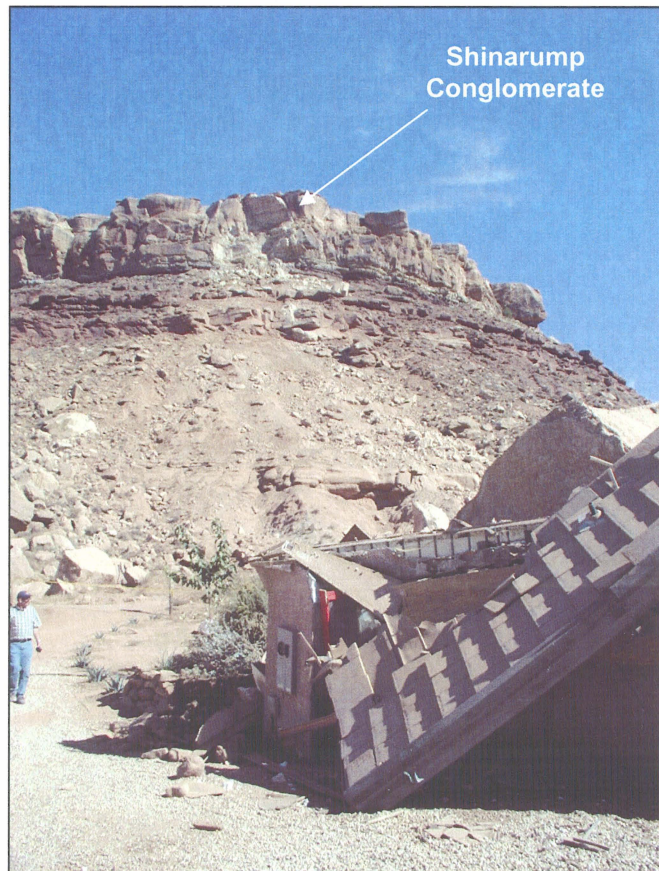
Figure 18. *Shinarump Conglomerate overlying the upper red member of the Moenkopi Formation above the damaged home. Note the fresh scar where the rock fall detached from the cliff.*

The boulder, measuring approximately 16 by 16 by 12 feet and weighing an estimated 300 tons, broke loose from an outcrop of the Shinarump Conglomerate Member of the Chinle Formation, which caps the Rockville Bench north of the Virgin River. The well-indurated Shinarump sandstone and conglomerate beds rest upon less resistant shale, mudstone, and silty sandstone beds of the upper red member of the Moenkopi Formation. The Shinarump outcrop stands about 200 feet above the adjacent valley floor and the damaged home (figure 18).
