THE UTAH GUIDE FOR THE SEISMIC IMPROVEMENT OF

UNREINFORCED MASONRY DWELLINGS

UTAH
EPICENTER
EARTHQUAKE PREPAREDNESS INFORMATION CENTER

RICHARDS CONSULTING
G R O U P

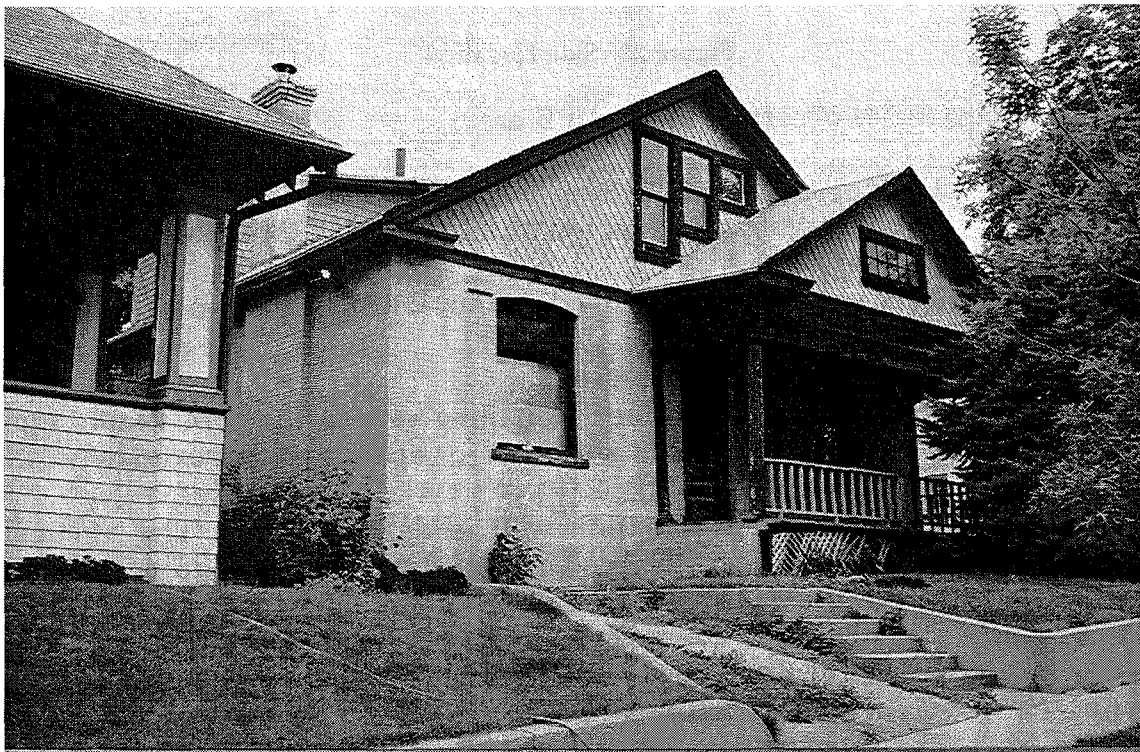
Figure 28: Front Elevation.

Model Home B was built in the late 1890's. This is a single story home with an attic area used as living space, and with a concrete shelf type basement. The construction consists of double wythe URM walls, concrete foundation walls supporting a wood floor, and roof/ceiling joists around the exterior and wood post and beams at the interior. The front and back porch roofs are supported by wood posts, it has one exterior chimney. Some of the posts are bearing on masonry piers.

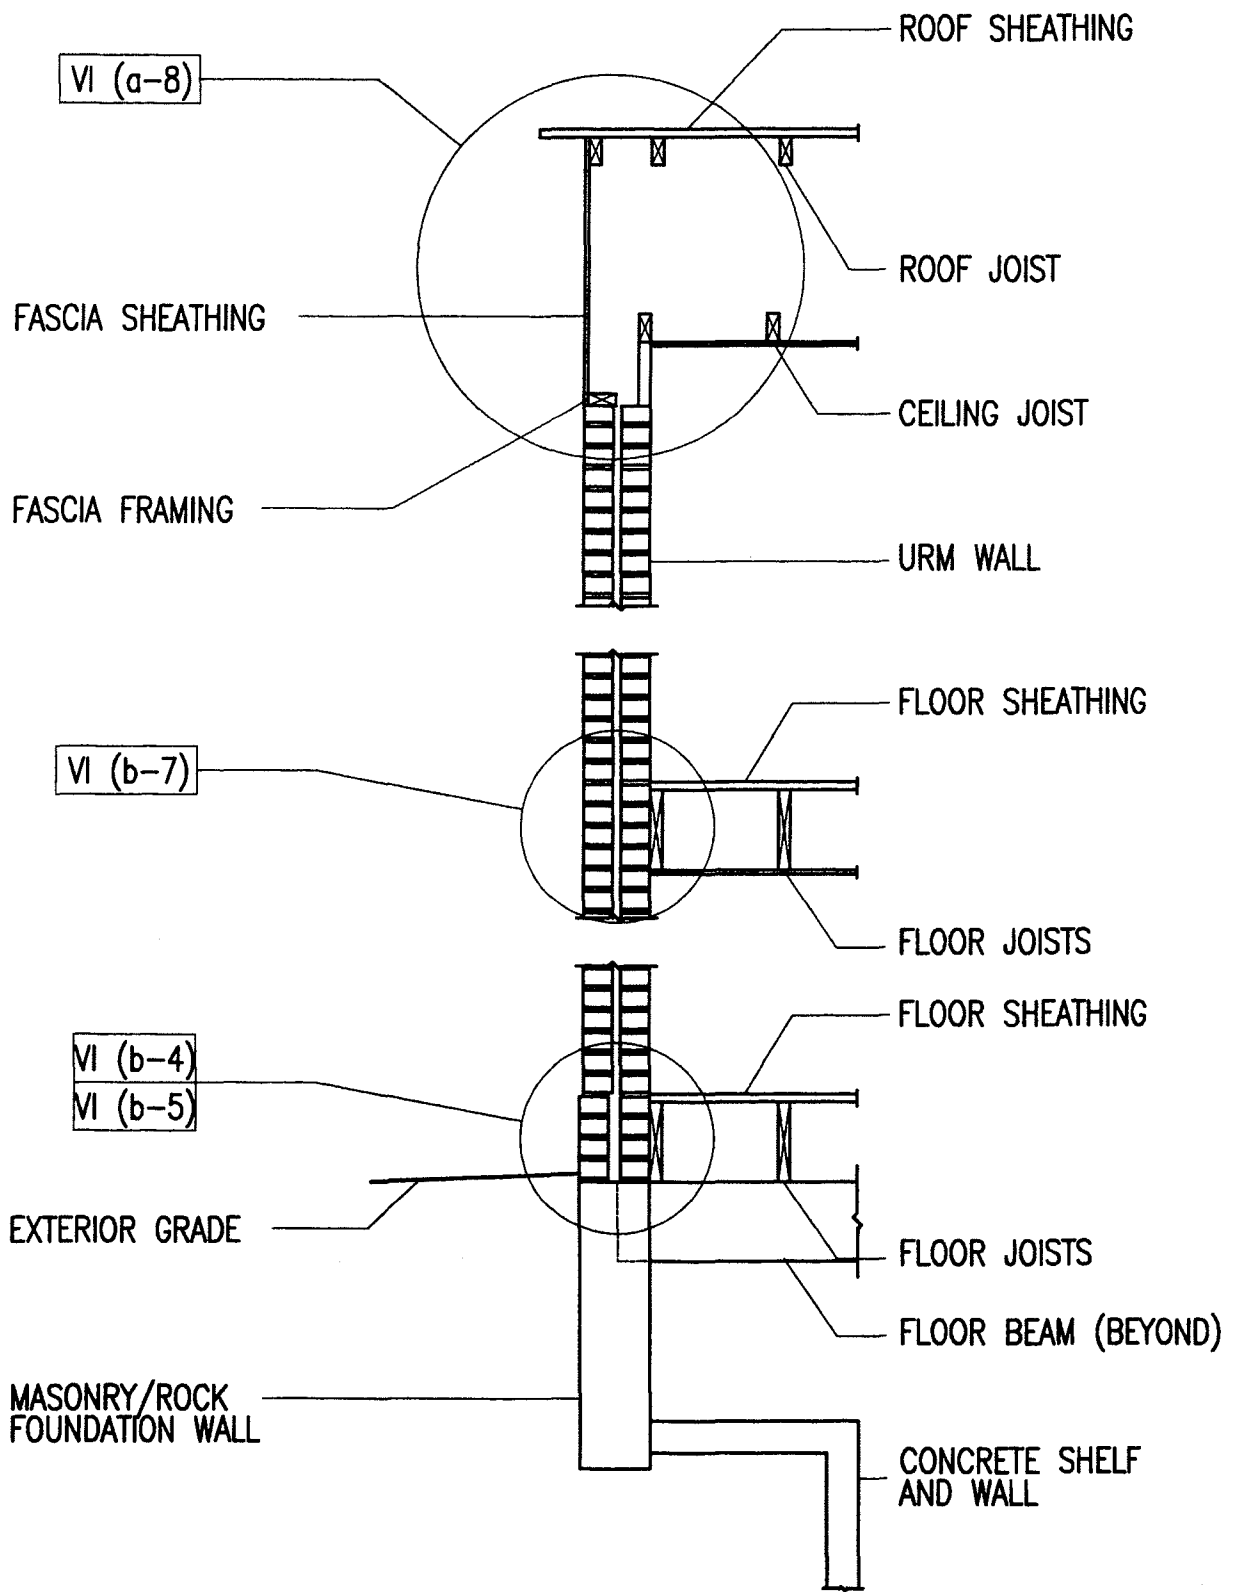
<p>Model Home Seismic Deficiencies</p>	<p>Home Type: MODEL C</p>	<p>Figure No.: V (C-2)</p>
--	-------------------------------	--------------------------------

EXTERIOR WALL SECTION

Figures V (C-1) and V (C-2) show two different existing exterior wall sections for Model C. Reference circles have been superimposed onto these figures showing the area of the wall where seismic deficiencies normally occur. The referenced details for these improvements which will help to strengthen these deficiencies are found in Chapter 6. Also, Table 1 on page 26 the special features section on page, and additional details in chapters 6 and 7 for other improvements that are recommended, but are not reflected in these exterior wall sections.

SEE FIGURE V (C-2) FOR
EXISTING CONDITION

SEE FIGURE V (C-2) & V (D-2)
FOR EXISTING CONDITION

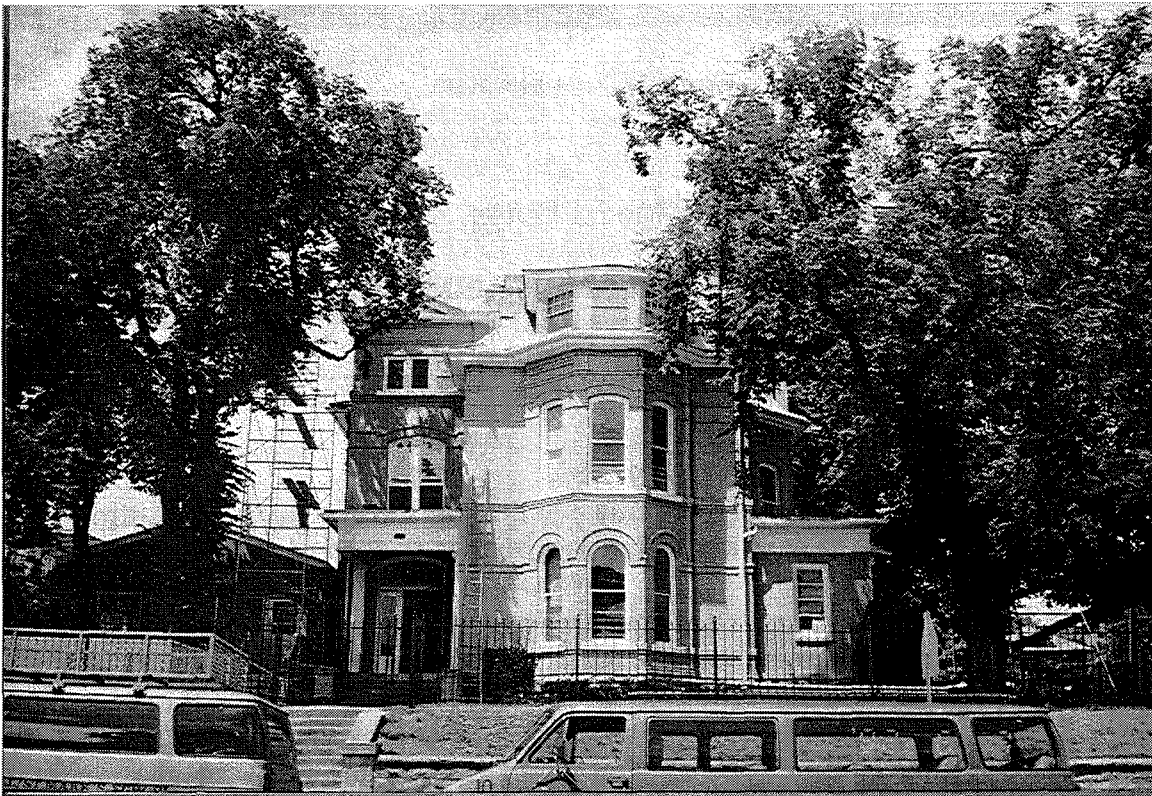
Figure 32: Front Elevation

Model Home D was built in the 1900's. This is a two story home with living space built into the attic area and a partial shelf basement. The construction consists of double wythe URM walls and masonry/rock foundation walls supporting wood floor and roof/ceiling joists around the exterior. A wood beam carried by masonry piers support the floor, while a wood stud wall supports the ceiling/floor joists. It has one exterior chimney and a few low roof areas at the floor line.

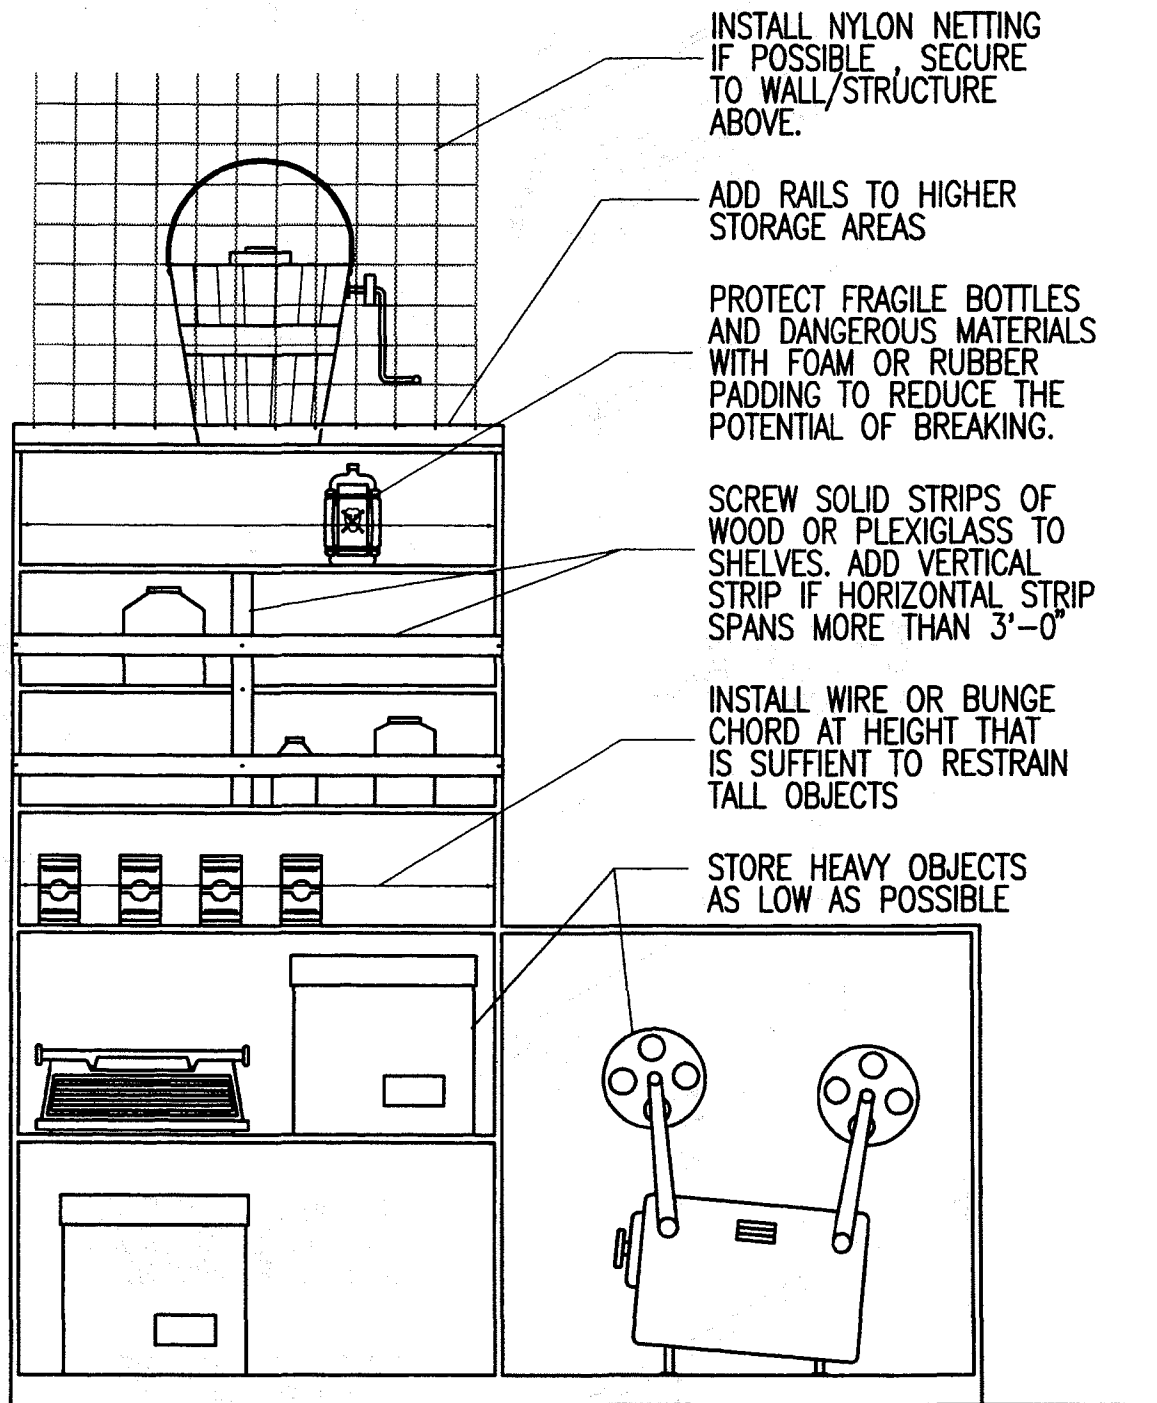
Seismic Improvement Non-Structural Detail	Home Type: VARIES	Figure No.: VII-3
--	----------------------	----------------------

RESTRAINT OF COMPUTERS, TYPEWRITERS, ETC.

ATTACH SHELVING SECURELY TO WALLS, SEE VII-6
