SEISMIC RISK ASSESSMENT OF PUBLIC CULINARY WATER SUPPLY SYSTEMS IN UTAH AND RECOMMENDATIONS FOR RISK REDUCTION

## SEISMIC RISK ASSESSMENT OF Public Culinary Water Supply Systems In Utah

AND RECOMMENDATIONS FOR RISK REDUCTION

SEISMIC SAFETY ADVISORY COUNCIL STATE OF UTAH

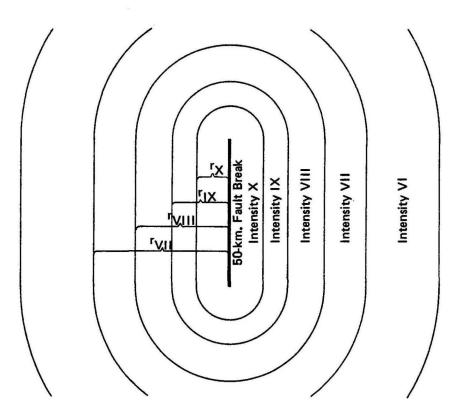
The attenuation pattern for such a break would appear as indicated in the diagram.

The area covered at Intensity X should equal 83 sq. km., and so on.  $r_X$  is defined as the length of the perpendicular to the break measured from the break to one of the boundaries of Intensity X. In general,  $r_j$  is the length of the perpendicular measured from the break to the boundary of some Intensity j. Given the expected areas at each intensity, one can derive values of  $r_j$  for  $X \ge j \ge 0$  if one knows the sum of all areas for Intensity X to Intensity j to equal  $\pi r_j^2 + 100 r_j$ .

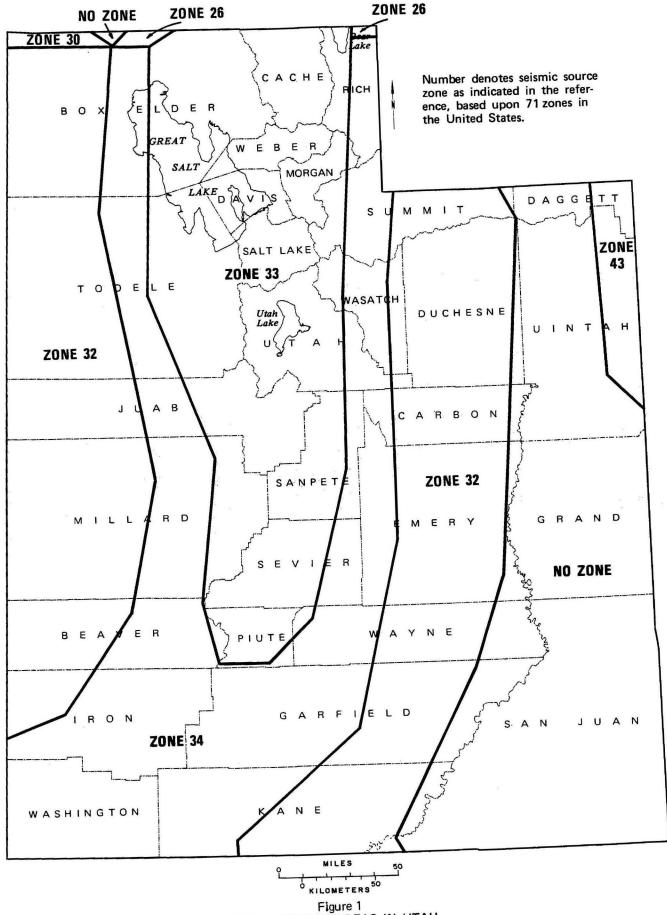
SEISMIC SOURCE AREAS IN UTAH (Reference: S.T. Algermissen, and D.M. Perkins, USGS Open File Report 76-416)

One can compare the more recently developed Algermissen and Perkins zonation map (Figure 1) with the map now in use in the 1979 <u>Uniform Building Code</u> (UBC) (See Figure 2). Although the UBC zones have provided the basis for designing earthquake-resistant buildings in Utah in recent years, it can be seen that the zones do not match very well the distribution of seismicity as presently understood.

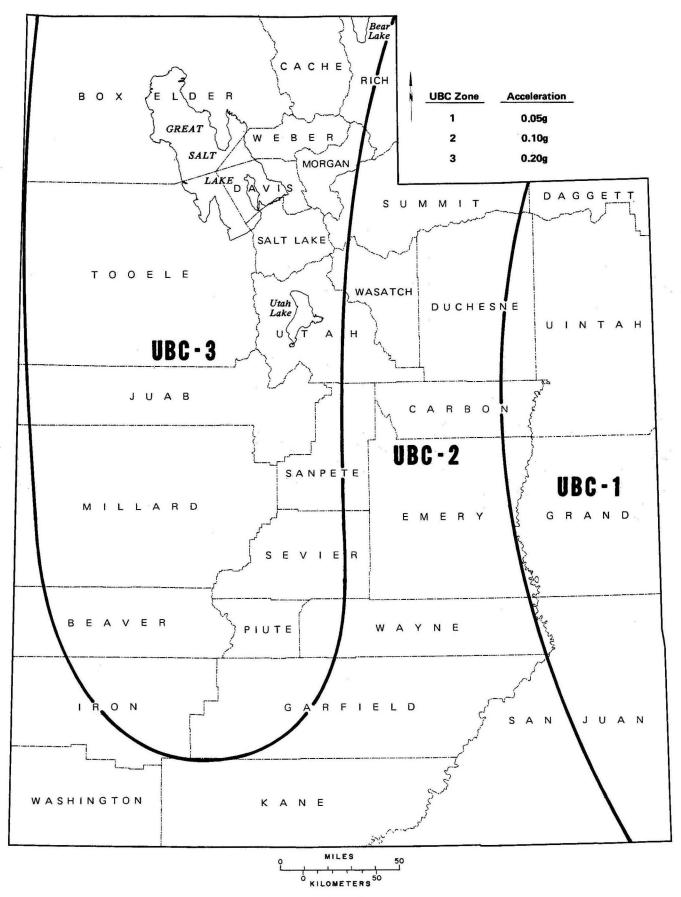
Figure 2 SEISMIC ZONES-1976 UNIFORM BUILDING CODE STATE OF UTAH

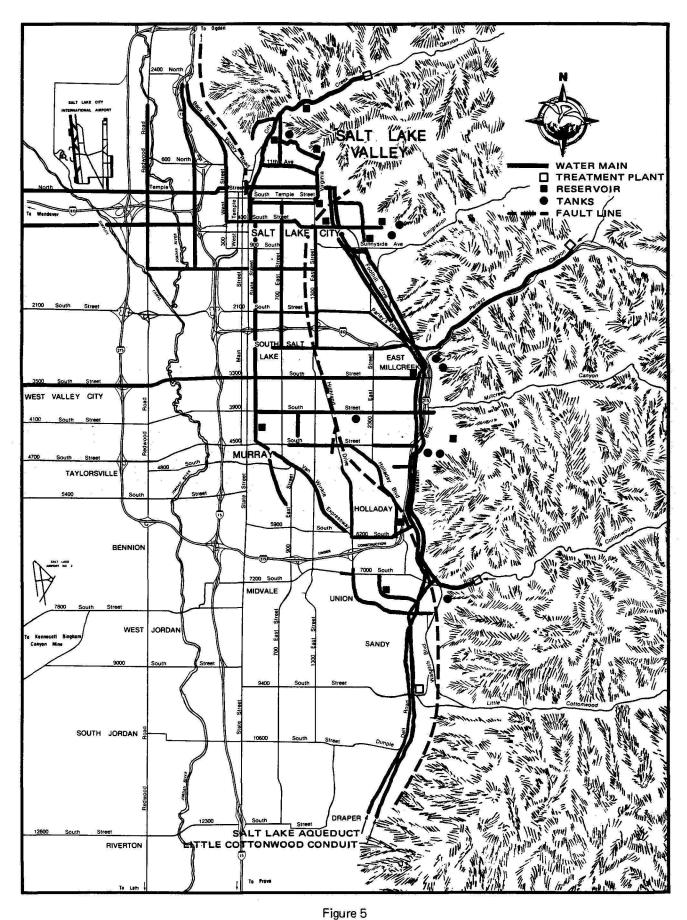
SCHEMATIC OUTLINE OF THE SALT LAKE CITY WATER SYSTEM (Supply Mains Generally At Least 18-in. In Diameter)

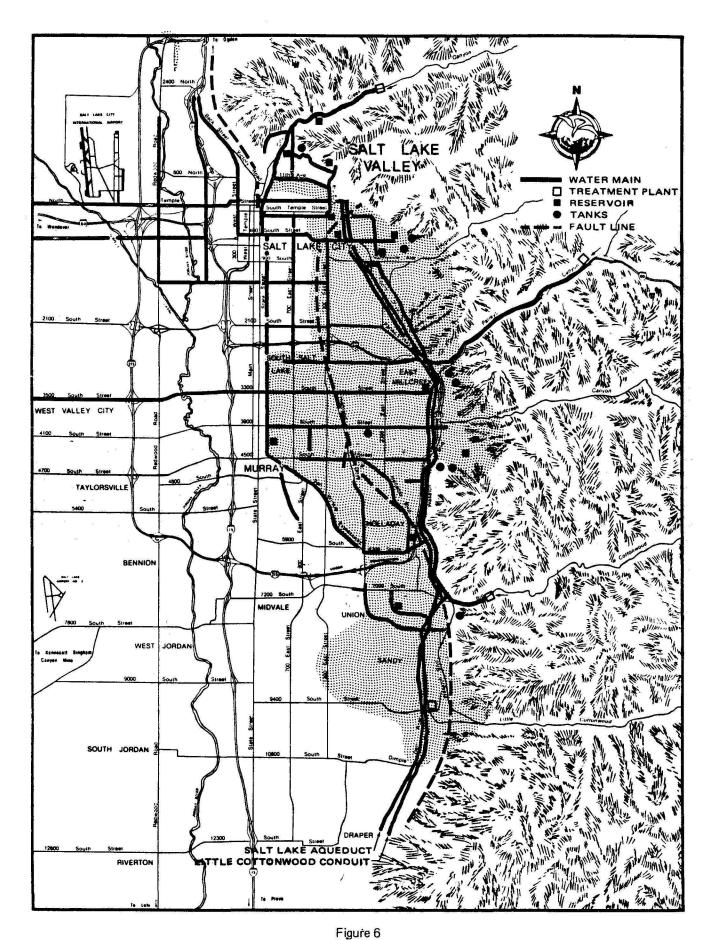
AREAS OF THE SALT LAKE CITY WATER SYSTEM THAT CANNOT RECEIVE FLOWS FROM THE CITY CREEK TREATMENT PLANT

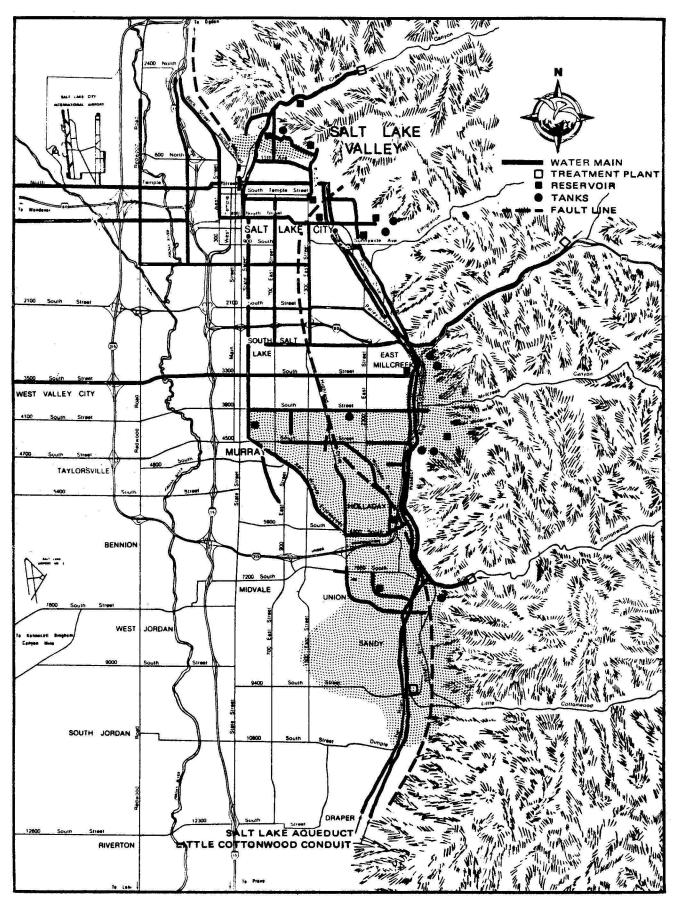
AREAS OF THE SALT LAKE CITY WATER SYSTEM THAT CANNOT RECEIVE FLOWS FROM THE PARLEY'S TREATMENT PLANT

Figure 7 indicates that the Parley's Treatment Plant can distribute water only as far south as 39th South. While supplying an average of about 15 percent of the system's water, the Parley's Treatment Plant has a flow capacity of about 30 MGD. It appears that the Parley's Treatment Plant is capable of providing water to a significant portion of the system after an earthquake. It also is noteworthy that the Parley's plant is distant enough from the other three plants so that one might expect it to survive an earthquake that damaged one of the other plants.

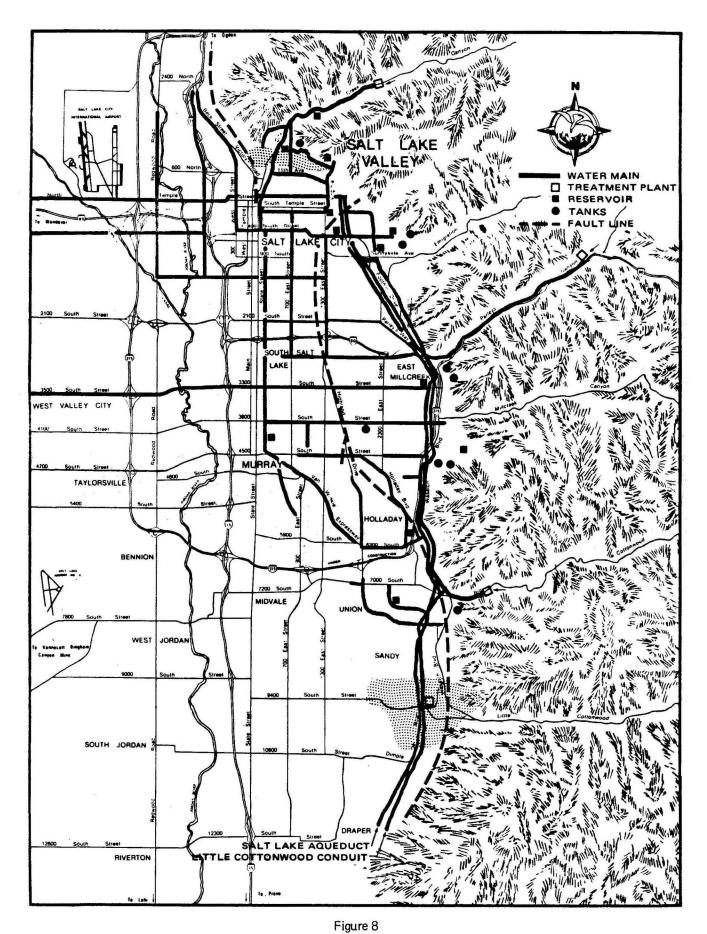
AREAS OF THE SALT LAKE CITY WATER SYSTEM THAT CANNOT RECEIVE FLOWS FROM THE BIG COTTONWOOD TREATMENT PLANT

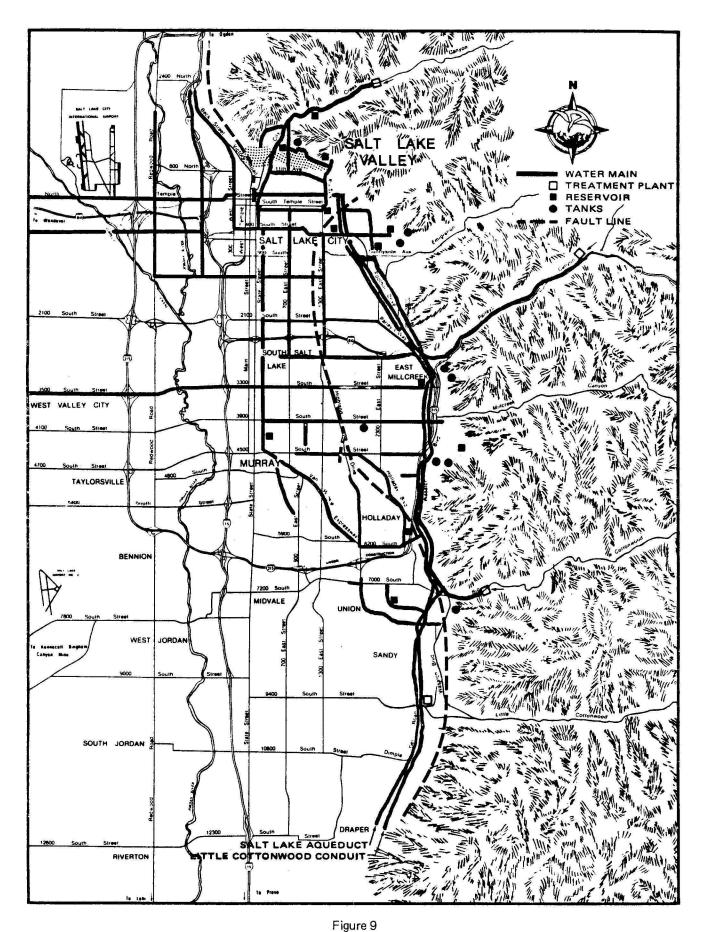
AREAS OF THE SALT LAKE CITY WATER SYSTEM THAT CANNOT RECEIVE FLOWS FROM THE METROPOLITAN TREATMENT PLANT

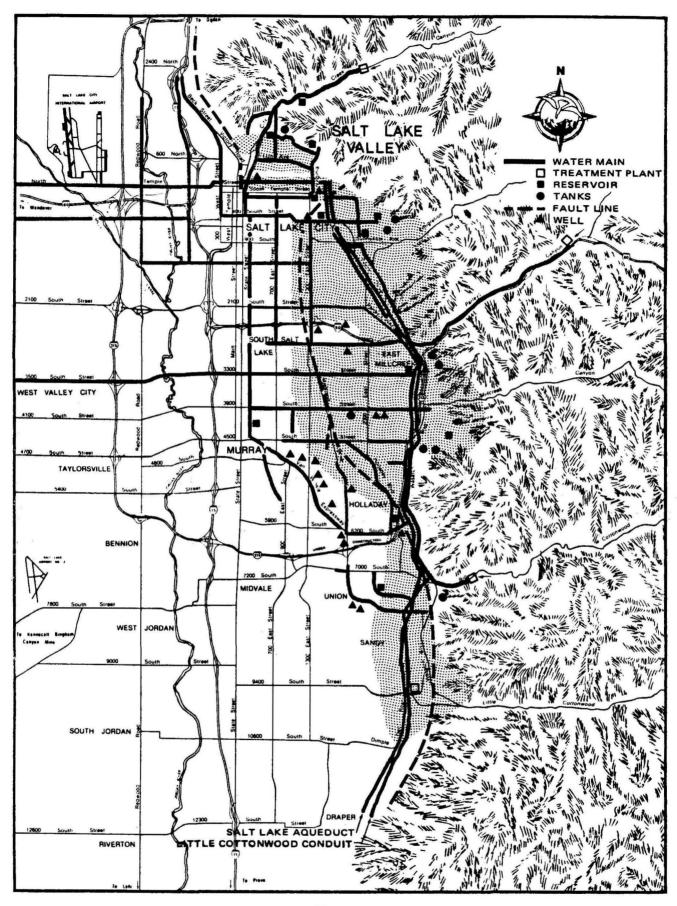
LOCATION OF DEEP PUMP WELLS AND AREAS OF THE SALT LAKE CITY WATER SYSTEM THAT CANNOT BE SERVED BY DEEP PUMP OR ARTESIAN WELLS

Deep pump wells and artesian wells supply an aggregate of almost 50,000 gallons per minute of water, or about 70 MGD ([24], p. 20; [25], p. 10). Artesian wells can supply a maximum flow of 15 MGD for about four hours maximum. Yet, even though flows from wells suffice for fire flow requirements, wells are localized and cannot supply all parts of the Salt Lake City system. Figure 10 provides locations of deep pump wells and indicates sections of the system that wells generally cannot feed. Table 3 provides information about how much water deep pump wells can supply.

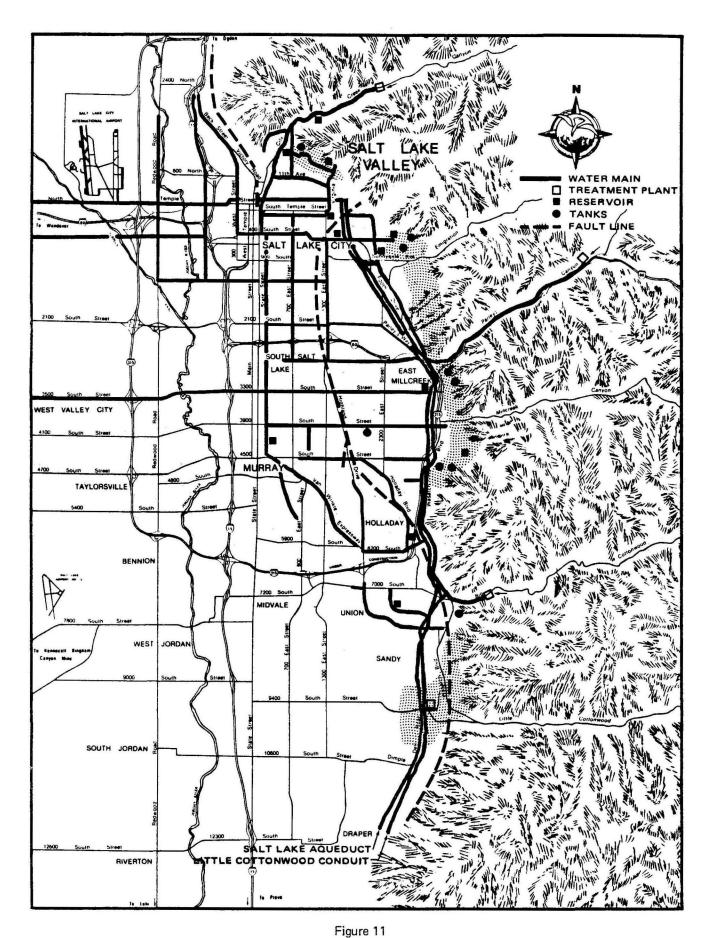
AREAS OF THE SALT LAKE CITY WATER SYSTEM DEPENDENT UPON TANKS FOR SUPPLY

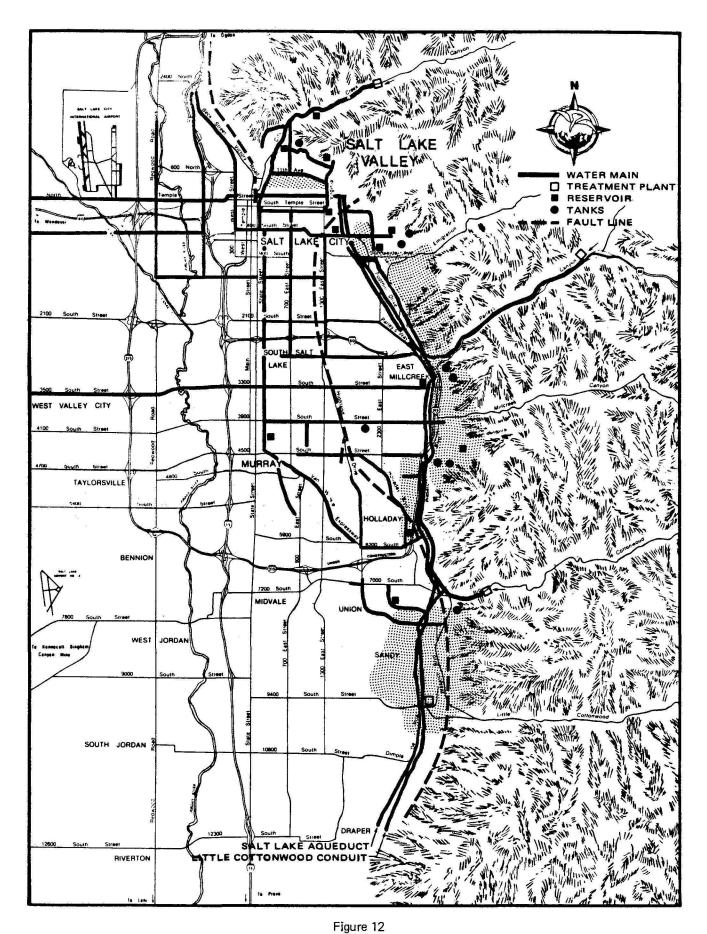
AREAS OF THE SALT LAKE CITY WATER SYSTEM DEPENDENT FOR SUPPLIES UPON PUMPING STATIONS

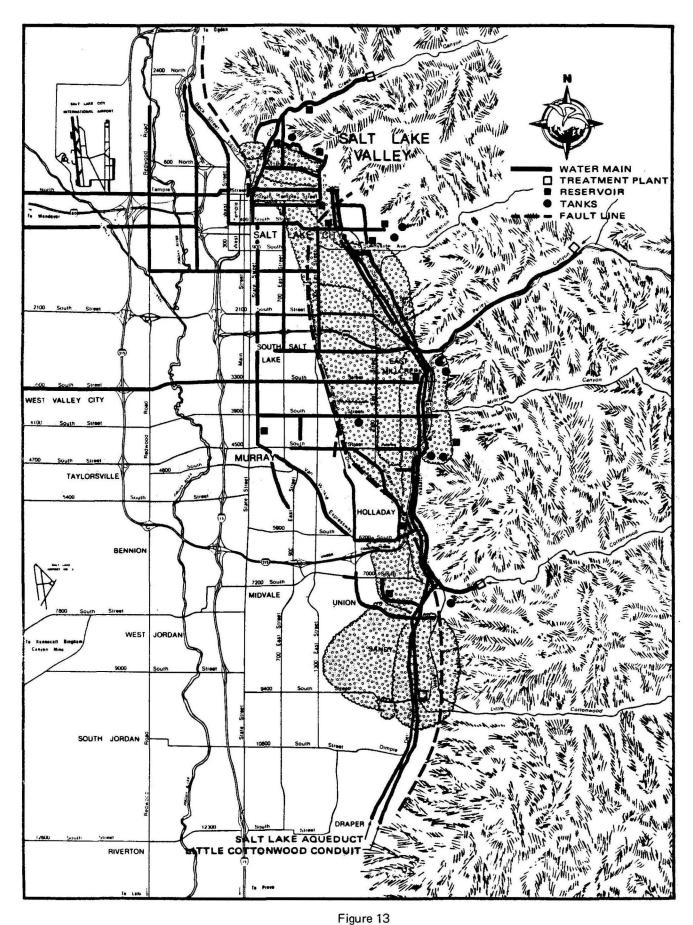
REGULATION ZONES FOR THE SALT LAKE CITY WATER SYSTEM (ROUGHLY DRAWN) IN RELATION TO THE WASATCH FAULT

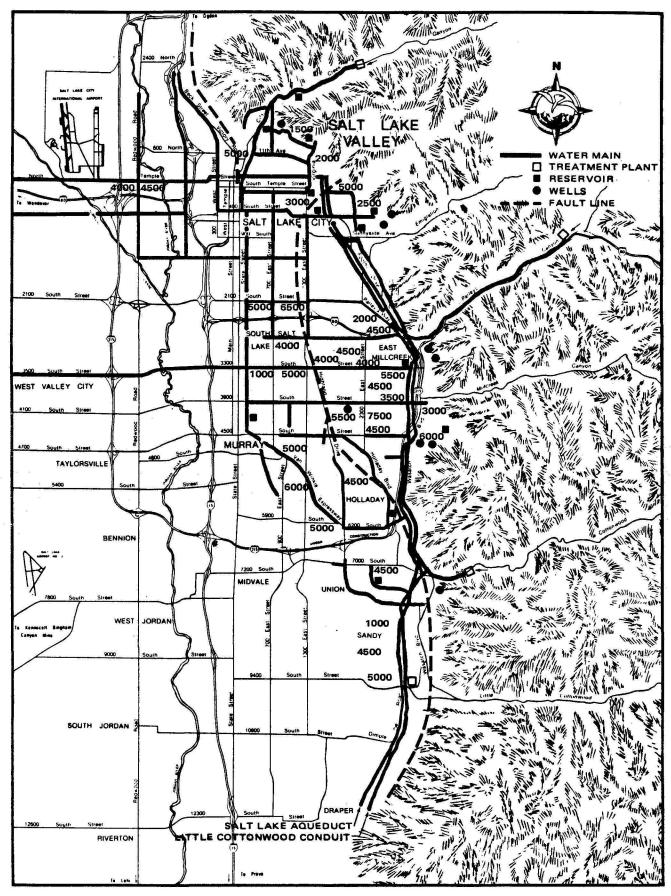
APPROXIMATE LOCATIONS AND FIRE FLOW REQUIREMENTS (IN GALLONS PER MINUTE AT 20 PSI PRESSURE) OF SITES IN THE SALT LAKE CITY WATER SYSTEM NOT SATISFYING 1973 AND 1975 FIRE FLOW TESTS

Figure 14 provides a rough criterion for determining city locations that may be more vulnerable to fires because they have not met fire flow standards. Locations with lower standards, such as residential areas, need less flow to meet such standards than do areas where, say, multi-unit apartment dwellings, larger industries, or business districts exist. The locations within the Salt Lake City water system indicated in Figure 14 did not meet the fire standards when tests were conducted in 1973 and in 1975. In some cases, inadequate flow may have been due to one or more of several factors, including insufficiently large pipes, and pipes in such poor condition that they have high friction losses and are unable to maintain sufficient "head" to meet the required flows. Some of the locations designated upon Figure 14, such as those on North Temple, may have been redesigned subsequently to meet existing standards.

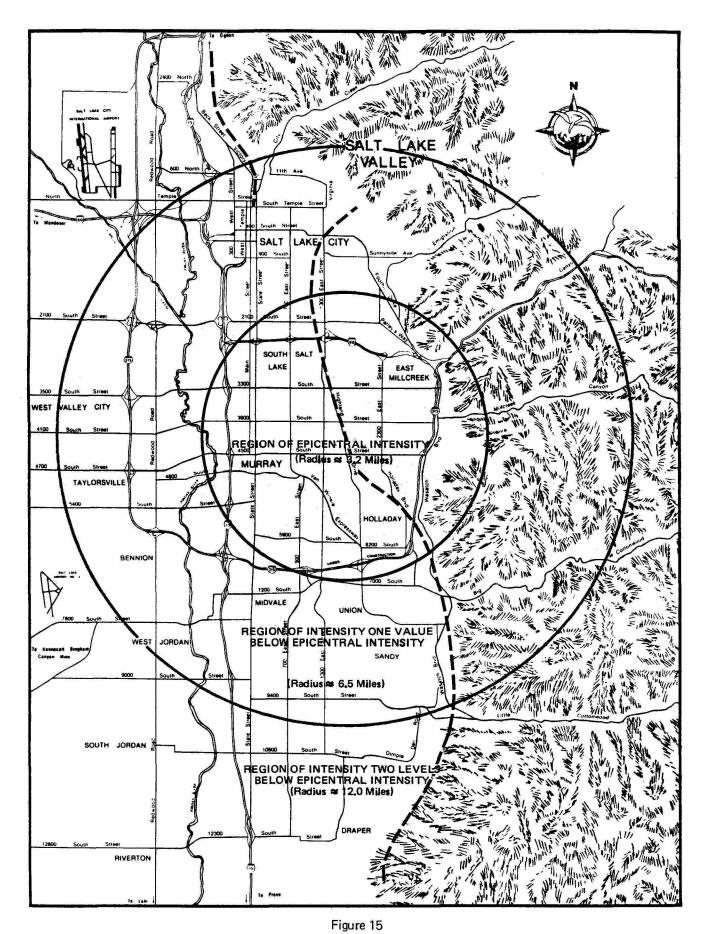
ISOSEISMAL MAP FOR MODELLING VARIOUS POSSIBLE EARTHQUAKES (Epicenter For The Model May Be Located Anywhere Along Or Near Fault)

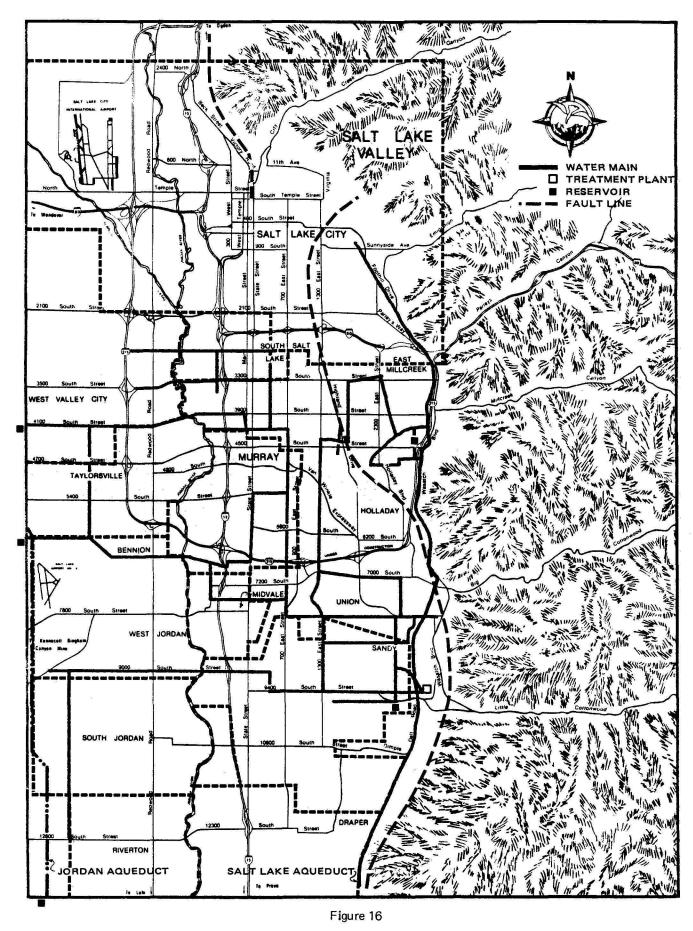
SCHEMATIC OUTLINE OF THE SALT LAKE COUNTY WATER CONSERVANCY DISTRICT SYSTEM

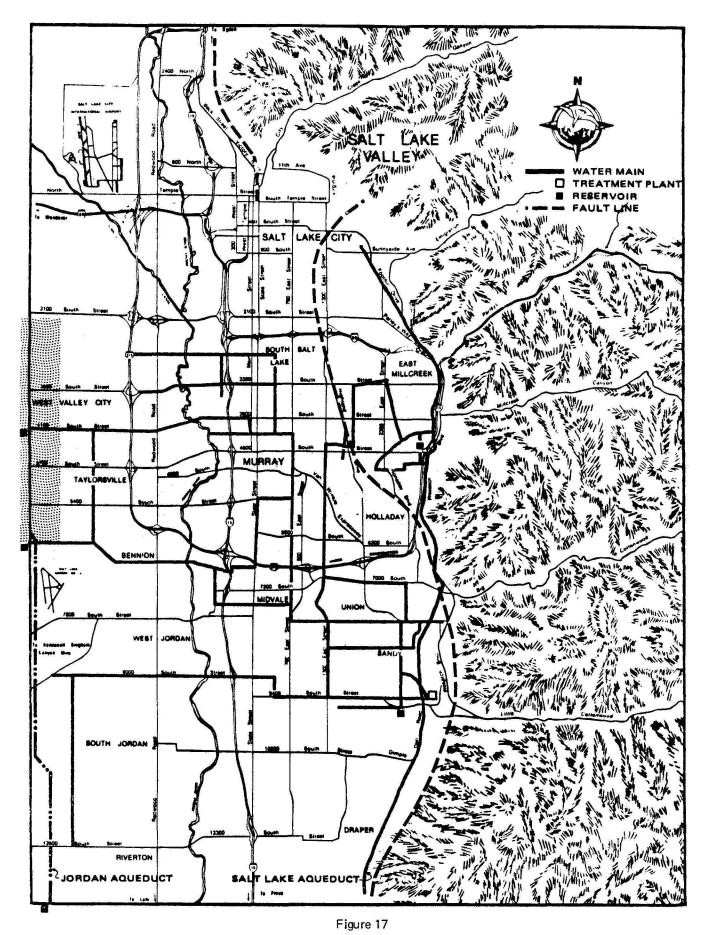
AREAS OF THE SALT LAKE COUNTY WATER CONSERVANCY DISTRICT DEPENDENT UPON TANKS OR RESERVOIRS FOR SUPPLY (Relevant Tanks Are At 45th South And 62nd South) (Identical To Areas Dependent Upon Power For Pumping)

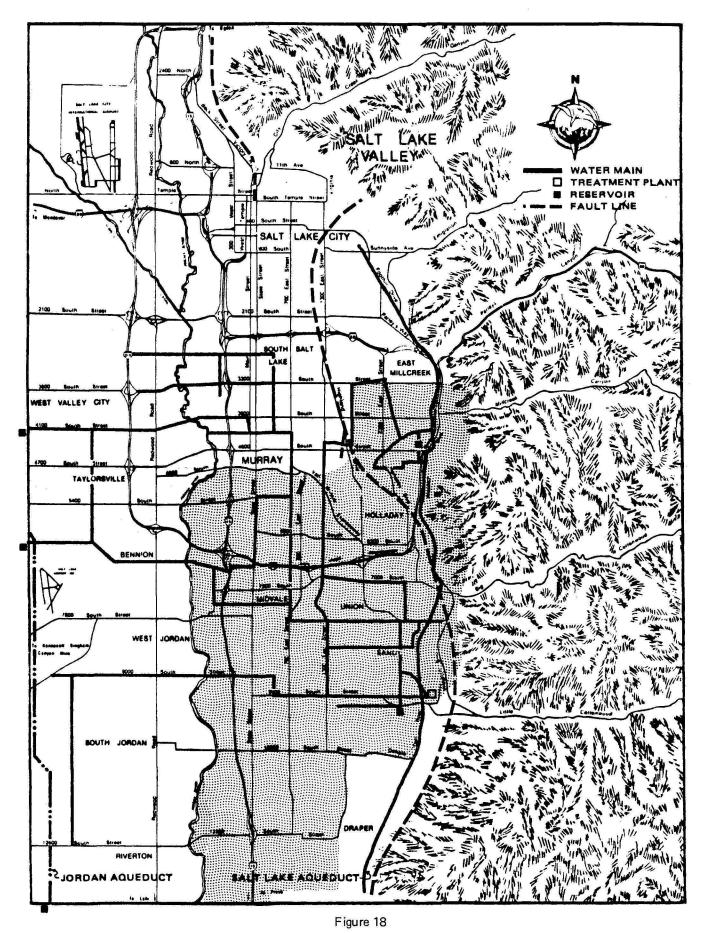
AREAS IN THE SALT LAKE COUNTY WATER CONSERVANCY DISTRICT THAT CANNOT BE SERVED BY GRAVITY FLOW FROM THE JORDAN AQUEDUCT

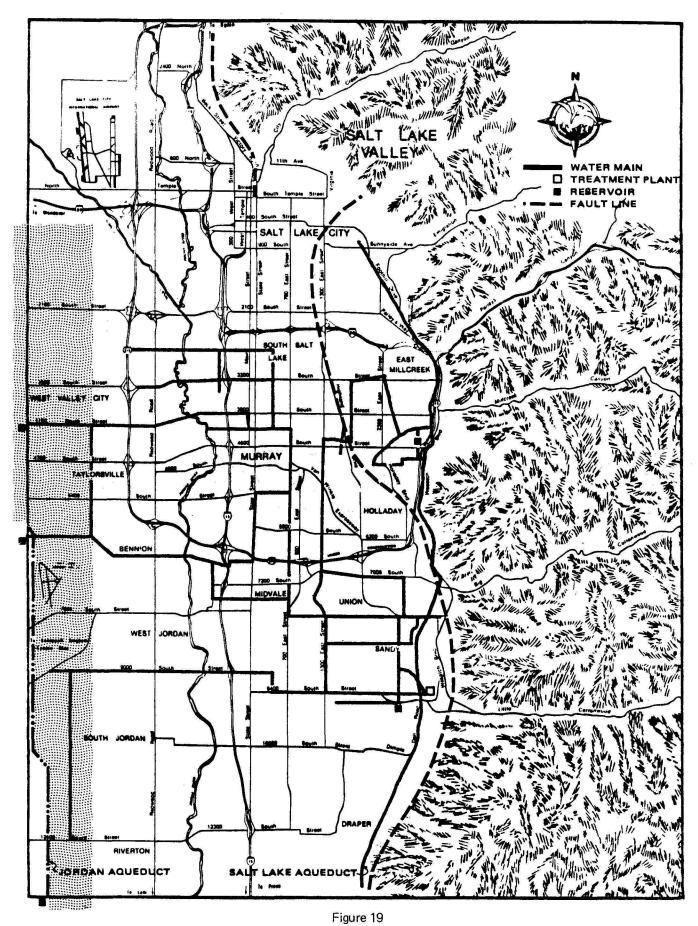
AREAS IN THE SALT LAKE COUNTY WATER CONSERVANCY DISTRICT THAT CANNOT BE SERVED BY GRAVITY FLOW FROM THE SALT LAKE AQUEDUCT AND METROPOLITAN TREATMENT PLANT (Based Upon Fire Flow Use)

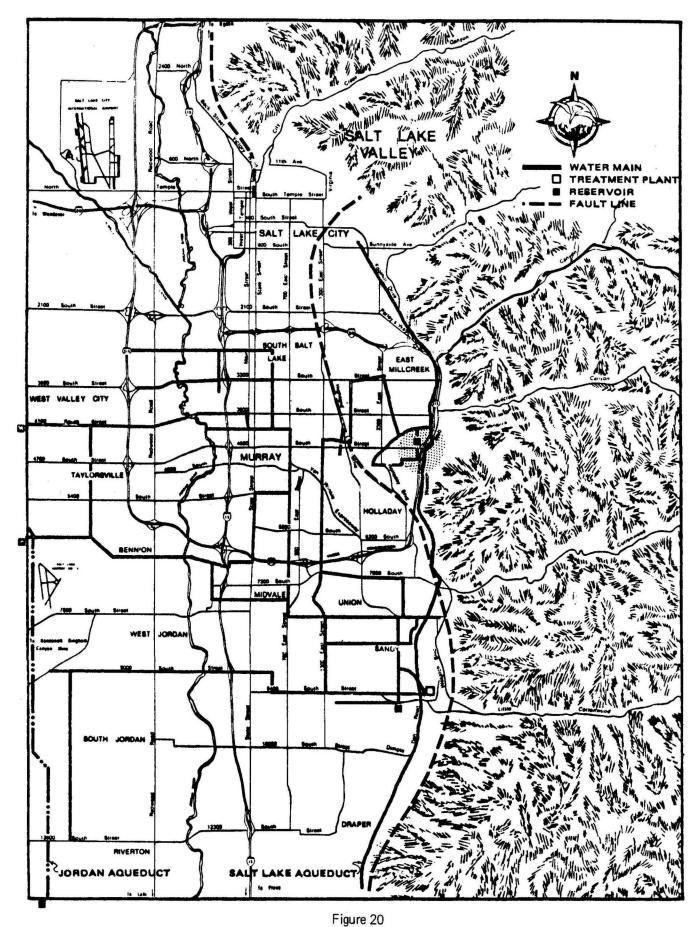
AREAS IN THE SALT LAKE COUNTY WATER CONSERVANCY DISTRICT THAT WELLS CANNOT SERVE (Identical With Areas That Tanks And Reservoirs Cannot Serve)
