**Lessons Learned from
the Loma Prieta, California, Earthquake
of October 17, 1989**

U. S. GEOLOGICAL SURVEY CIRCULAR 1045

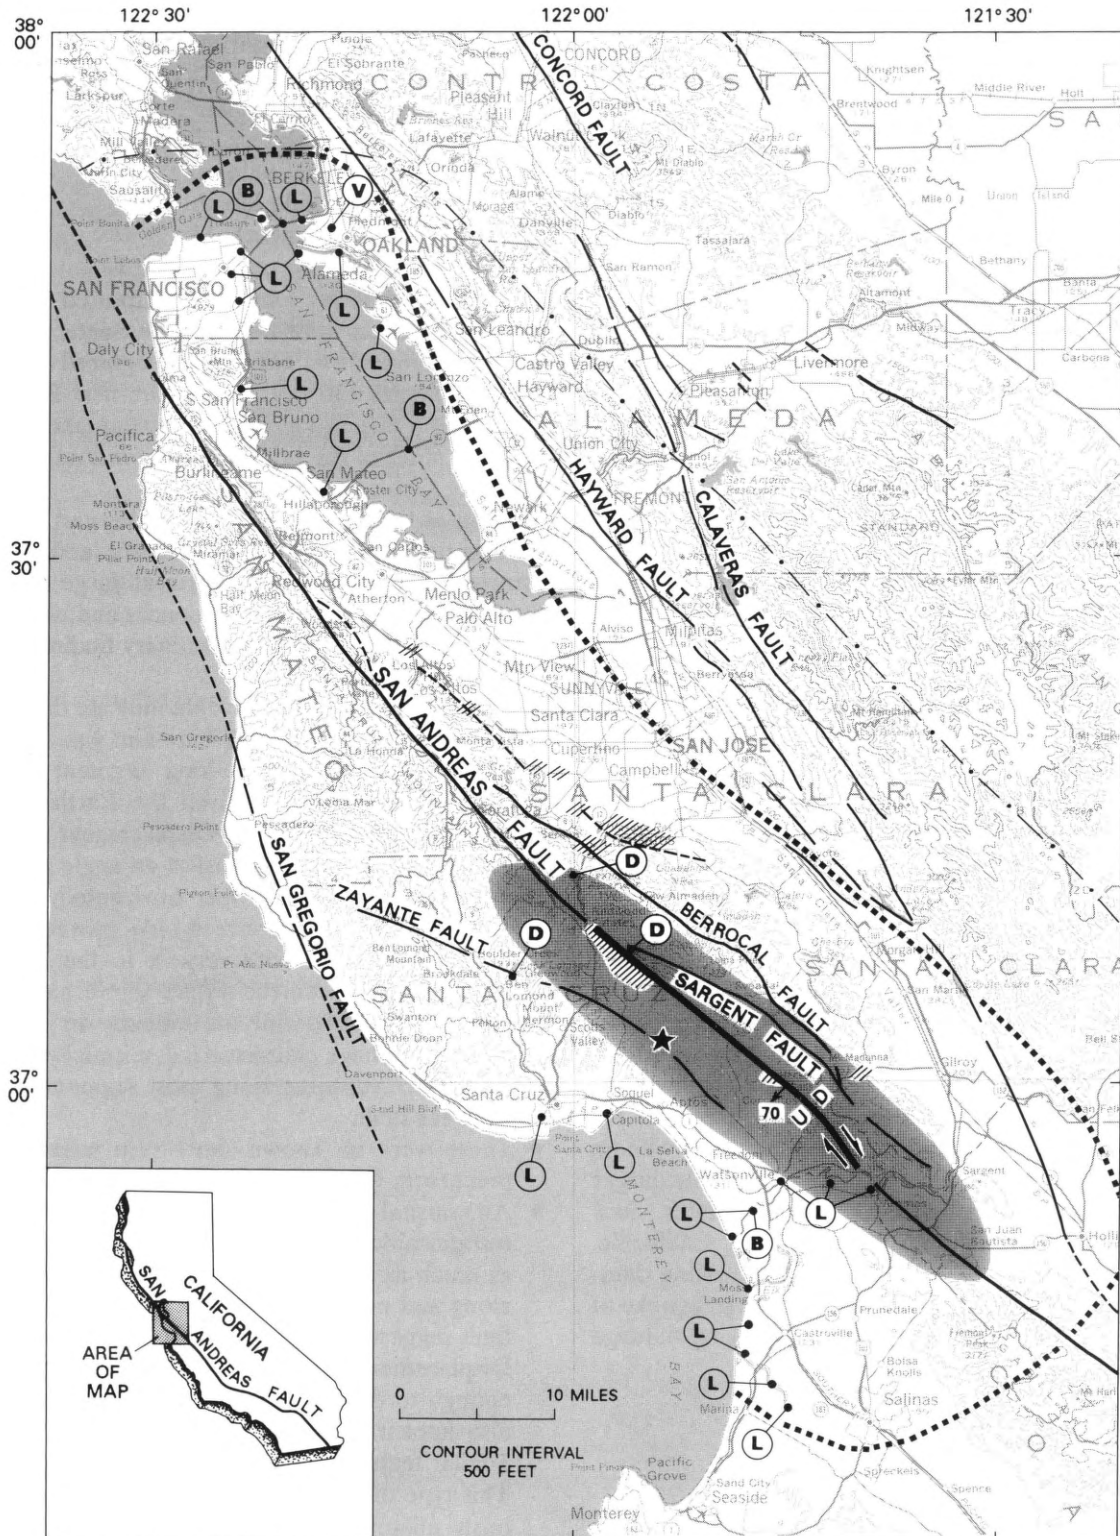
Figure 1. Mainshock epicenter of Loma Prieta earthquake and inferred fault rupture relative to areas of larger aftershocks, abundant ground cracks, and landslides and to limits of structural damage. Also shown are locations of major damaged structures and principal areas of ground cracks and liquefaction.

The epicenter of the October 17 earthquake, at 37°02' N. latitude, 121°53' W. longitude in the Santa Cruz Mountains, is about 10 miles east-northeast of the city of Santa Cruz and 60 miles southeast of San Francisco (fig. 1). The main rupture began at 4 minutes 15 seconds after 5 p.m. (Pacific daylight time), at a depth of about 11 miles beneath the Earth's surface. During the next 7 to 10 seconds, the rupture spread about 25 miles northwest and southeast and upward about 8 miles, stopping about 3 to 4 miles below the surface. Although it failed to reach the Earth's surface, the earthquake rupture ultimately involved slip on a 190-square-mile area of the buried fault surface.

Along the northeastern margin of the Santa Cruz Mountains there is a northwest-trending discontinuous zone of relatively intense damage to structures and local areas of ground cracks and deformation that extends northwestward from east of Los Gatos to Palo Alto (fig. 1).

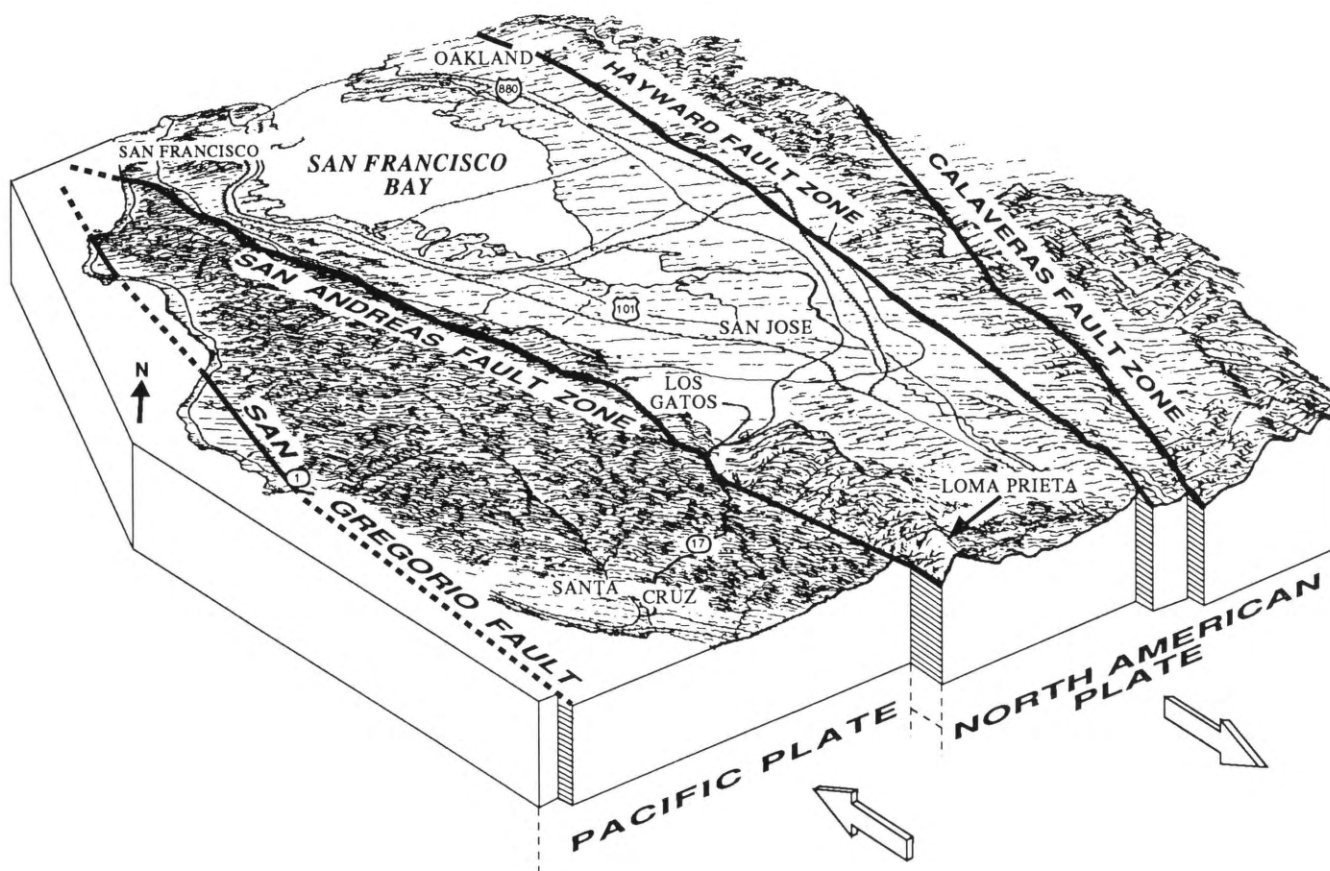
Figure 2. Block diagram illustrating relative motion of Pacific and North American plates and direction of movement on principal active strike-slip faults in San Francisco Bay region. Faults dashed where concealed. Modified from Alpha and others (1989).

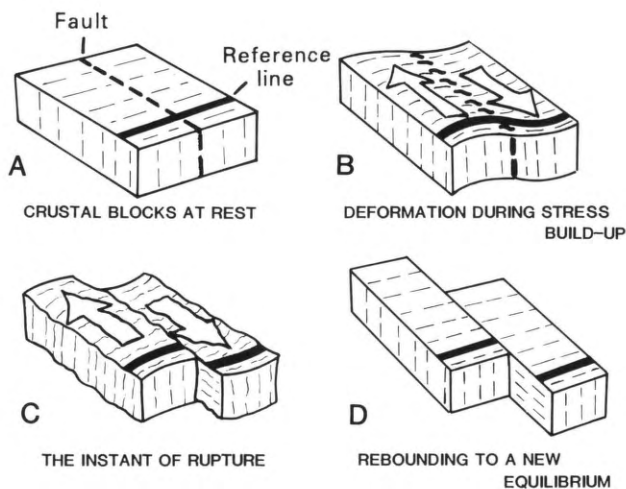
Figure 3. Block diagrams illustrating earthquake cycle for a right-lateral strike-slip fault according to elastic rebound theory.

theory, was developed as a result of studies of the fault displacement that accompanied the 1906 earthquake (Reid, 1910). According to this theory (see fig. 3), the sections that produce large earthquakes remain locked and quiet over periods of tens to hundreds of years while strain builds up by gradual deformation of the crust adjacent to the fault; this strain is relieved periodically in sudden fault displacements that produce earthquakes.

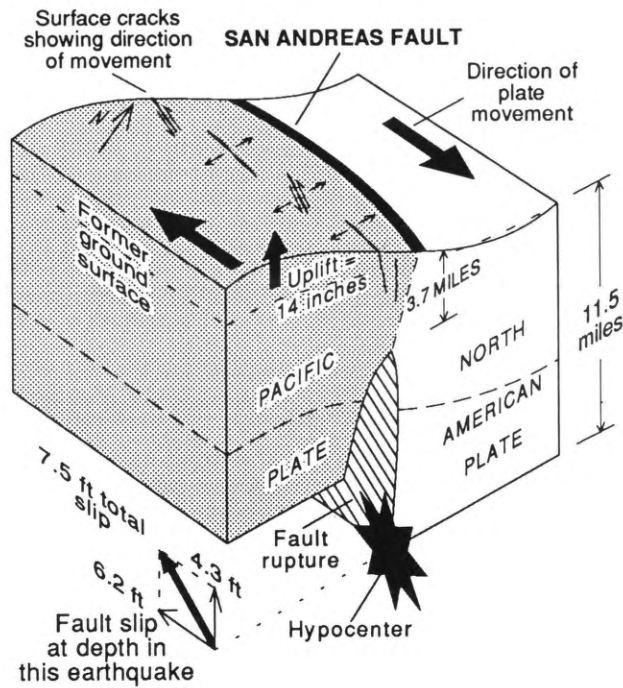
Figure 4. Schematic diagram showing inferred motion on San Andreas fault during Loma Prieta earthquake. Along southern Santa Cruz Mountains segment of fault, Pacific and North American plates meet along inclined plane that dips approximately 70° southwest. Plate motion is mostly accommodated by about 6.2 feet of slip along strike of this plane and by 4.3 feet of reverse slip, in which Pacific plate moves up fault and overrides North American plate. Amounts of fault slip and vertical surface deformation were determined from geodetic data. Modified from figure by M. J. Rymer.

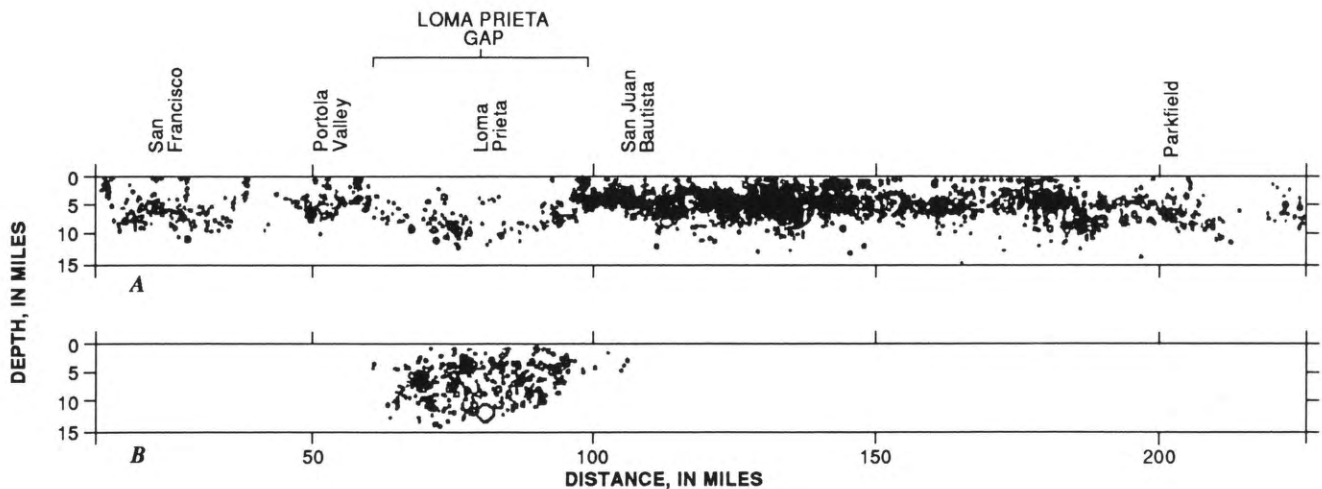
Figure 5. Cross sections showing seismicity along San Andreas fault from north of San Francisco to south of Parkfield. A, Background seismicity recorded during 20-year period before earthquake. Dense zone of activity south of San Juan Bautista is creeping segment of San Andreas fault. North of San Juan Bautista, San Andreas fault has been virtually aseismic since 1906. On Loma Prieta segment, what little seismicity has occurred has effectively outlined a U-shaped area (Loma Prieta gap) that has been virtually aseismic over the past 20 years. B, Aftershocks and mainshock (largest circle) almost completely filled former quiet zone of Loma Prieta gap.

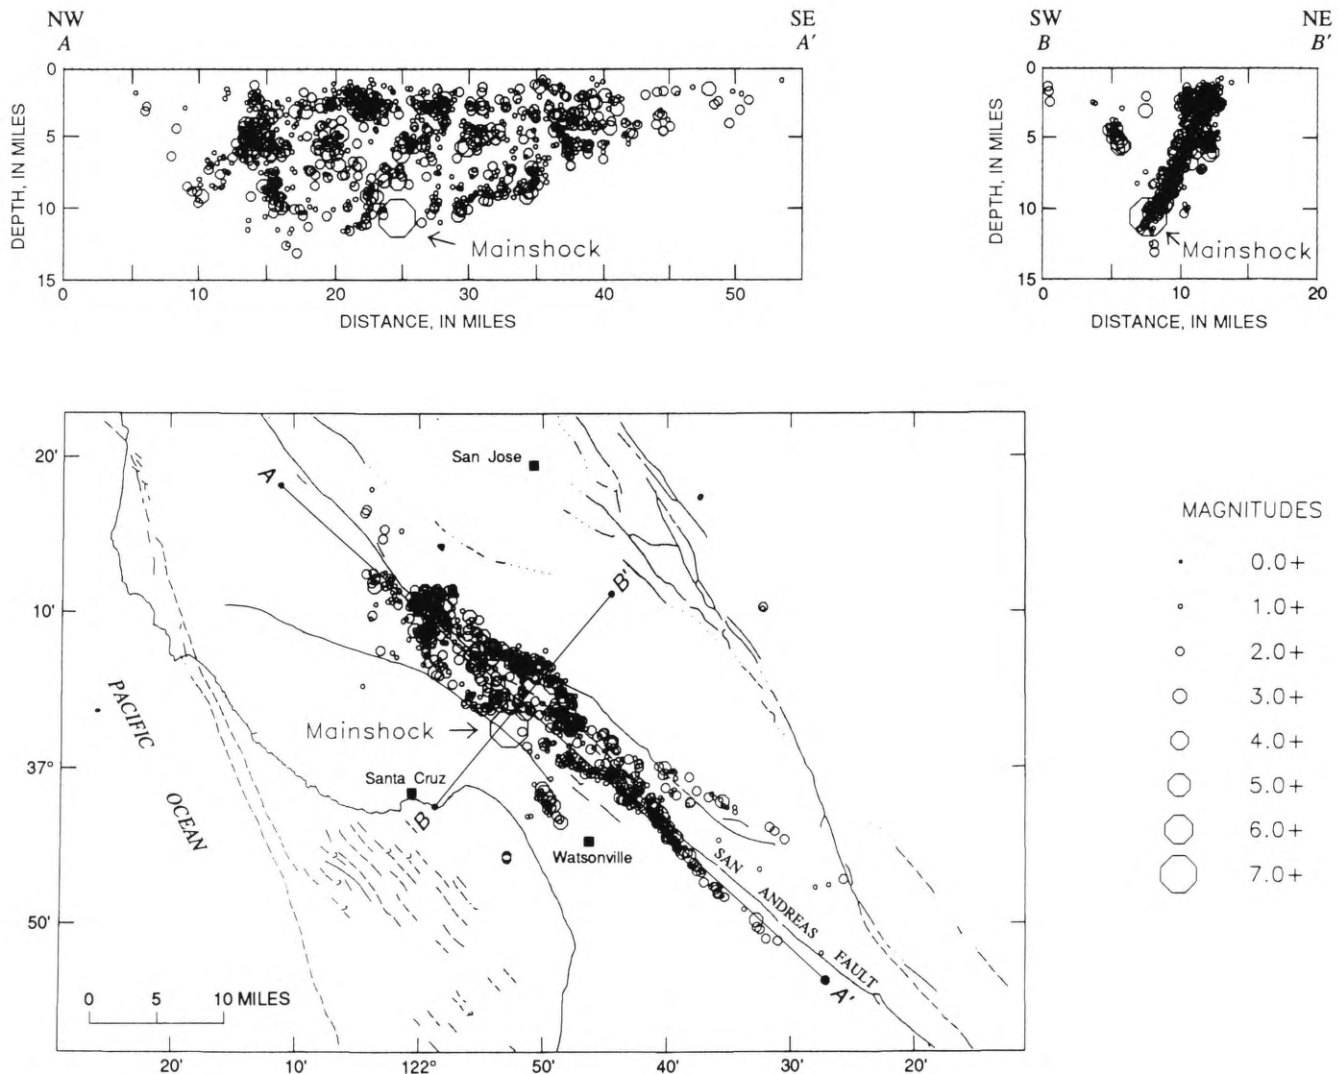
Figure 6. Spatial distribution of aftershocks of Loma Prieta earthquake in relation to San Andreas fault. Along-fault, or longitudinal, cross section *A-A'* and cross-fault, or transverse, cross section *B-B'* display depth distribution of aftershocks on vertical planes. Faults are dashed where approximately located, dotted where inferred, and queried where uncertain.

Faults that ruptured during and after the mainshock are defined by the 3-dimensional distribution of the aftershocks (fig. 6). These aftershocks are caused by redistribution of stress following slip on the San Andreas fault during the mainshock. The mainshock hypocenter lies at the bottom and center of the aftershock distribution (fig. 6, section A-A'). Most of the aftershocks are

confined to a plane that extends upward and laterally from the mainshock hypocenter with a dip of 70° southwest (fig. 6, section *B-B'*). This plane, the mainshock plane, projects to the surface between the traces of the San Andreas and Sargent faults. However, the dense clusters of shocks between 2 and 4 miles depth mark the inferred upper extent of the mainshock rupture. Above this point, the complex pattern of aftershocks probably represents movement on multiple branching faults, including shallow vertical segments of the San Andreas and Sargent faults. Thus, from the geometry of the deeper aftershocks, the primary rupture occurred on a dipping, buried portion of the San Andreas fault.

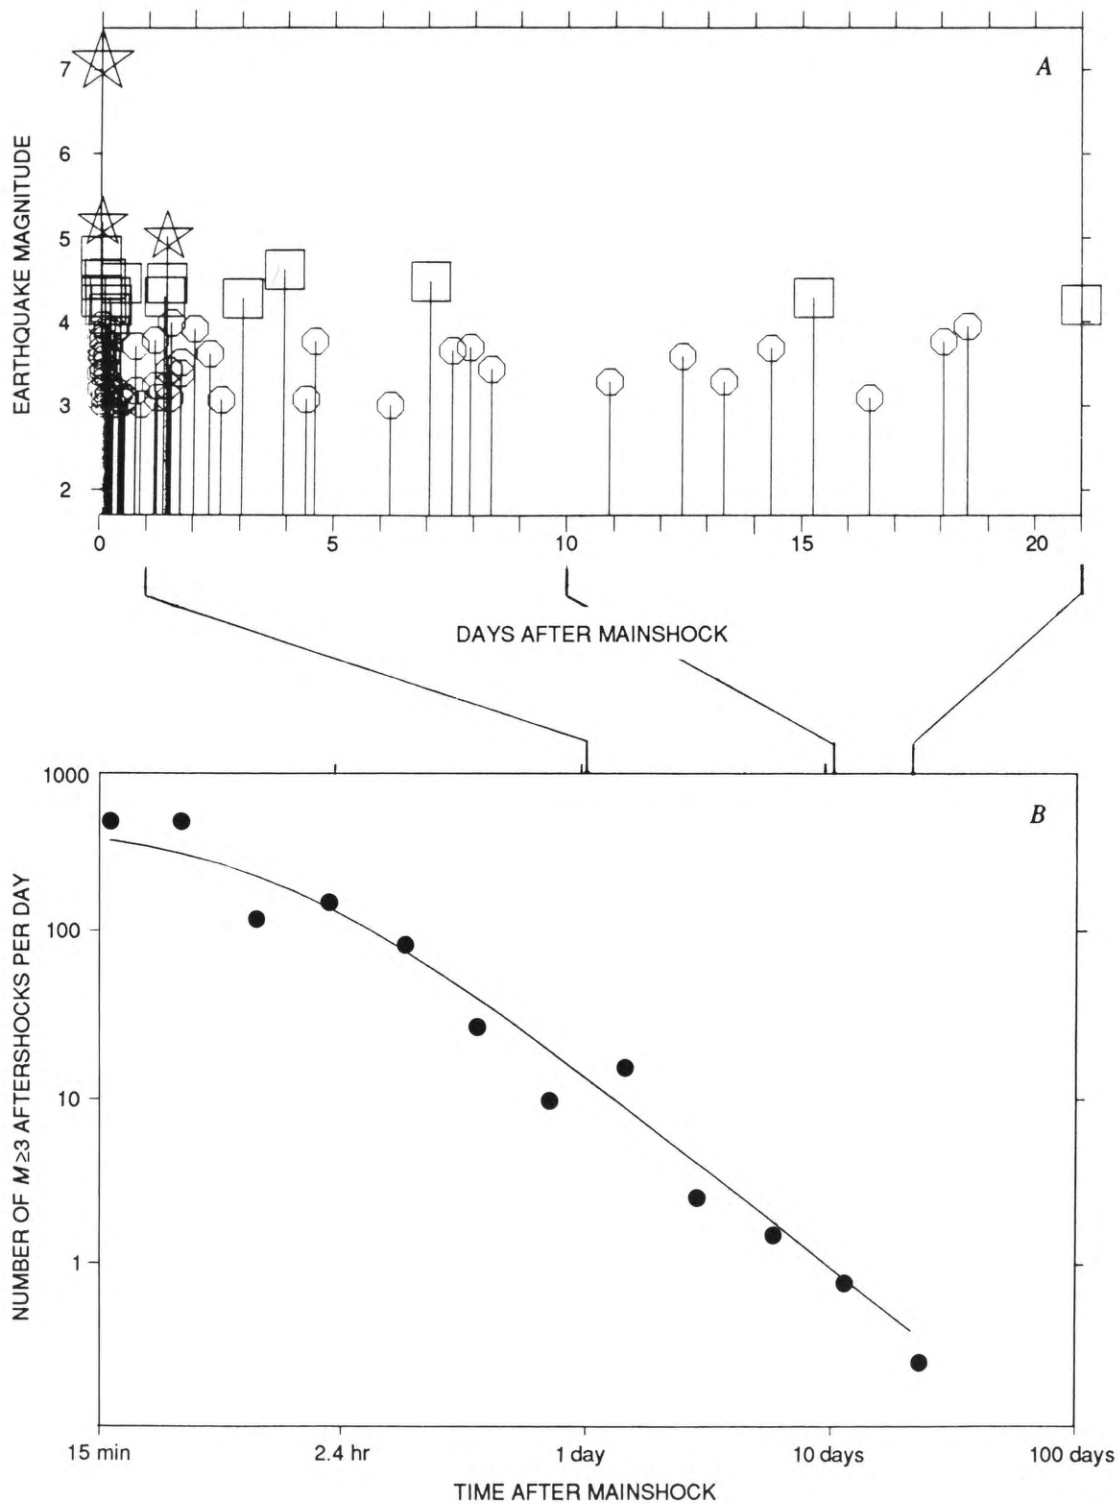
Figure 7. Time distribution of aftershocks of magnitude (M) 3 or greater of Loma Prieta earthquake. *A*, Aftershocks during first three weeks are represented by circles ($M \geq 3$), squares ($M \geq 4$), and stars ($M \geq 5$). Rate of aftershocks decreases rapidly in first week of sequence. *B*, Rate of $M \geq 3$ aftershocks as a function of time, shown on logarithmic scales. Points plotted represent rate observed in aftershock sequence. Solid line is theoretical curve representing expected aftershock rate. Earthquake sequence closely follows expected time behavior.

The rate of aftershock activity decreased rapidly with time after the mainshock, a pattern typical for a California earthquake sequence (fig. 7). A total of 51 aftershocks of magnitude 3.0 and larger occurred the day after the mainshock and 16 occurred the following day. After 21 days, 87 magnitude 3.0 and larger aftershocks had occurred. Extrapolation of the observed pattern, using a well-established law of aftershock decay, suggests that magnitude 3 or larger aftershocks will continue to be felt in the epicentral region for at least two years.

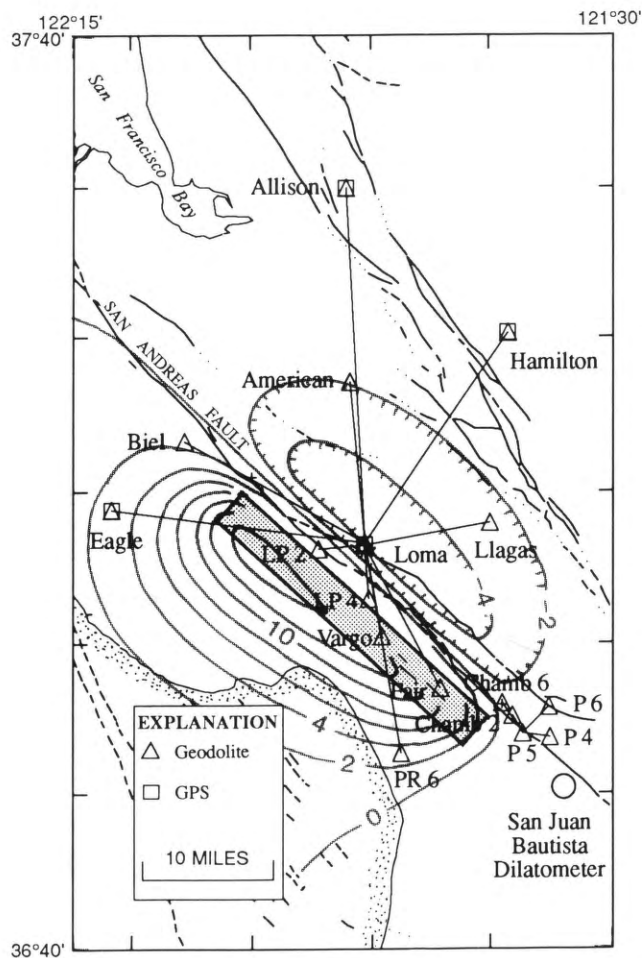
Figure 8. Geodolite lines and Global Positioning System (GPS) vectors that were observed following Loma Prieta earthquake. Projection of rupture surface, which extends to depths of about 4 to 11 miles, is shown by shaded rectangle. Contours show inferred uplift (gray lines) and subsidence (barbed gray lines) of surface due to oblique slip on fault plane; contour interval about 2 inches. Maximum uplift and subsidence were 1.5 and 0.5 feet, respectively. Location of San Juan Bautista Dilatometer is shown by circle. Faults (from Jennings, 1975) are dashed where approximately located and dotted where inferred.

On the basis of a preliminary analysis of the change observed in 11 geodolite distances and 4 GPS vectors surveyed immediately after the event, we have inferred that the rupture included about 6 feet of right-lateral strike slip and 4 feet of reverse slip on a fault surface that strikes N. 48° W. and dips 70° to the southwest (fig. 4). The best-fitting rupture surface extends about 25 miles along strike and at a depth of about 4 to 11 miles. The data suggest a broad uplift of the surface to a maximum of about +1.5 feet on the southwest block and a more limited area of subsidence to a maximum of -0.5 foot of the northeast block as depicted schematically by contours in figure 8. A buried rupture surface is consistent with the lack of surface offset associated with the earthquake. The slip in the plane of the fault, with a considerable component of reverse slip, is about the same as that inferred from the seismological data. The amount of reverse slip on the fault rupture is not well constrained by the geodolite and GPS data, which are most sensitive to horizontal deformation. A better estimate of the vertical deformation may be obtained from a resurvey of 124 miles of leveling routes in the Loma Prieta area. Most of the initial level surveys, several of which extend across the Santa Cruz Mountains near the fault rupture, were made in the 1940's and 1950's and, except for segments along the coast and in the Santa Clara Valley, none have been repeated.

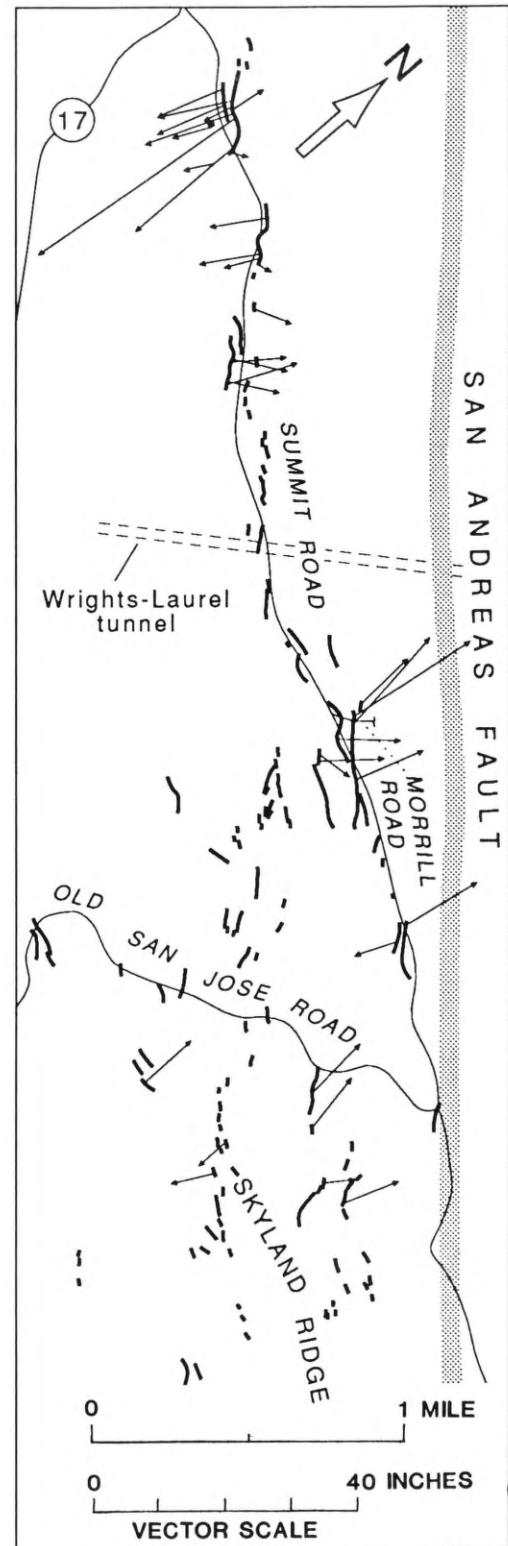
Figure 9. Zones of prominent surface cracks (heavy lines) and net-displacement vectors (arrows) near Summit Road, Santa Cruz Mountains. Open cracks obviously related to local ground failure or landslides are not shown. Only vectors greater than 5 inches long and next to Summit Road are shown. Wide gray band is approximate location of main trace of San Andreas fault as shown by 1906 offset in Wrights-Laurel tunnel and by topography along and beyond northwest and southeast boundaries of figure.

Ground cracks in the Skyland Ridge area (fig. 9) exhibit nearly the same trend and sense of displacement as the cracks located along Summit Road. Displacement of the Skyland Ridge cracks is largely extensional but with a component of left slip. Displacement is generally

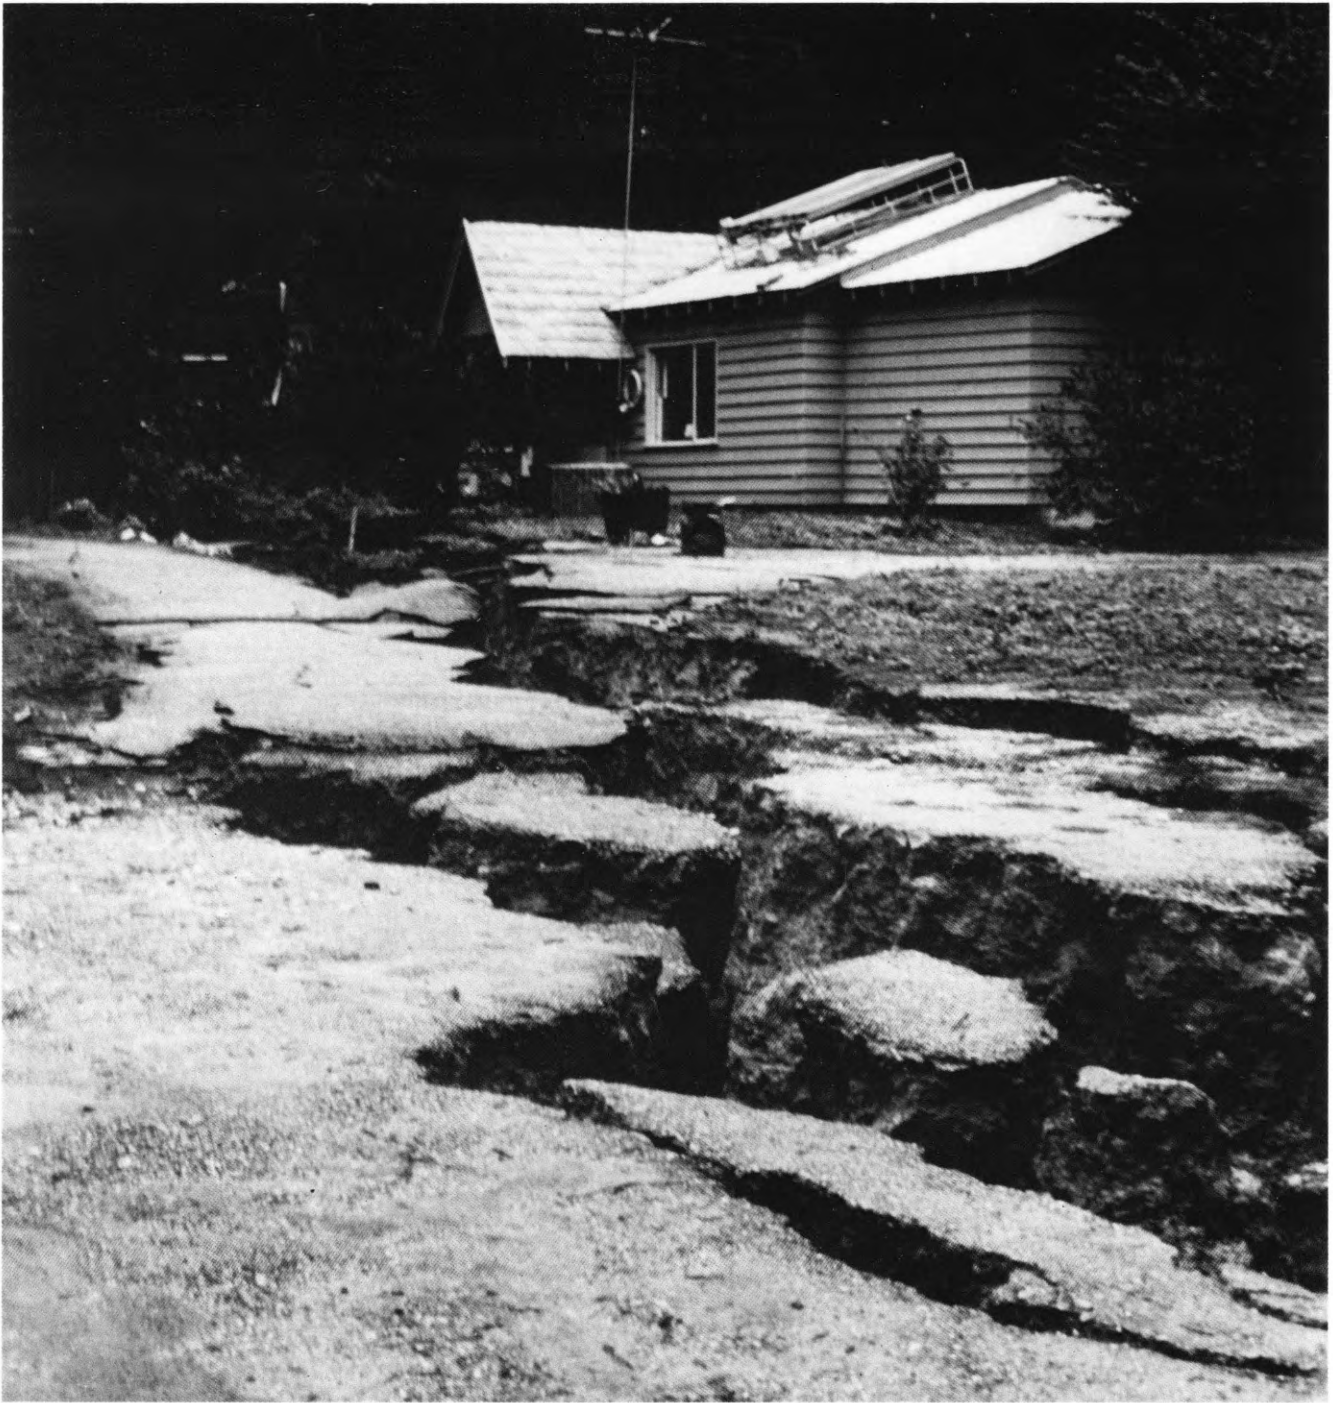
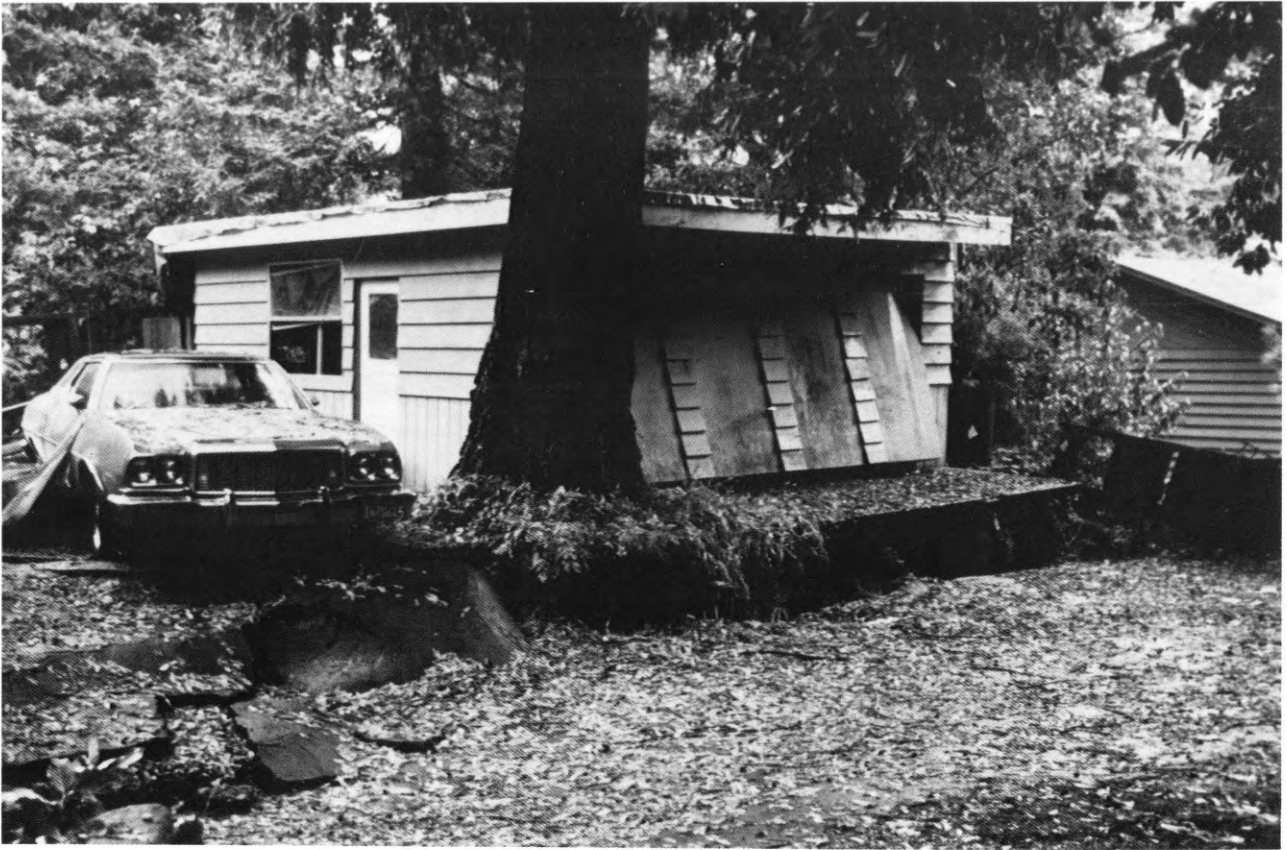
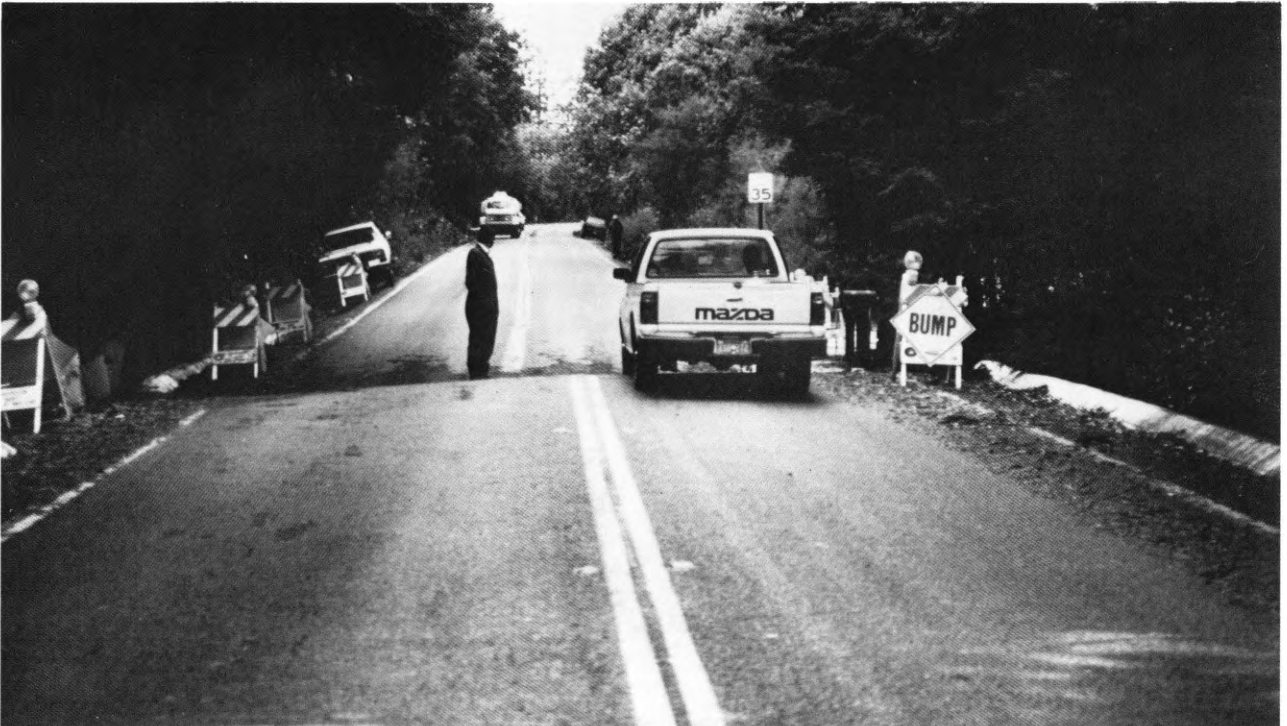
Figure 10. Crack system near Summit Road, 1/2 mile southeast of Highway 17. *A*, View northwest of wide zone of dominantly extensional cracks passing several feet in front of house. *B*, View southeast back toward house showing driveway dropped down relative to garage. *C*, Same crack where it crosses Summit Road; crack trends nearly north here rather than northwest and displays large component of left-lateral displacement. In general, upthrown block is on downhill side of this crack. Swale along crack on northeast side of Summit Road ridge in this area suggests similar displacement may have occurred in the past.

and they vary from single large crack to en echelon, anastomosing, or discontinuous crack sets (figs. 10, 11). Displacement across these cracks is mainly extensional, generally with a component of left slip of as much as 2.5

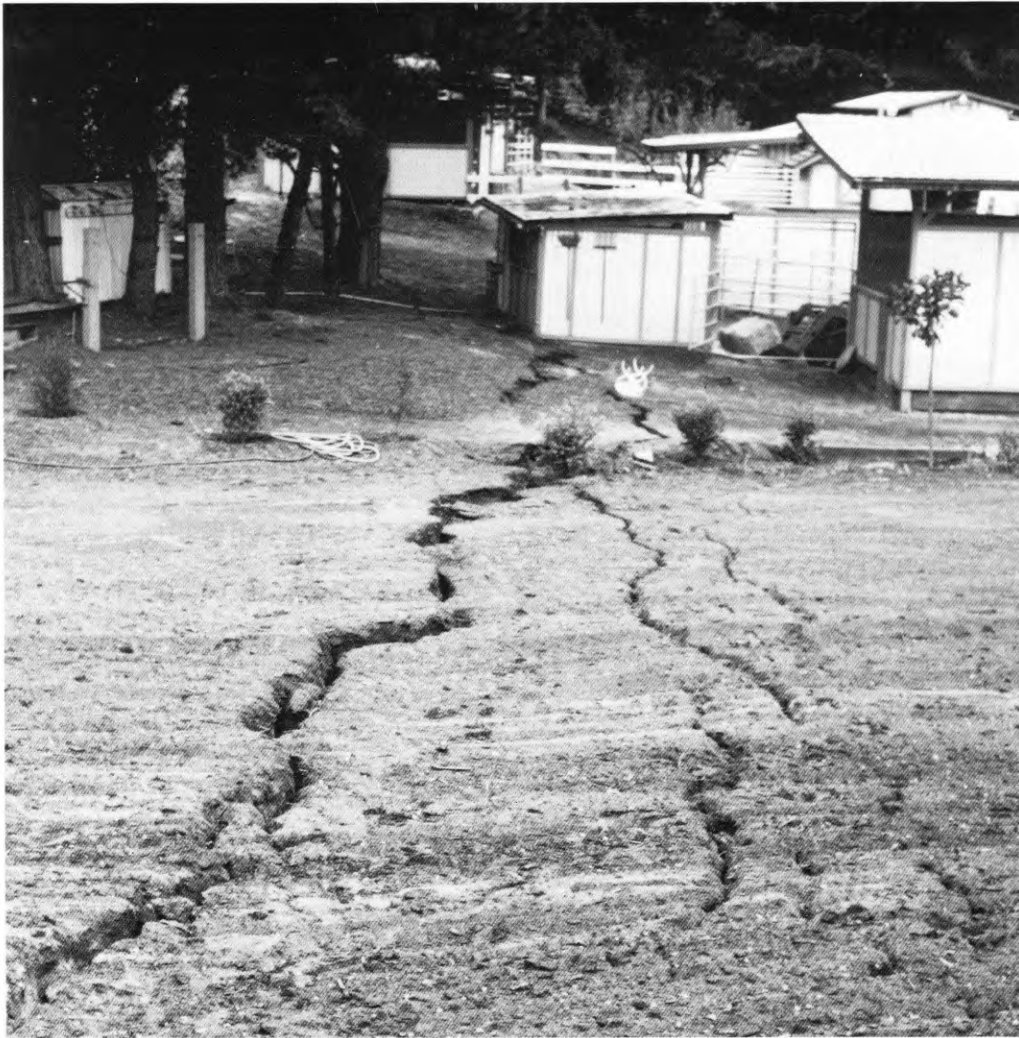
Figure 11. Cracks through corral near Summit Road, about 1.1 miles southeast of Highway 17, along southwest edge of elongate, closed depression. Cracks are also found along northeast edge of same depression. Displacements on both sets of cracks deepened depression.

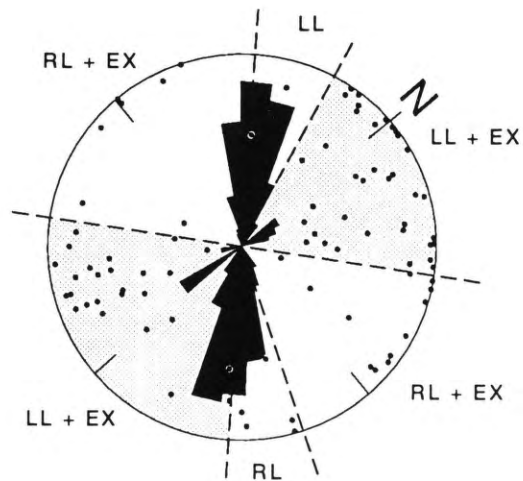
Figure 12. Crack trends and displacement vectors for 94 surface cracks in Summit Road area. Rose diagram (black) shows strike of cracks, which, on average, are subparallel to San Andreas fault. Dots are lower-hemisphere equal-area projection of slip vectors. Note that dominant sense of slip is within both mixed left-lateral and extensional (shaded) and right-lateral and extensional domains. LL, left lateral; RL, right lateral; EX, extensional. Modified from figure by Ze'ev Reches.

12). Repeated measurements across these cracks have detected no postearthquake displacement in 1 month after the earthquake.

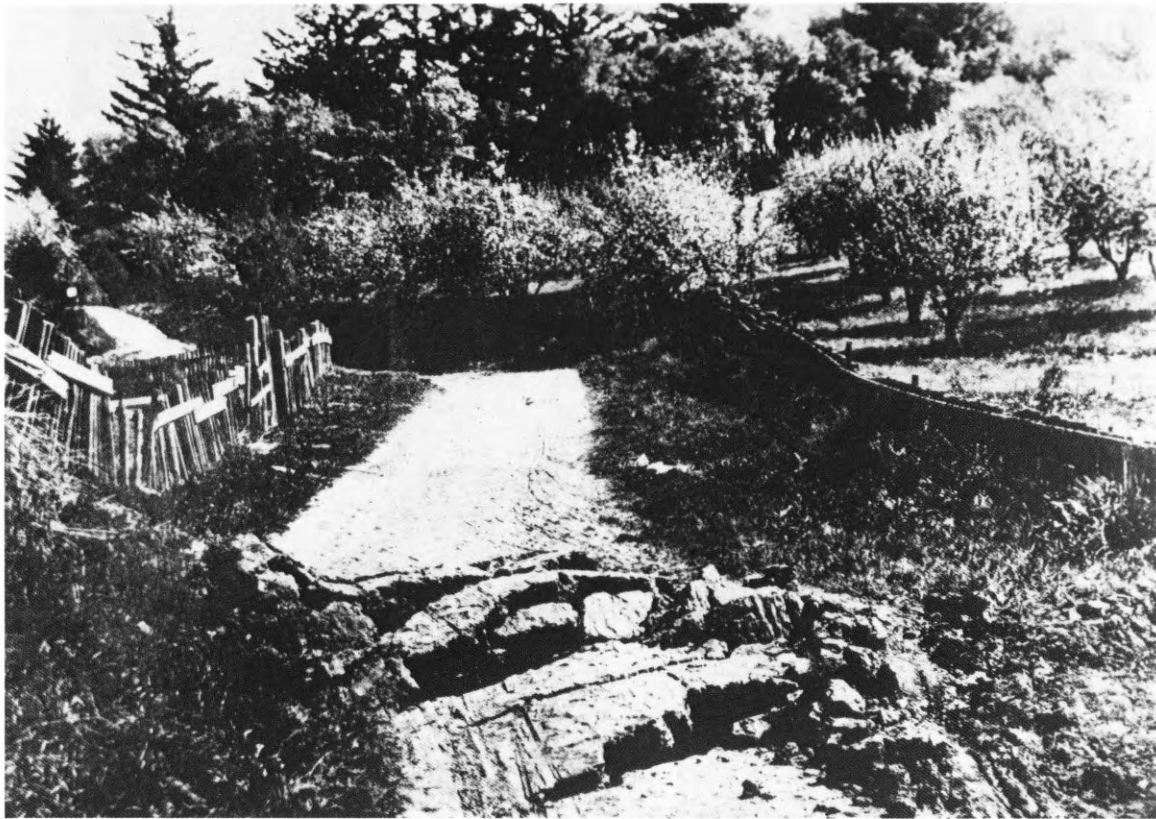
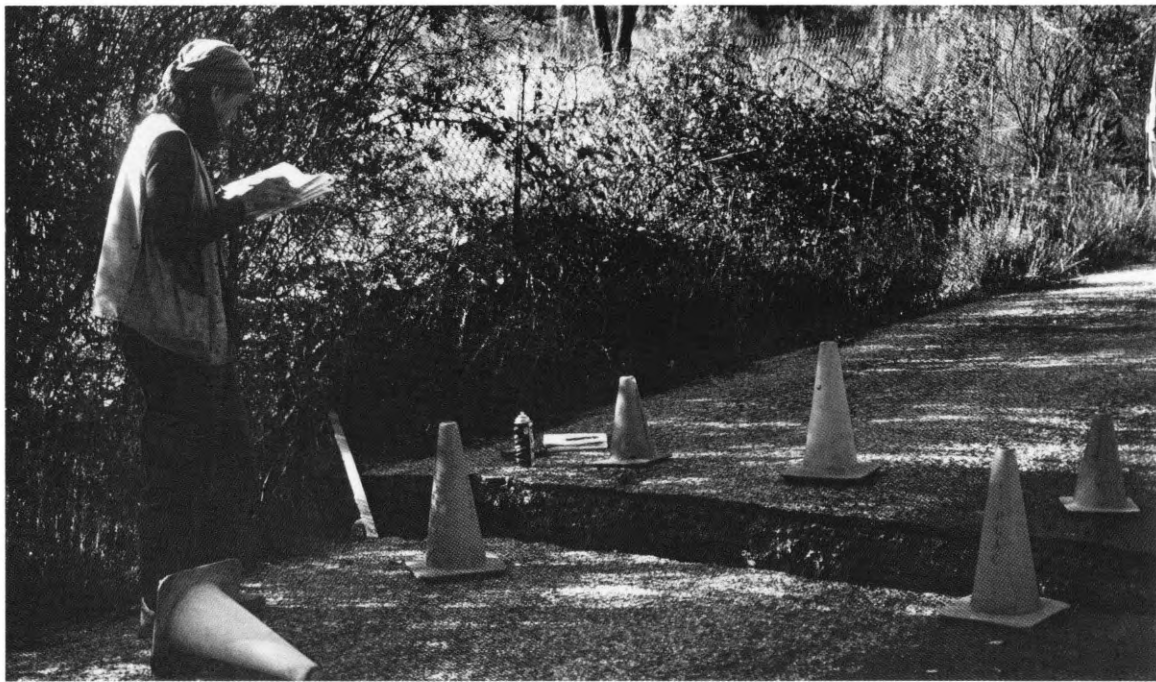
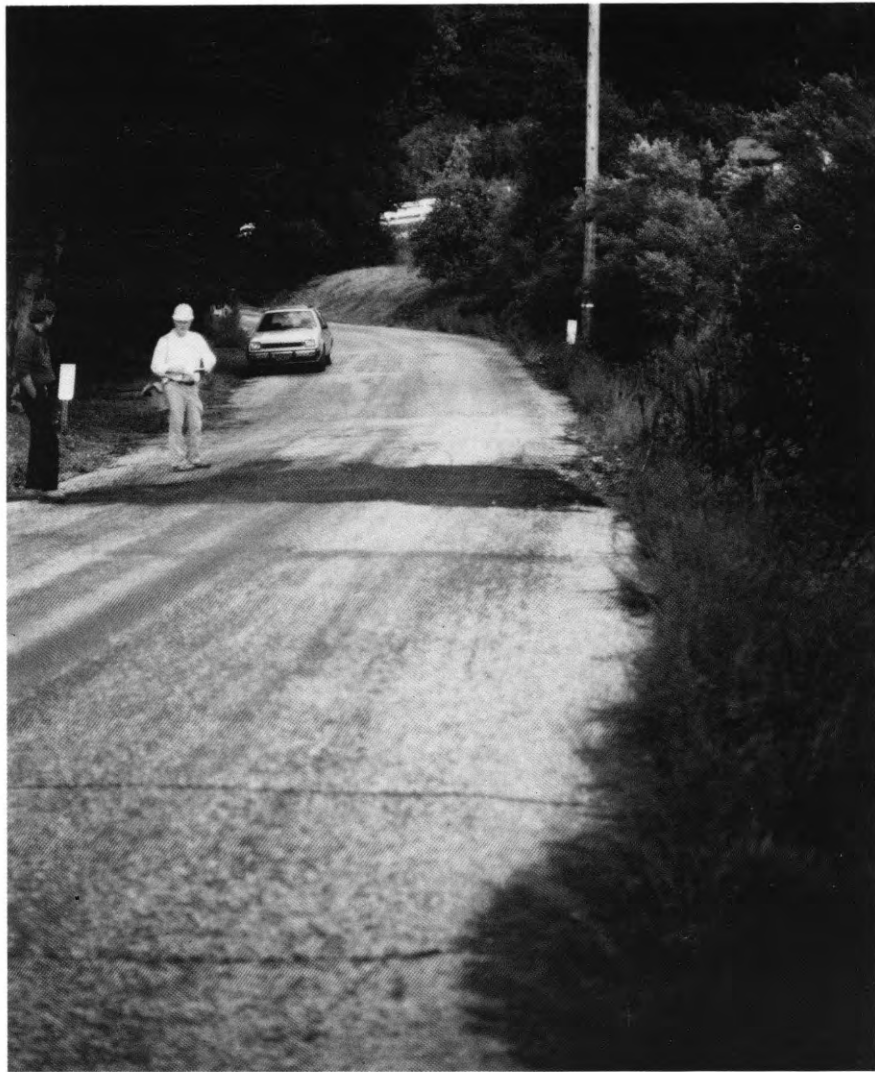
Figure 13. Larger of two cracks that broke Morrill Road by left-lateral motion in both 1906 San Francisco earthquake and 1989 Loma Prieta earthquake. *A*, View southwest across Morrill Road in 1906 showing left-lateral displacement of 3.6 feet (Lawson, 1908, plate 65A). *B*, Same crack on October 18, 1989, morning after earthquake, before road repairs, show-

ing 1.1 feet of extension, 1.2 feet of left lateral displacement, and 0.3 feet of vertical displacement. Yardstick is aligned in direction of movement of opposite sides of crack. *C*, View of present-day Morrill Road (October 1989) similar to 1906 view after asphalt road had been patched, showing left-lateral displacement of edge of road.

offsets mapped during the field investigations following the 1906 earthquake. The larger of the two cracks showed left slip of about 4 feet in 1906 but 1.2 feet in the Loma Prieta earthquake (fig. 13). The 1989 cracks cross Morrill Road southeast of the axis of the now abandoned and closed Wrights-Laurel railroad tunnel, which passes 700 feet beneath the crest of the ridge. After the 1906 earthquake, the most reliable measurement of offset along this reach of the fault, 4.5 feet of right slip, was made in the tunnel about 3,000 feet north-northeast of these left-slip cracks. The offset, however, was not observed at the surface above the tunnel.

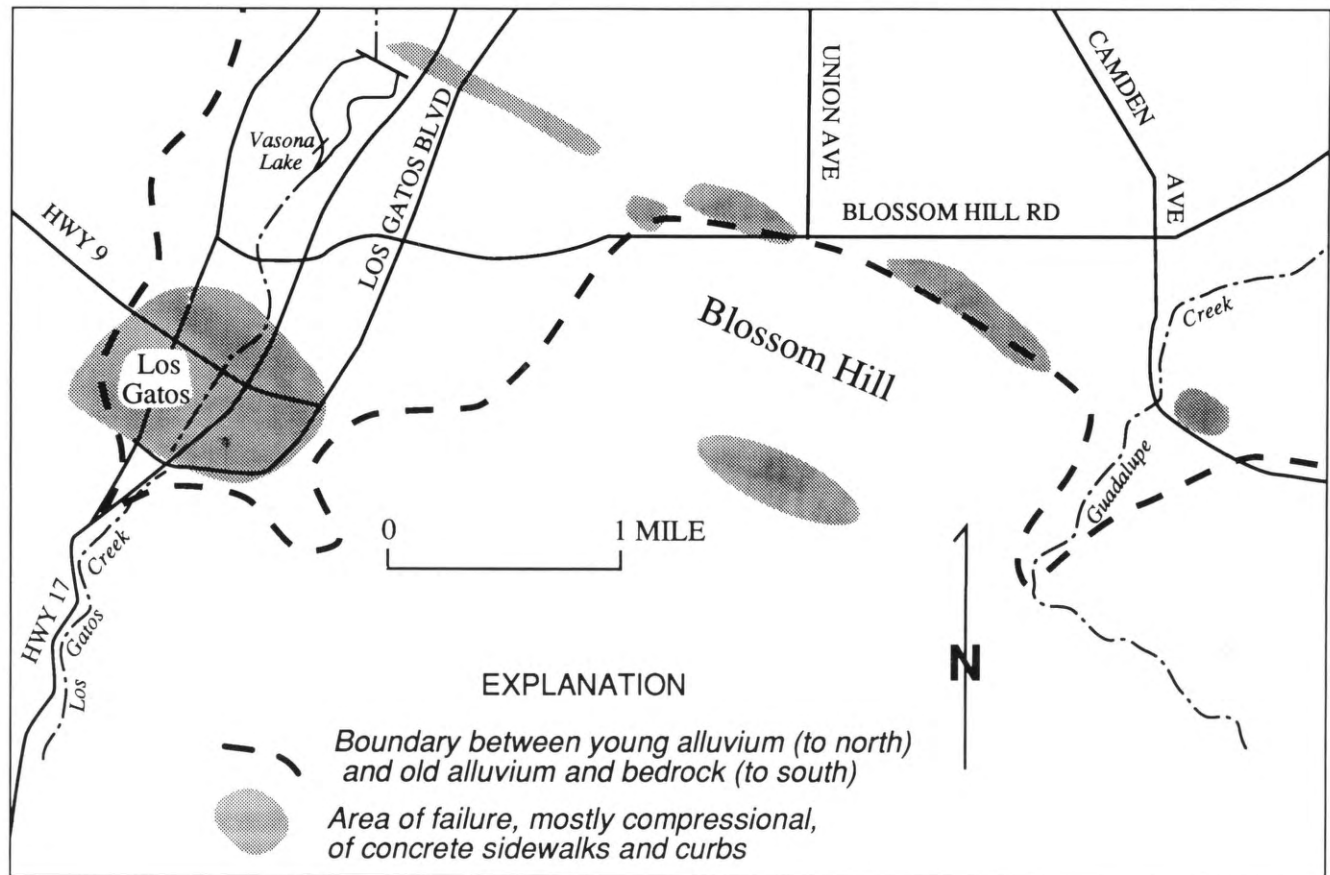
Figure 14. Areas of ground cracks and compressional deformation in Los Gatos and vicinity.

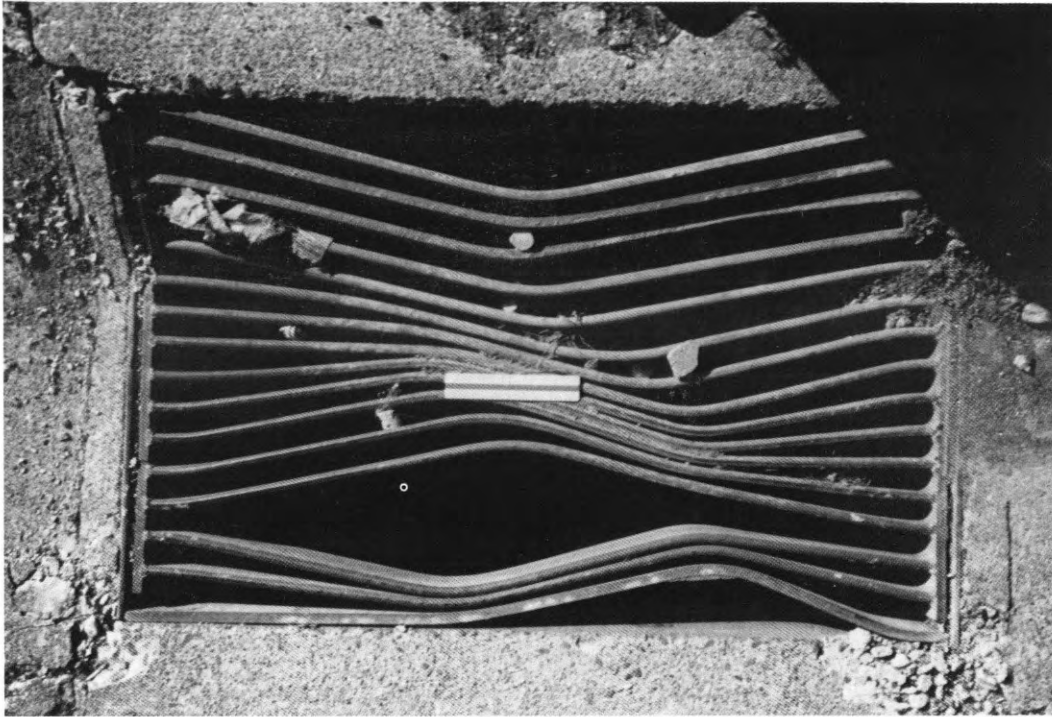
Figure 15. Sewer grate in Los Gatos showing effects of compression perpendicular to long direction of grate. Ruler is about 6 inches long.
