**Lessons Learned from
the Loma Prieta, California, Earthquake
of October 17, 1989**

U. S. GEOLOGICAL SURVEY CIRCULAR 1045

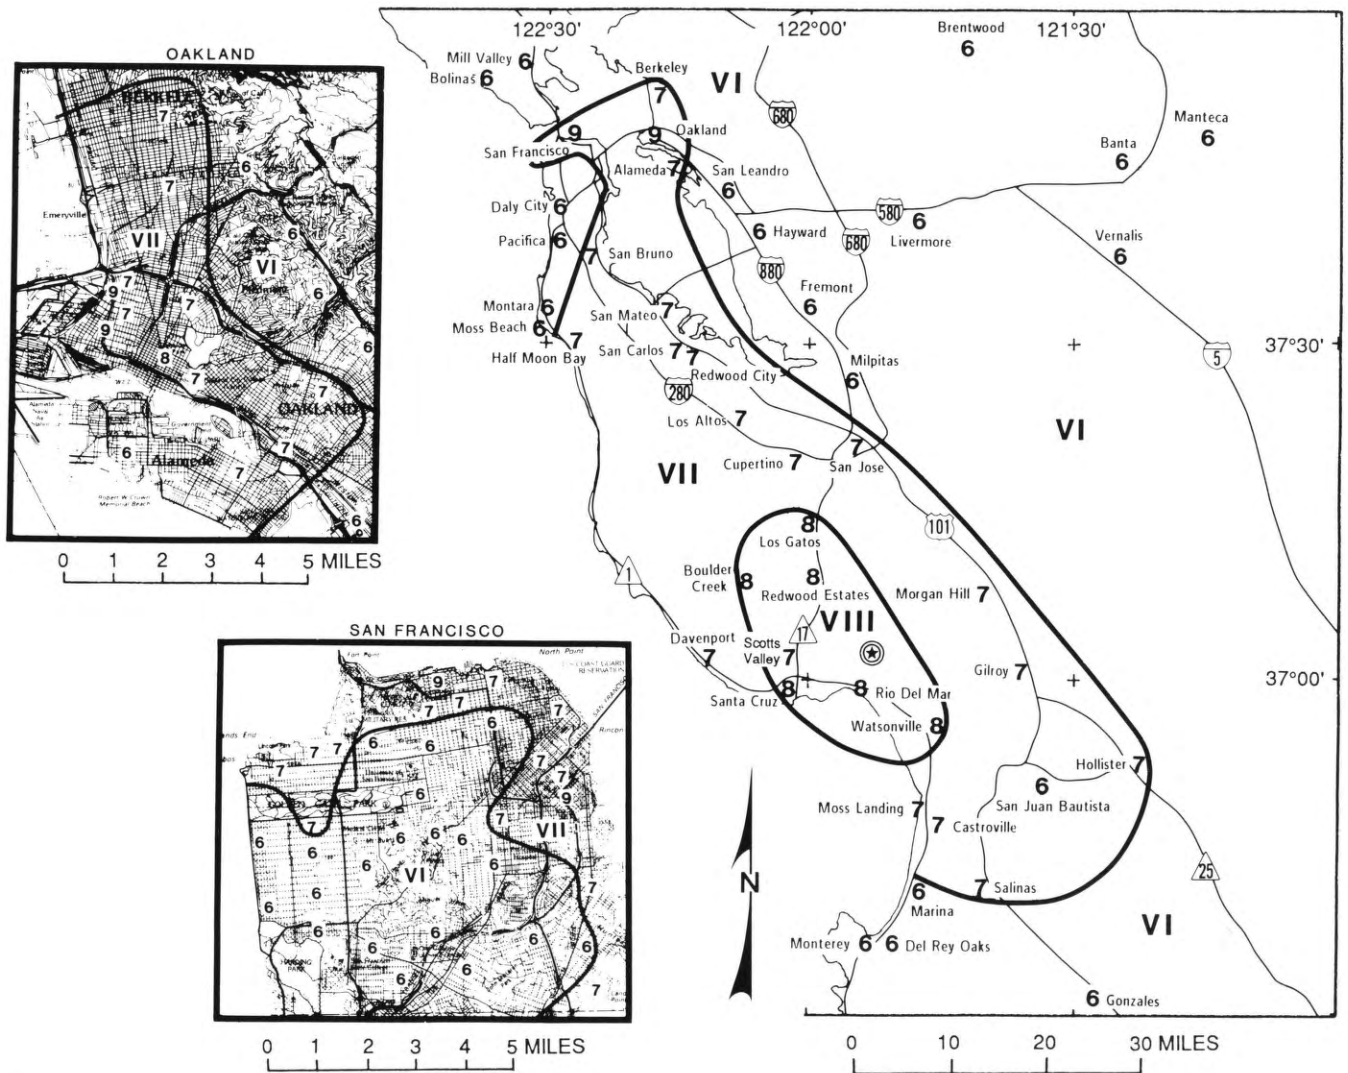
Figure 16. Preliminary map showing distribution of modified Mercalli intensity for Loma Prieta earthquake. Numbers indicate intensity values for localities where observations were made; Roman numerals represent intensity level between isoseismal lines. Location of mainshock epicenter is shown by circled star. Insets show more detailed assessments in cities of San Francisco and Oakland. See table 1 for descriptions of intensity levels.

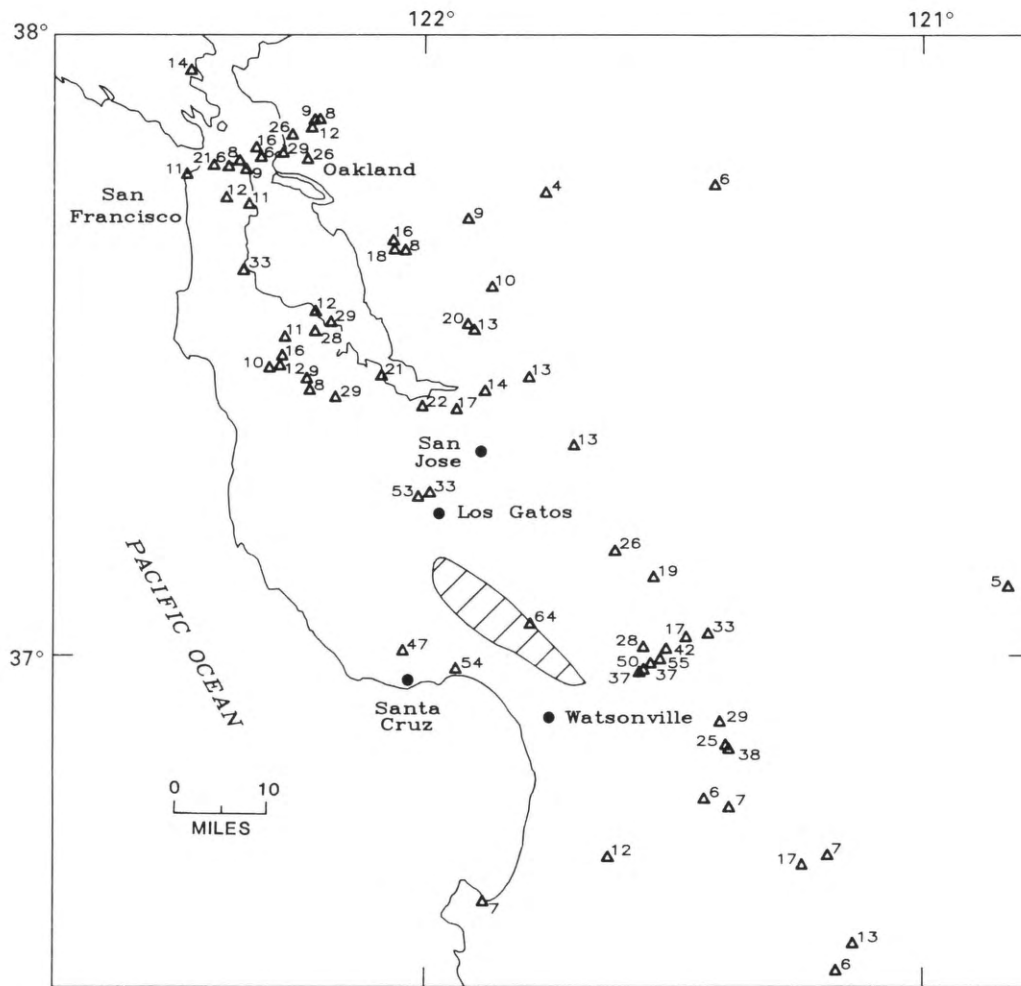
Figure 17. Free-field, peak horizontal acceleration, in percent gravity (32 feet per second per second), of ground motion during Loma Prieta earthquake measured from stations shown by triangles. Value plotted is larger peak acceleration of the two horizontal components of motion; vectorial peak motion would be even larger. Lined region is fault plane of mainshock projected to Earth's surface.

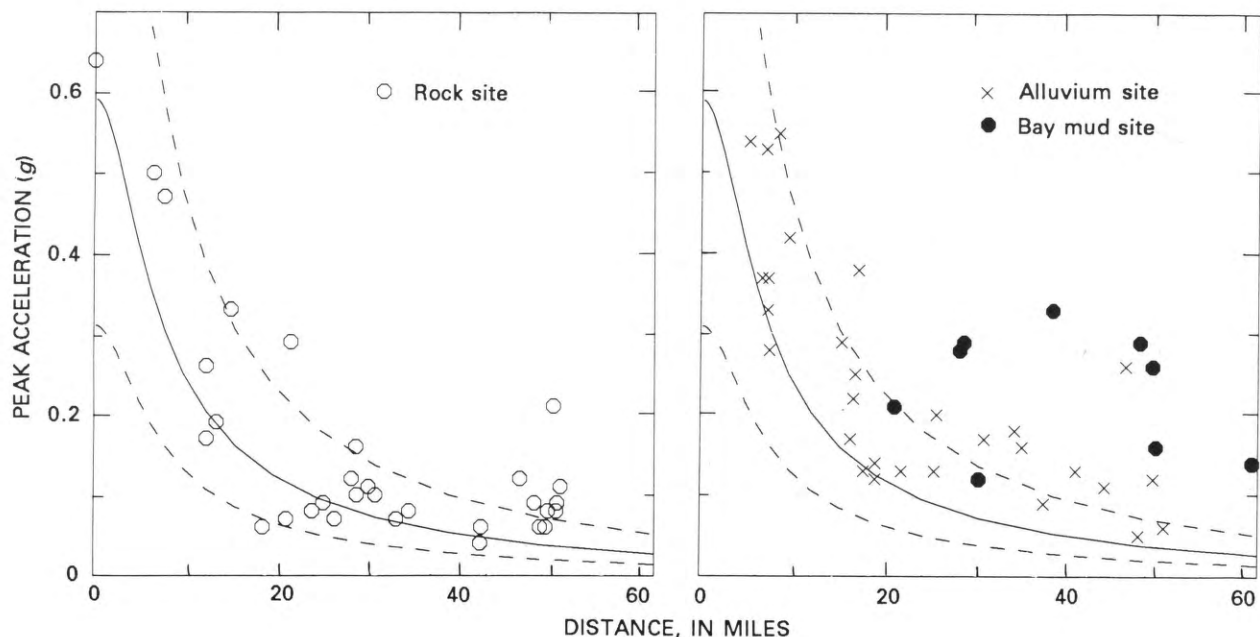
Figure 18. Peak horizontal accelerations of different geologic materials during Loma Prieta earthquake plotted as a function of closest distance from recording station to surface projection of fault (shown in fig. 17). Solid line is prediction of Joyner and Boore (1988); dashed lines indicate expected variation in individual observations. About two-thirds of observations should theoretically lie between dashed lines.

As shown in figure 18, the accelerations from rock sites are in reasonable agreement with the predictions. Although there is considerable scatter in the data, which is an inherent feature of representing a complex physical process by a single number, the points cluster about the expected value (solid curve). The recordings at soil sites as a group are systematically greater than the predictions for rock sites, with the accelerations at bay mud sites much larger than those from most of the alluvium sites. Relative to rock sites, ground-motion records obtained on young, poorly consolidated, water-saturated alluvial deposits and bay mud tend to be deficient in high-frequency amplitudes and enriched in lower frequency motion, the frequency-dependent amplification being a function of rigidity contrasts in the local geology and basin geometry. The effect of local geologic conditions is shown in figure 19, where the record from 1295 Shafter Street in San Francisco is the only one written at a hard rock site. The Emeryville and 575 Market Street records

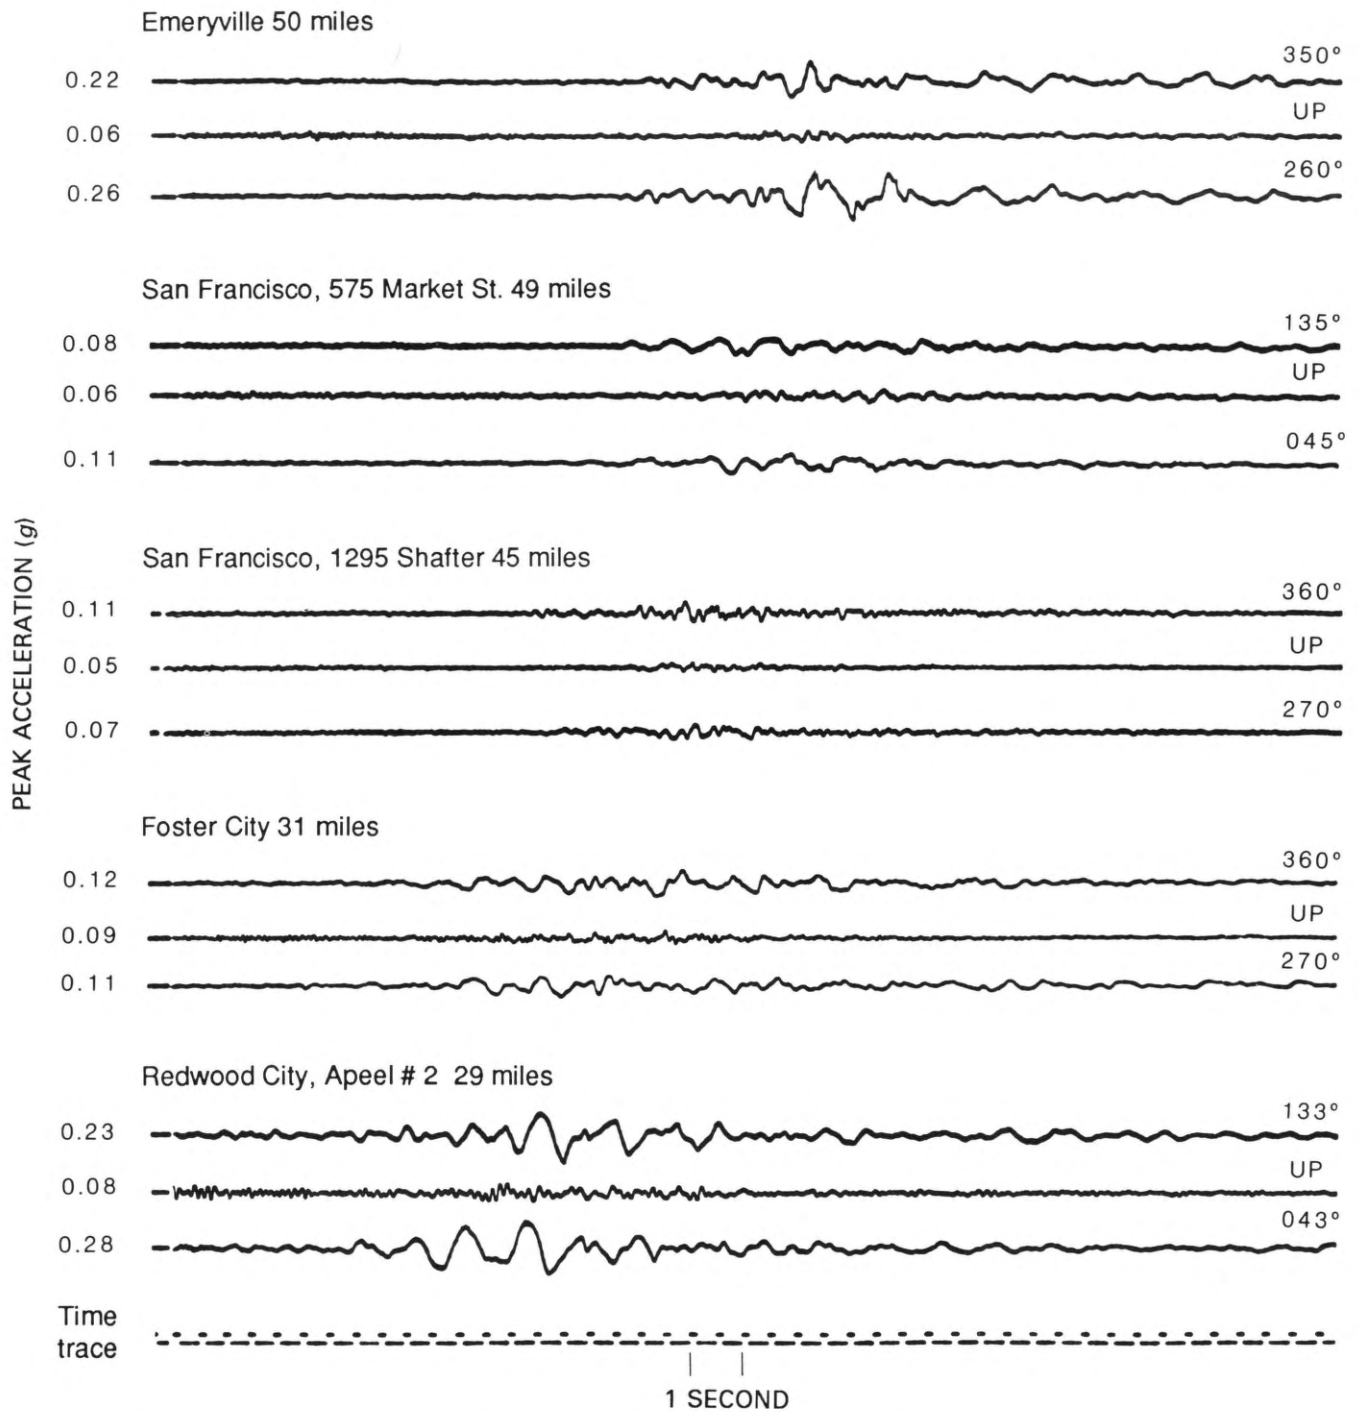
Figure 19. Three-component accelerograms from five stations, showing large difference in trace amplitudes between bedrock (1295 Shafter) and unconsolidated deposits (other sites). Stations arranged in order of decreasing distance from

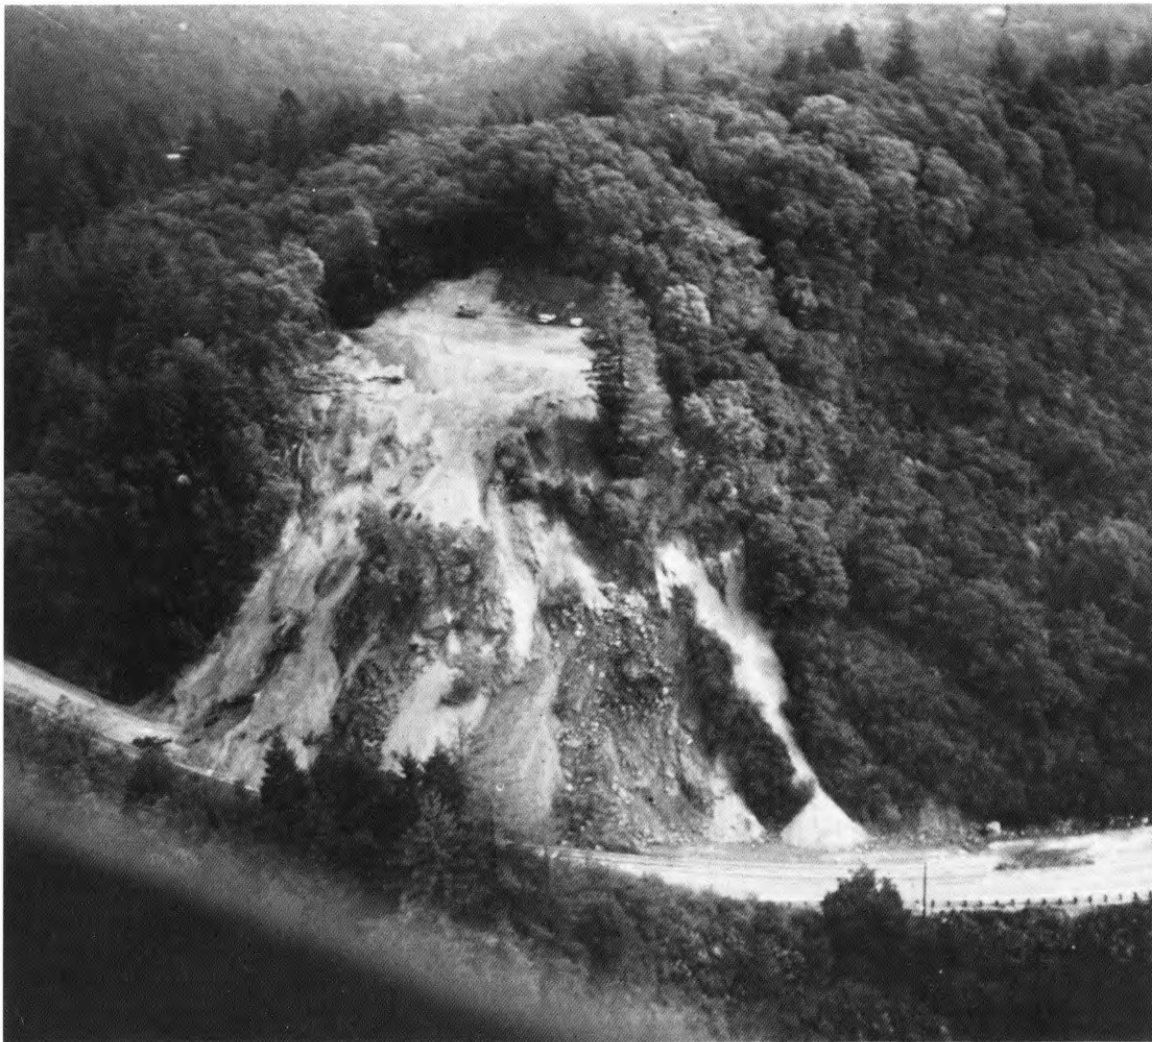
Figure 20. Aerial photograph of rock slide near summit of Santa Cruz Mountains that has an estimated volume of 6,000 to 10,000 cubic yards. Slide nearly completely blocked northbound lanes of Highway 17 that links Santa Cruz and surrounding

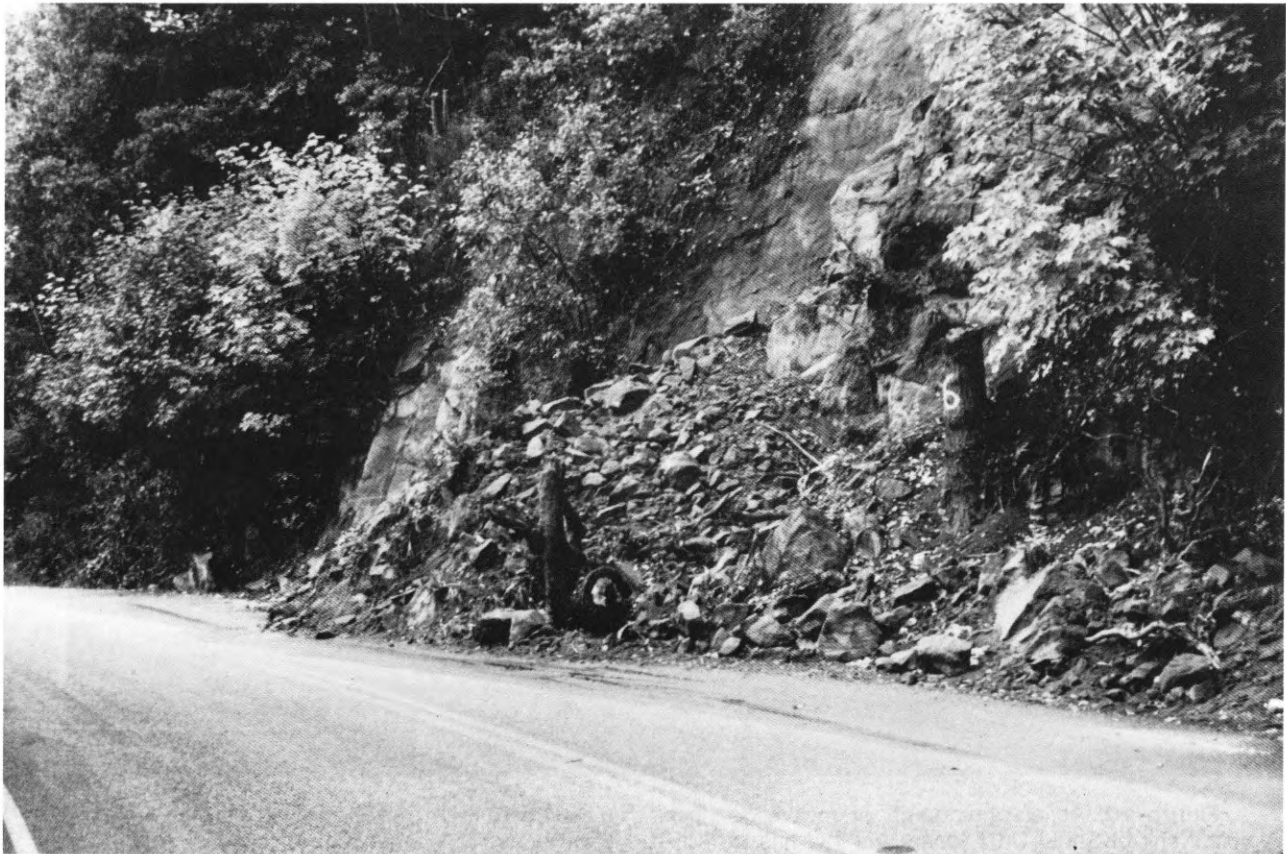
Figure 21. Small rock-fall deposit at roadcut, typical of those caused throughout Santa Cruz Mountains by Loma Prieta earthquake.

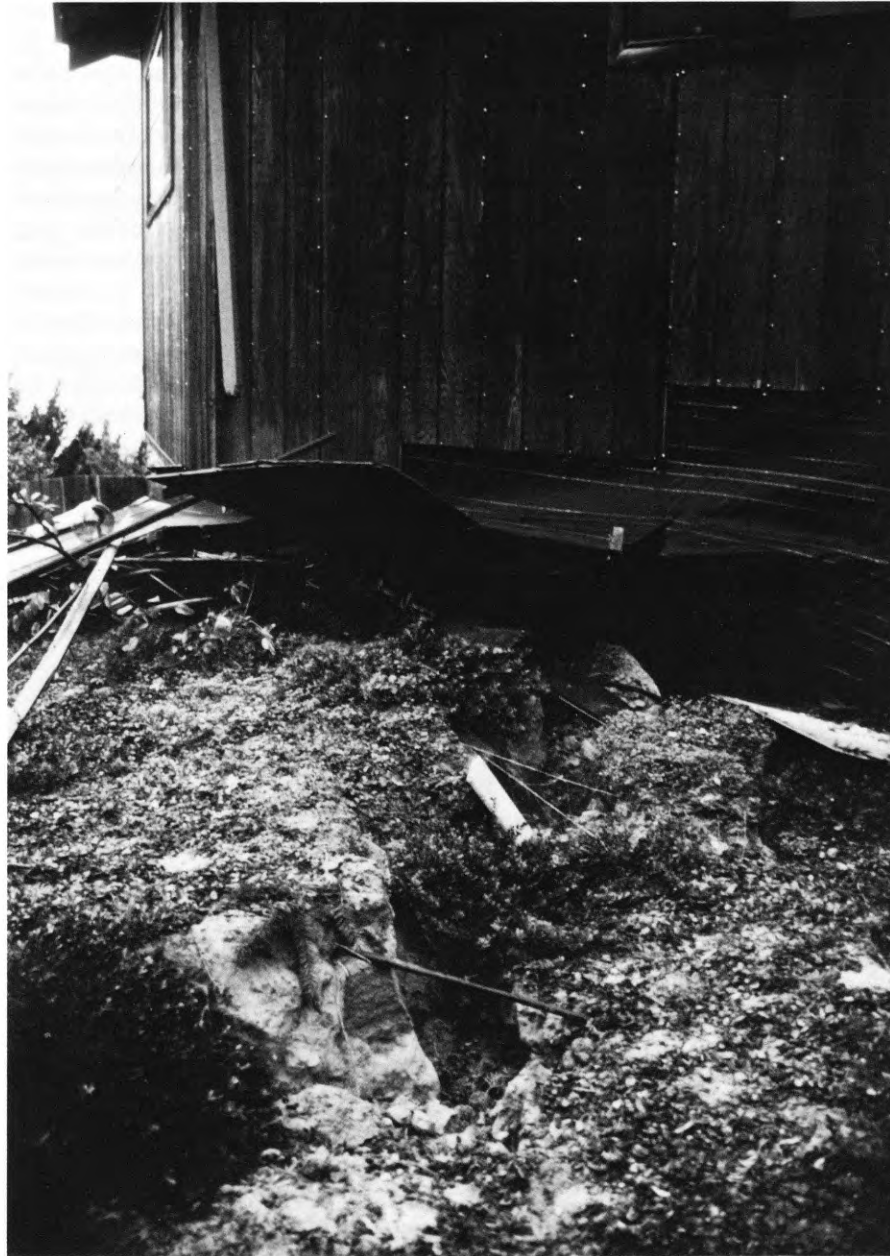
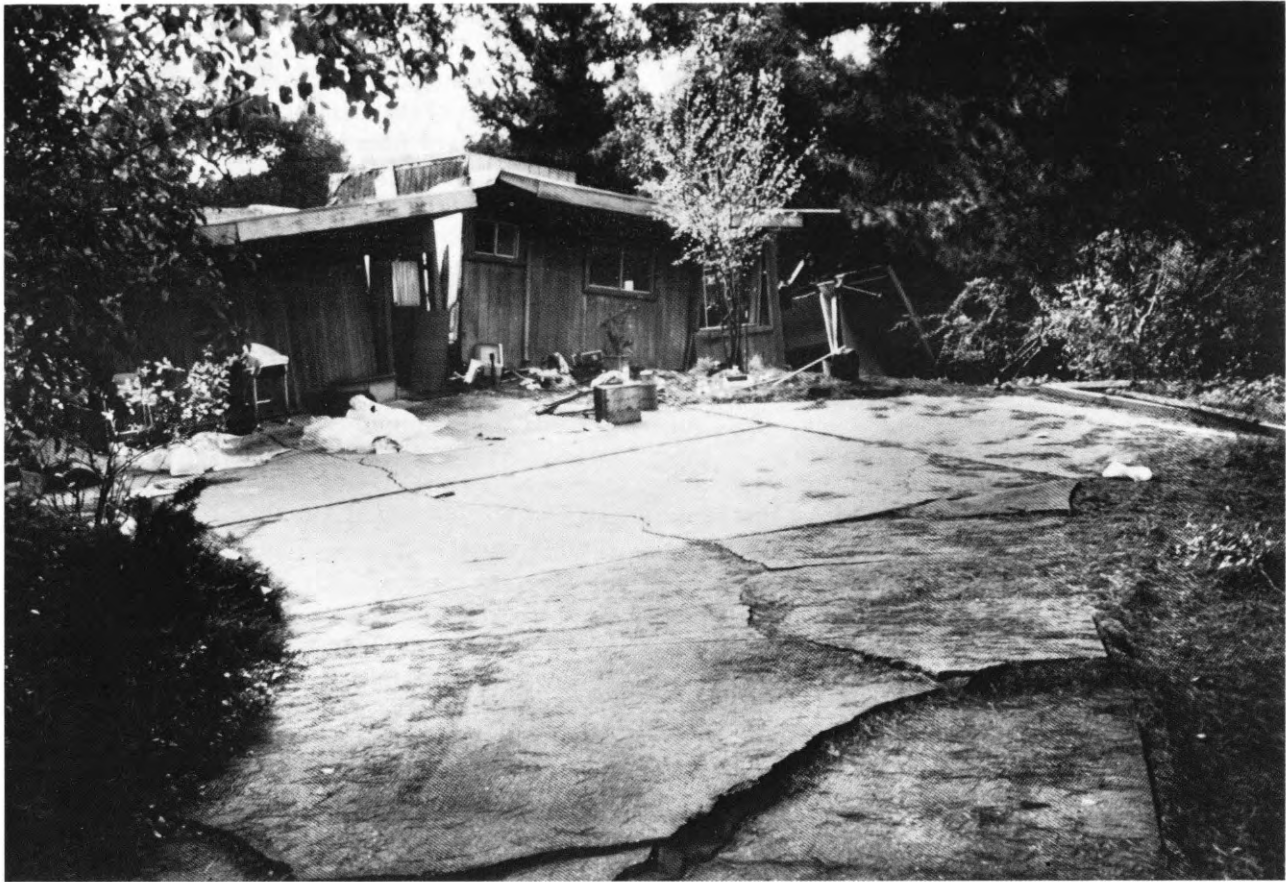
Figure 22. Scarps and cracks associated with movement of deep-seated slumps. *A*, Scarp at head of block slide in residential area of Brookdale in Santa Cruz Mountains. Block slide moved approximately 1.5 feet downslope (to right). Part of house to left of scarp remained on undisturbed ground while part to right moved downslope on slide block. Notebook on scarp is 8×10.5 inches. *B*, Home destroyed by landslide movement. Note cracks, from internal fissuring of landslide block, in pavement. Part of house on right has separated from part on left and tilted downslope as a result of differential movement within landslide block.

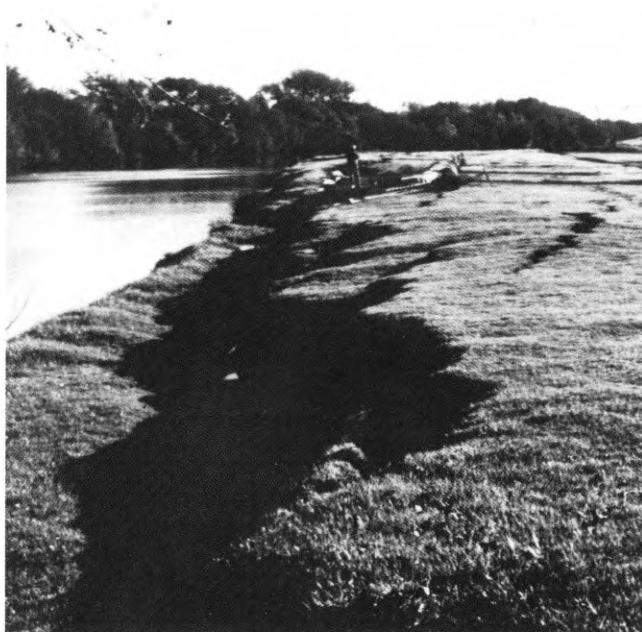
Figure 23. Lateral spreading along Pajaro River banks due to liquefaction.

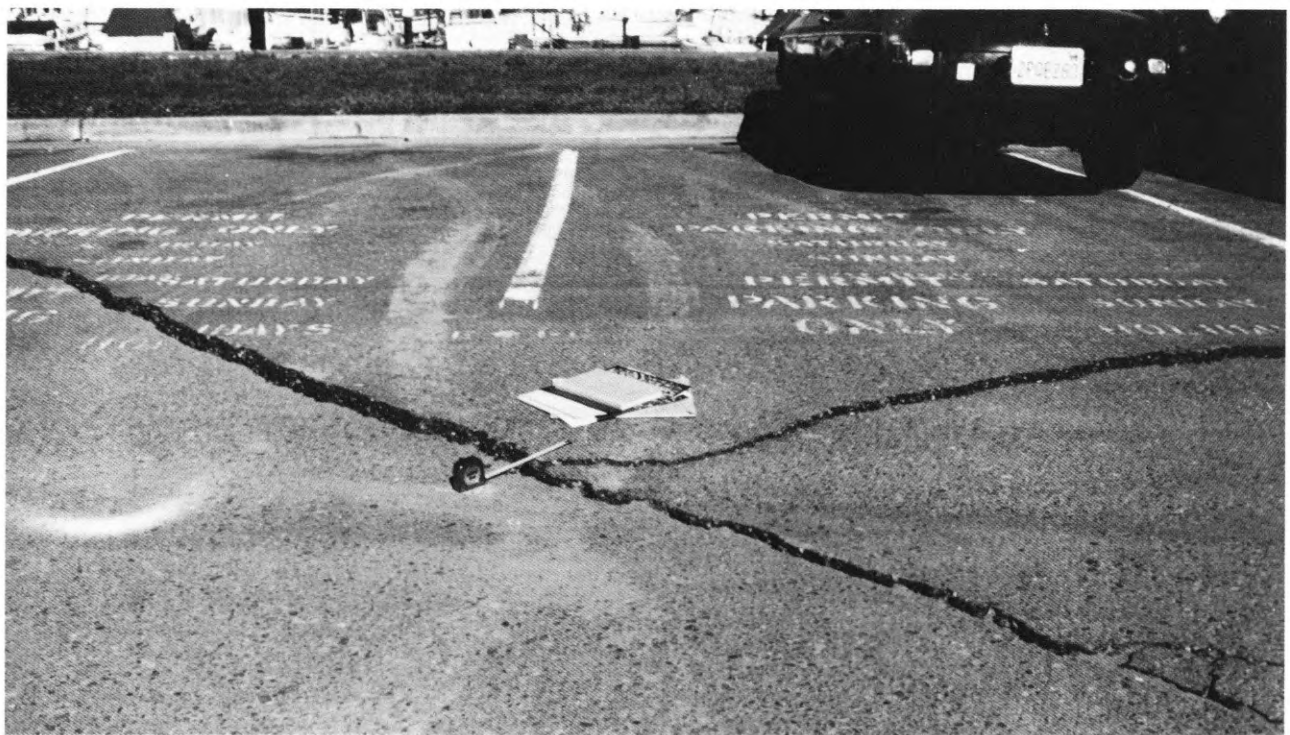
Figure 25. Extension cracks in Marina district formed by lateral spreading of liquefied sandy landfill.

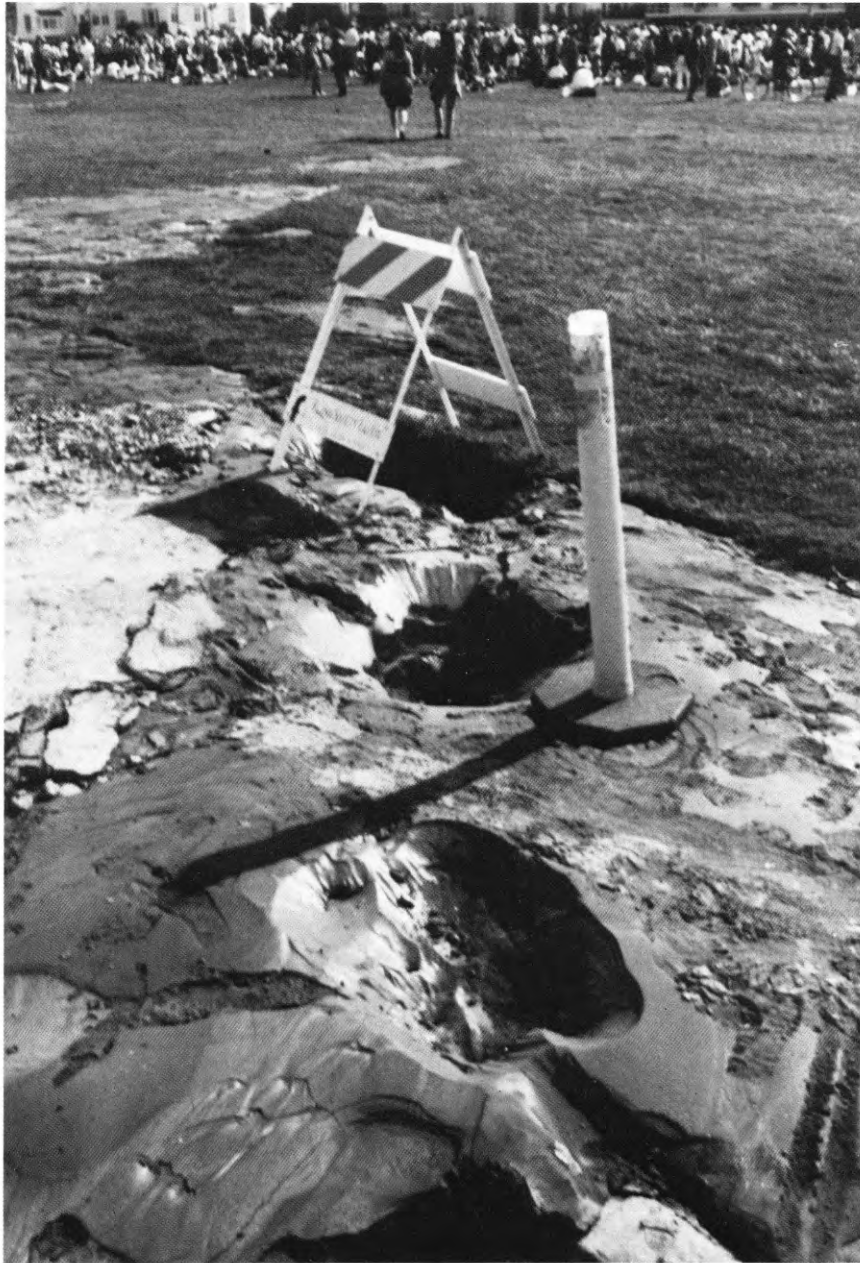
Figure 26. Sand boils formed by liquefaction in Marina district.

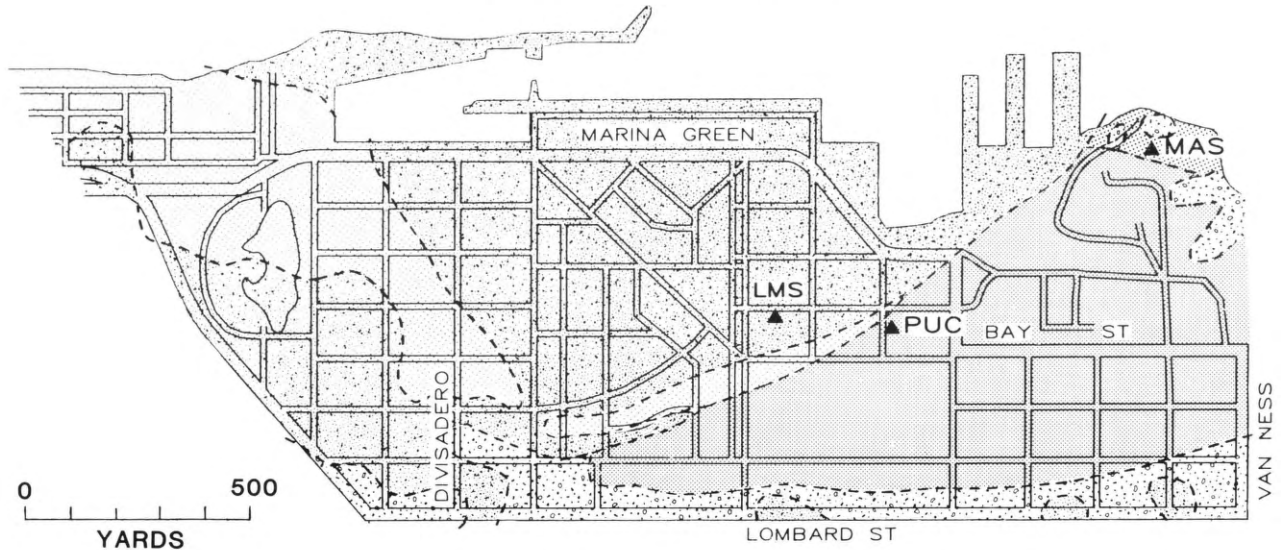
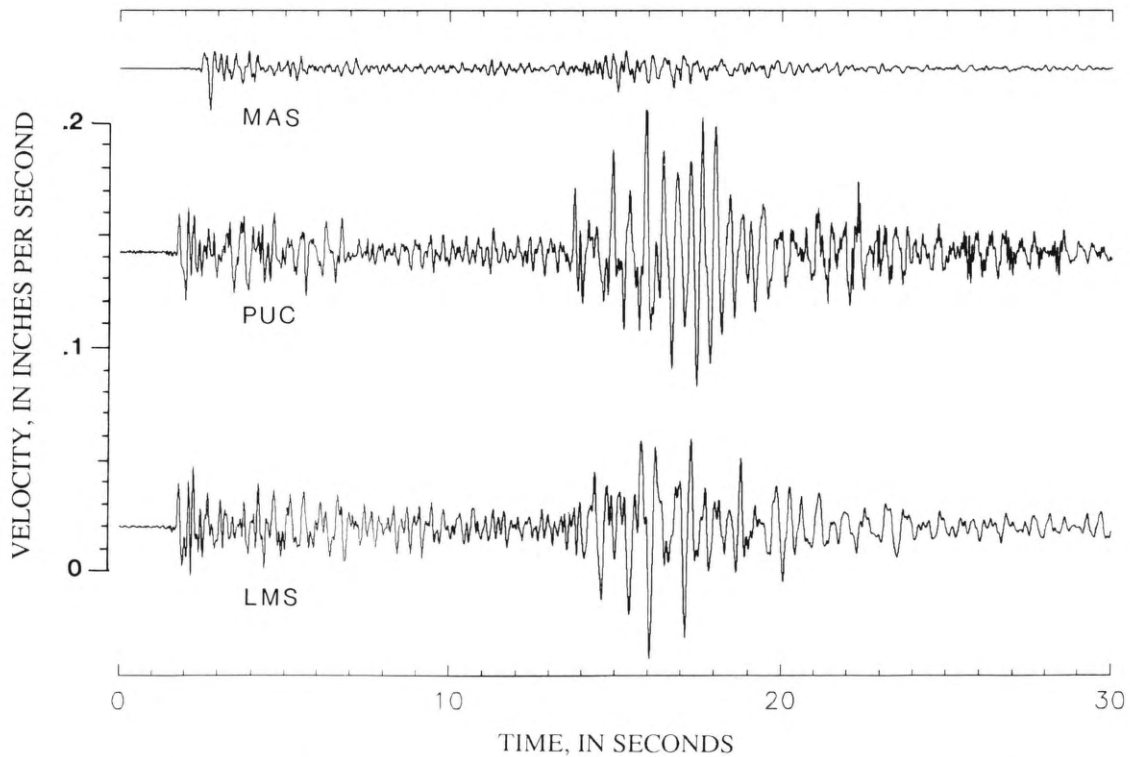
Figure 27. Three temporary seismograph stations in Marina district. *A*, Locations of stations and types of geologic material. *B*, Vertical velocities during a magnitude 4.6 aftershock on October 21, 1989, show amplification of ground motion in both damaged (LMS) and undamaged (PUC) areas in Marina district relative to ground motion on bedrock (MAS). Damage occurred in area underlain by artificial fill.

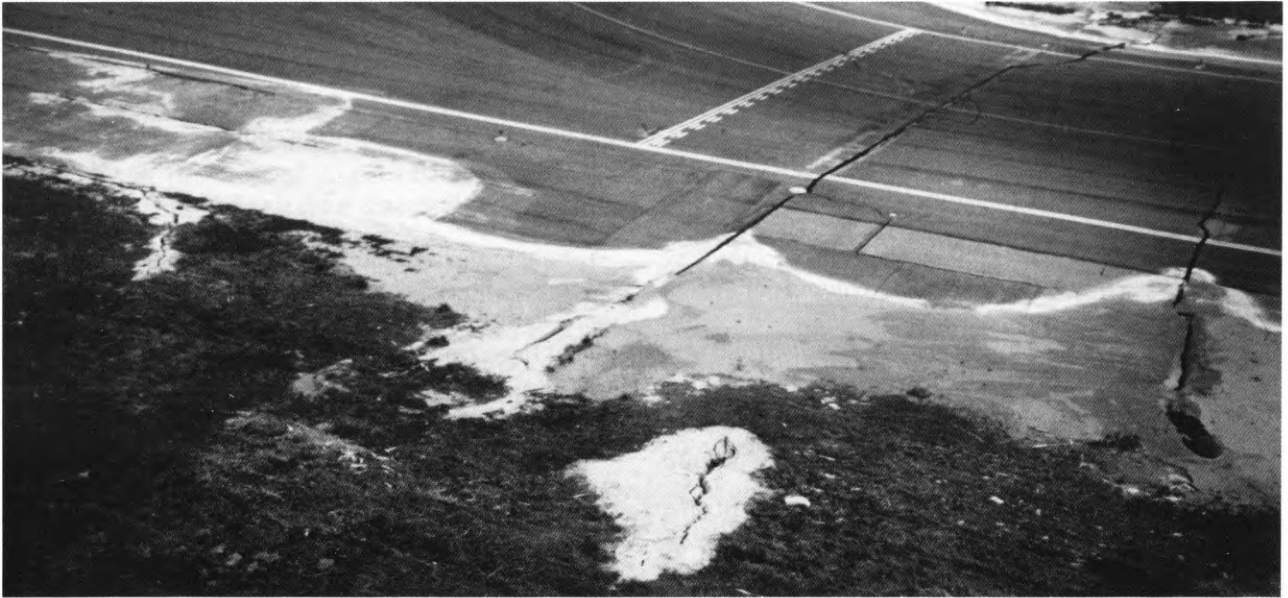
Figure 28. Sand boils at Oakland International Airport.

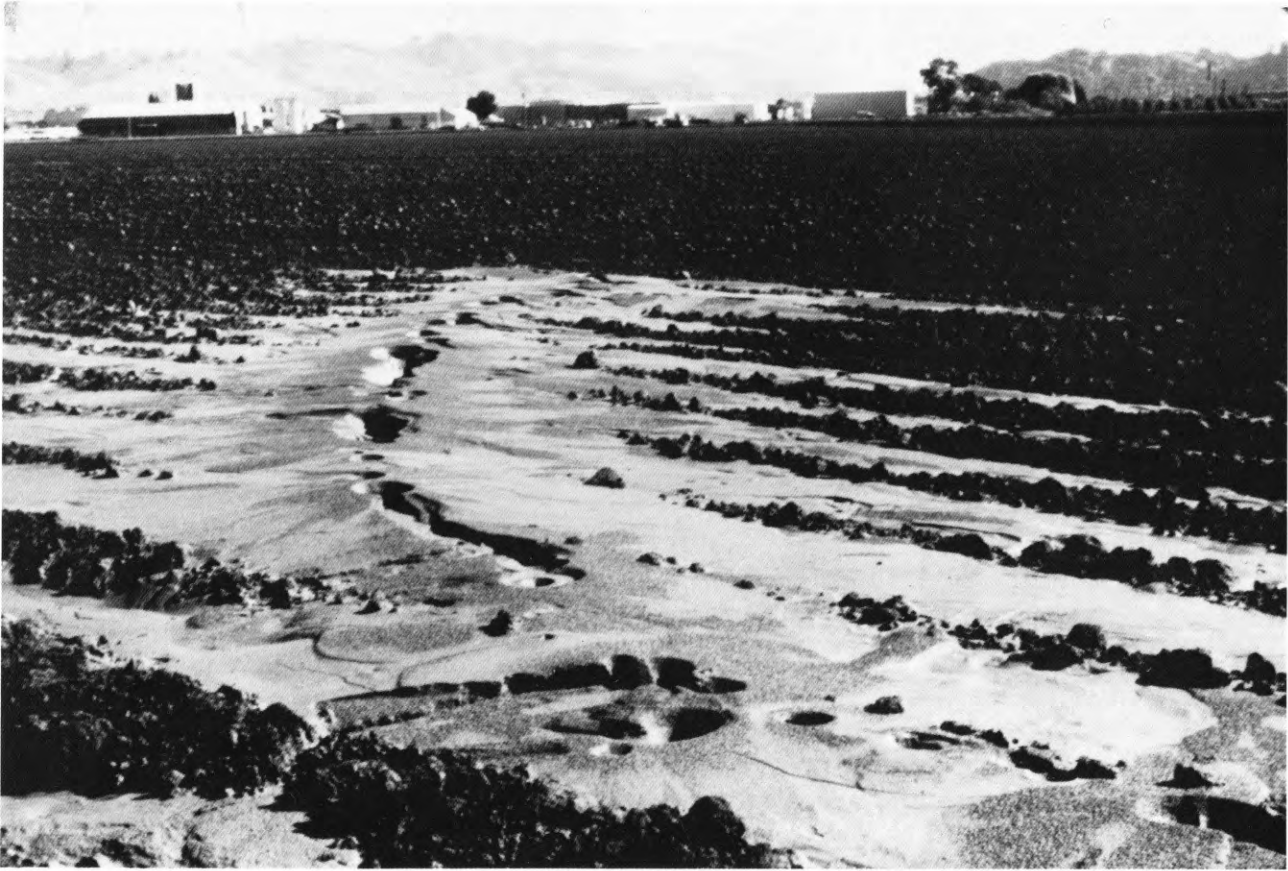
Figure 29. Sand boils in irrigated fields near Hollister.

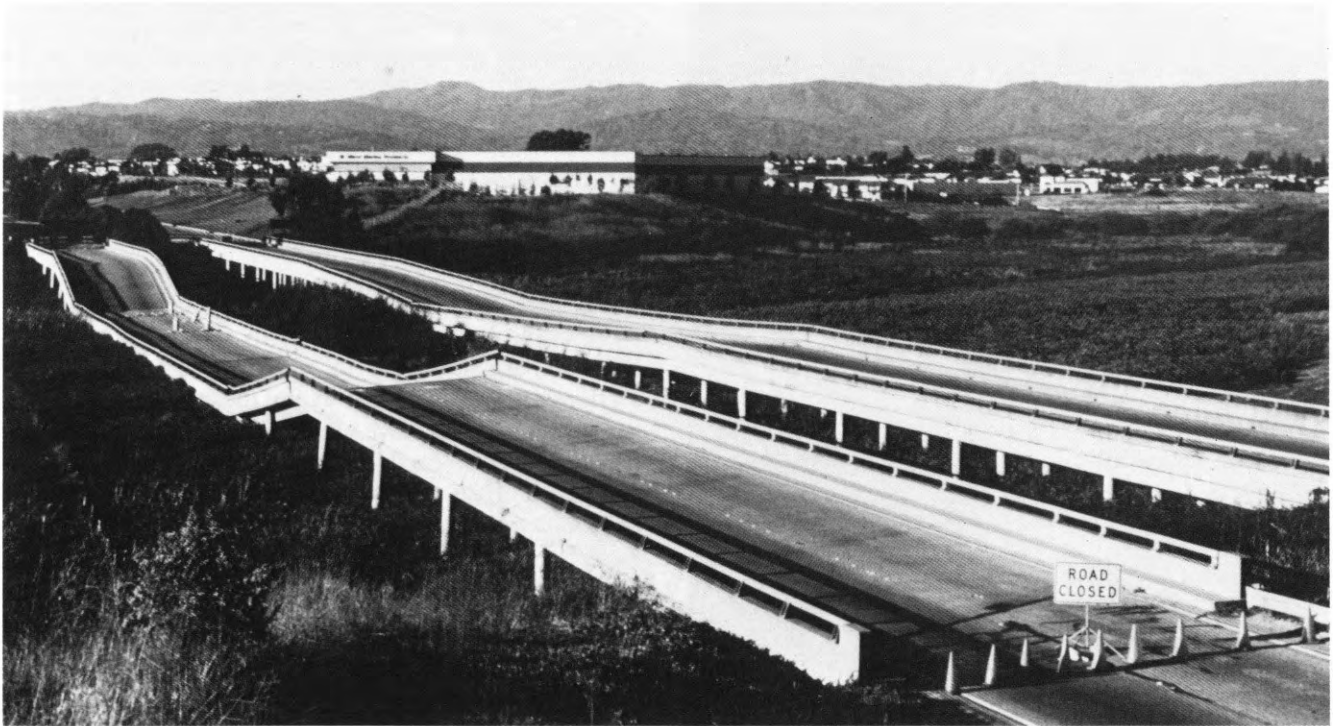
Figure 31. Highway 1 bridge destroyed by strong shaking and liquefaction of river deposits at Struve Slough.

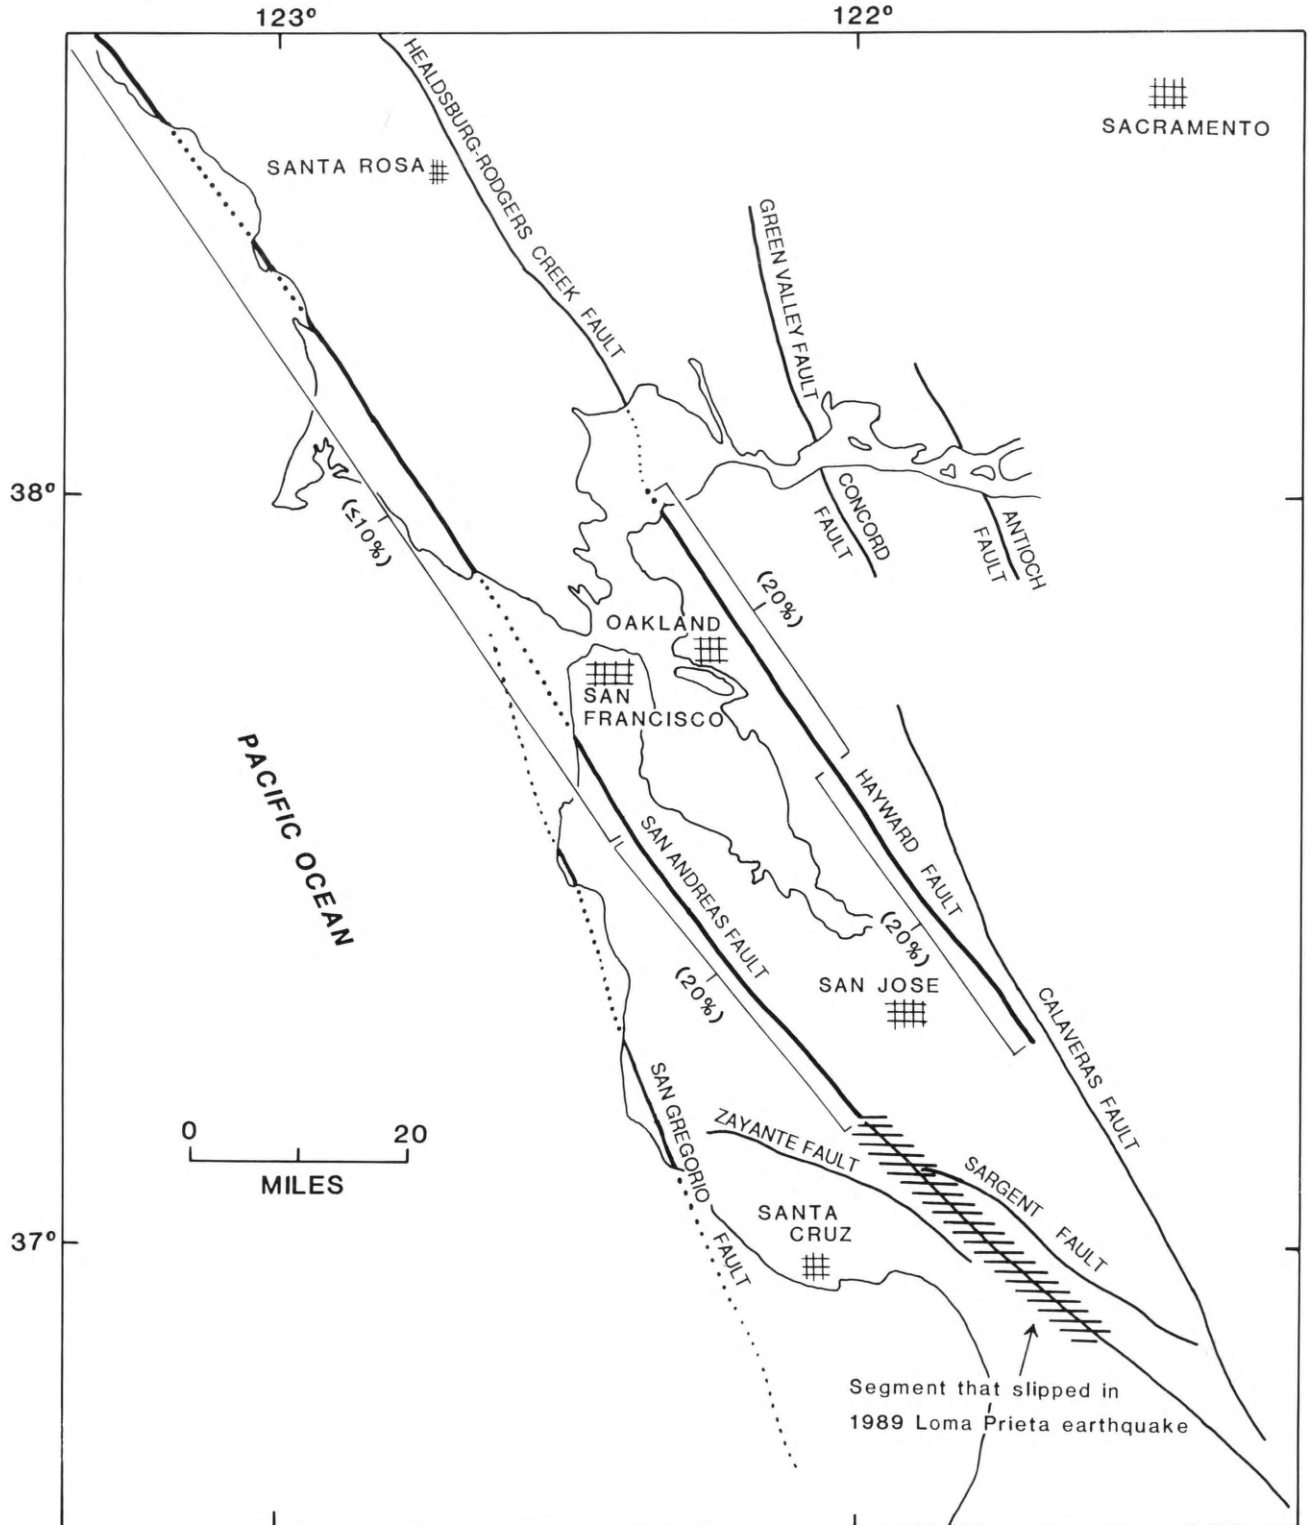
Figure 32. Segments of San Andreas and Hayward faults (heavy lines) showing chance of occurrence of an earthquake in the next 30 years (U.S. Geological Survey, 1988). Faults dotted where concealed.

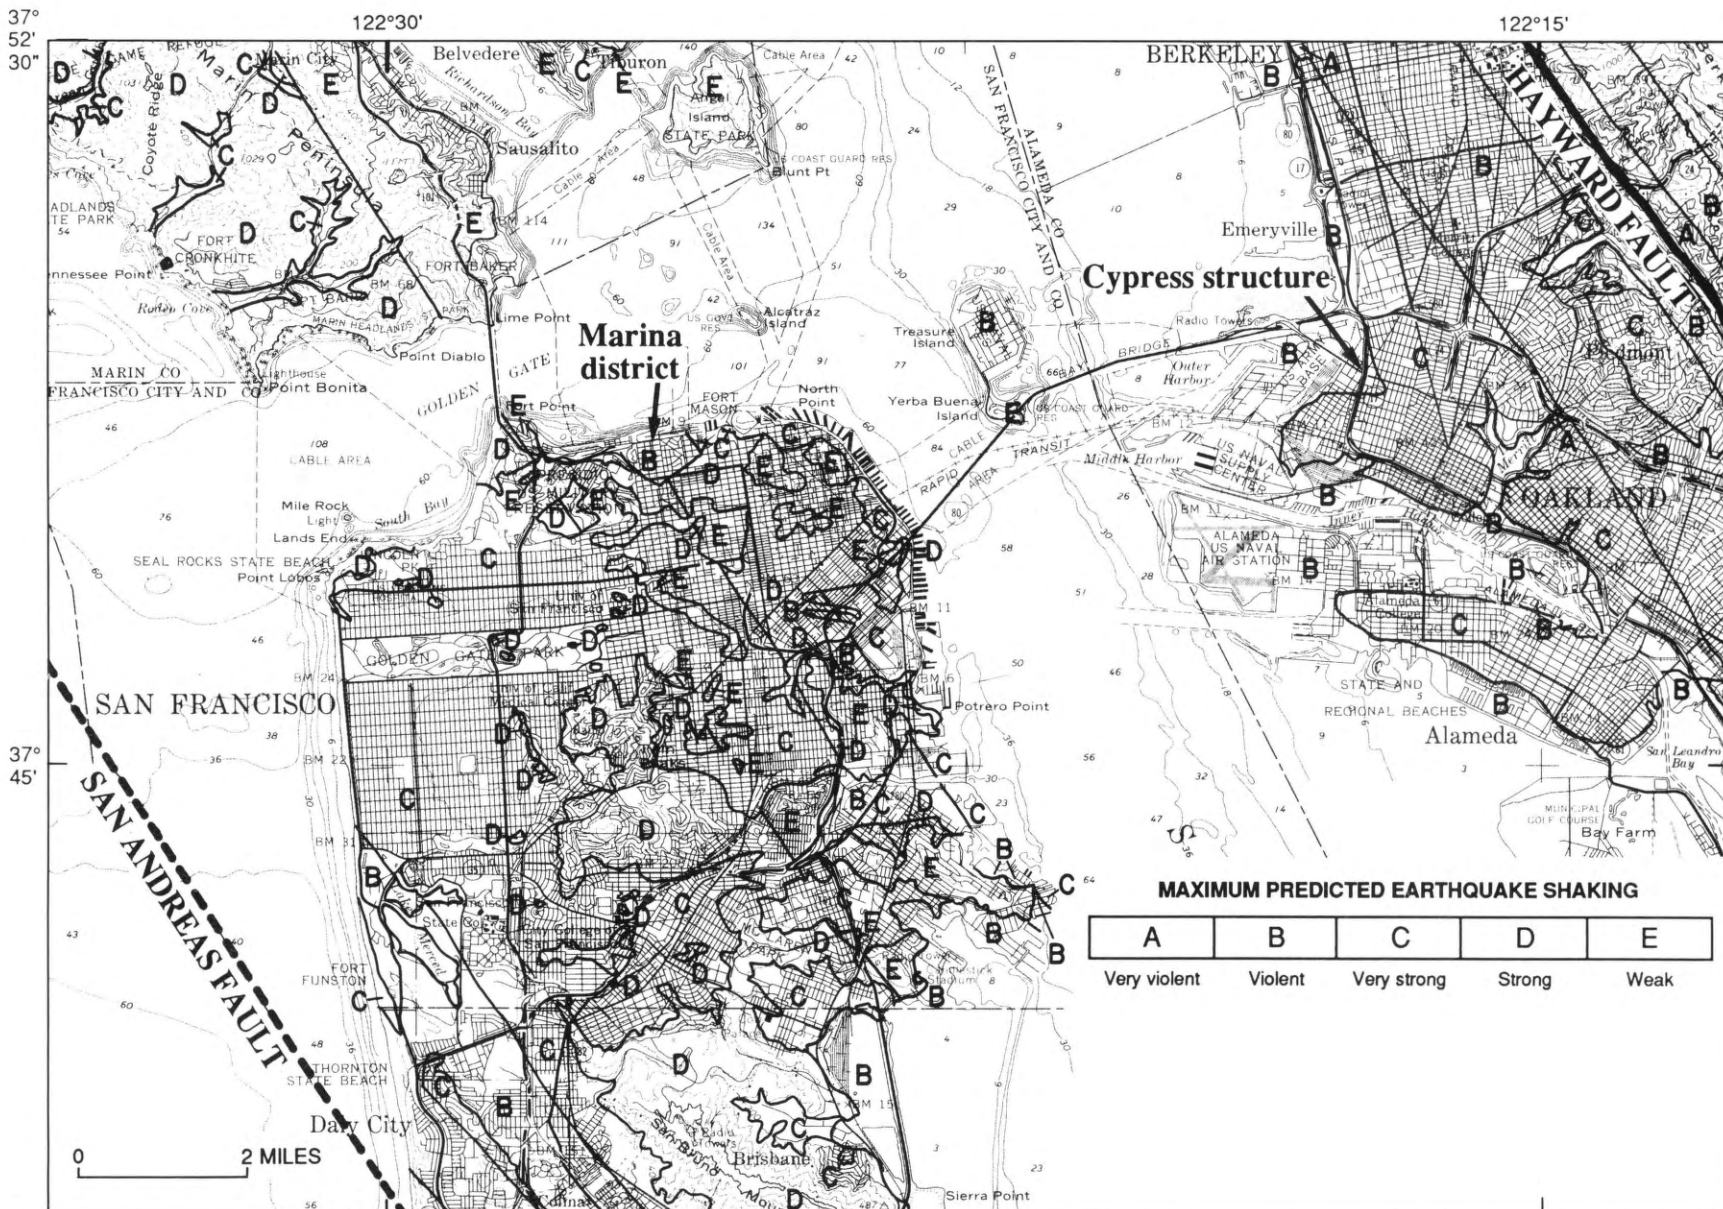
Figure 33. Predicted maximum intensity of ground shaking (lettered areas) from large earthquakes on San Andreas fault (heavy dashed line) and Hayward fault (heavy solid line). Map from Borchardt and others (1975). Areas marked A apply to earthquake on Hayward fault but not to more distant Loma Prieta earthquake. Damage will be influenced not only by shaking but also by ground failure and design and construction quality of structures.
